Bundesstelle für Seeunfalluntersuchung
Federal Bureau of Maritime Casualty Investigation

Investigation Report 285/20

Serious Marine Casualty

**Allision with a lock gate at Kiel-Holtenau on the
Kiel Canal (NOK) by the multi-purpose vessel ELSE
on 29 August 2020**

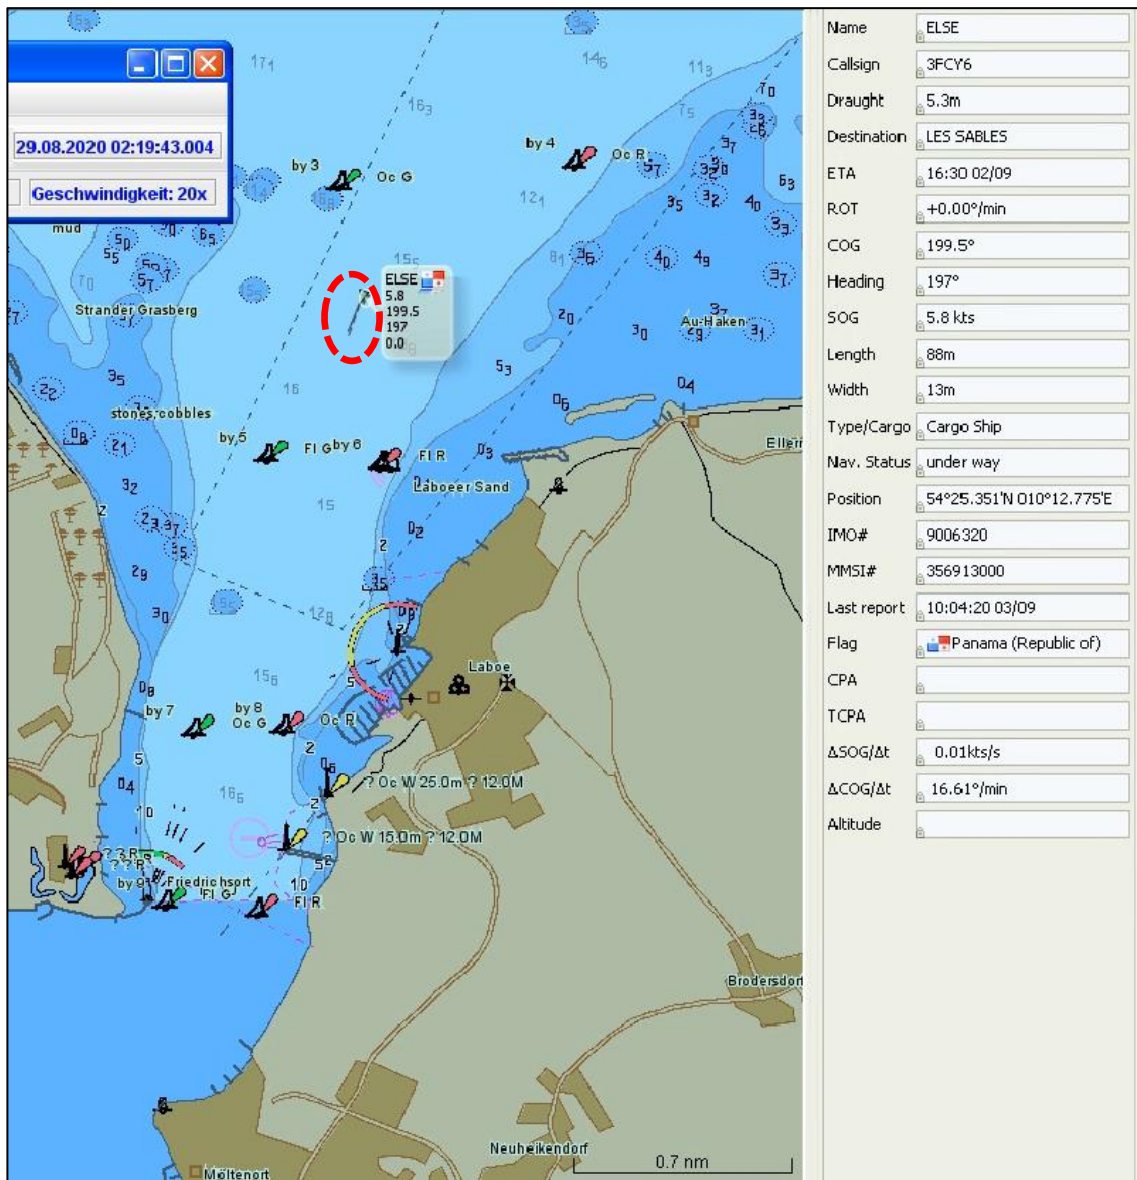
Figure 25: Position of the ELSE in the fairway between buoys 3 and 5 at 0420⁴³

The following screenshots (**Figures 25 ff.**) of the course of the ELSE's voyage are taken from the AIS recording of the WSV. They confirm that the ship (outlined in red in the below figures) initially used the buoyed fairway completely inconspicuously and in accordance with the rules and observed the course alteration points due to the course of the fairway on Kiel Fjord until she reached the pilot boarding point at the southern edge of the Holtenau roadstead. The ship's SOG was a consistent 5-6 kts throughout the voyage, until immediately before the allision with the lock gate.

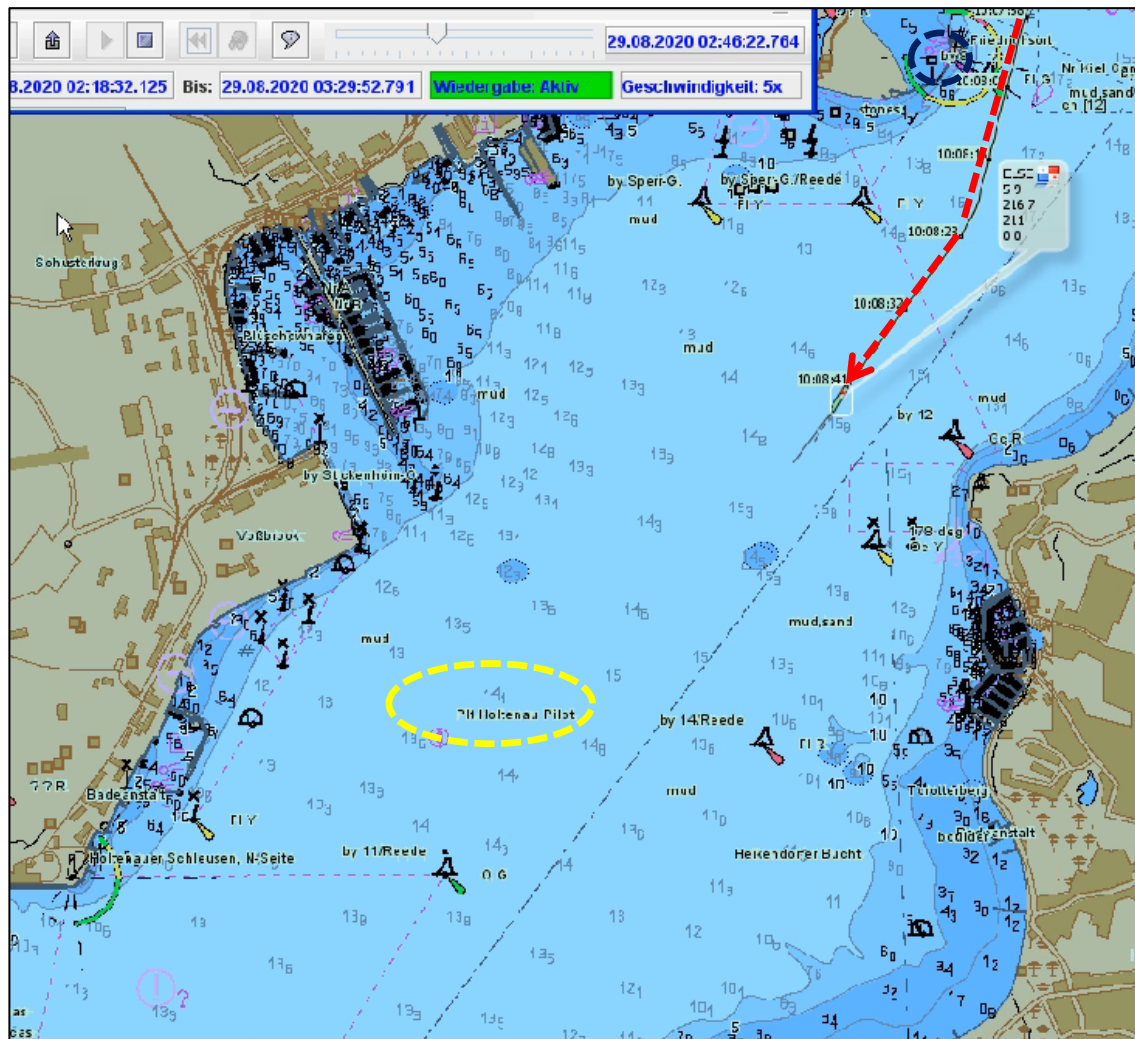
Figure 26: Course of the ELSE's voyage (red highlighting) after passing buoy 9⁴⁴ (in this case up until 0446)

Shortly after passing fairway buoy 9 (level with Friedrichsort Lighthouse), the ELSE duly altered course for the Holtenau roadstead at **0442** (see **Figure 26** below).

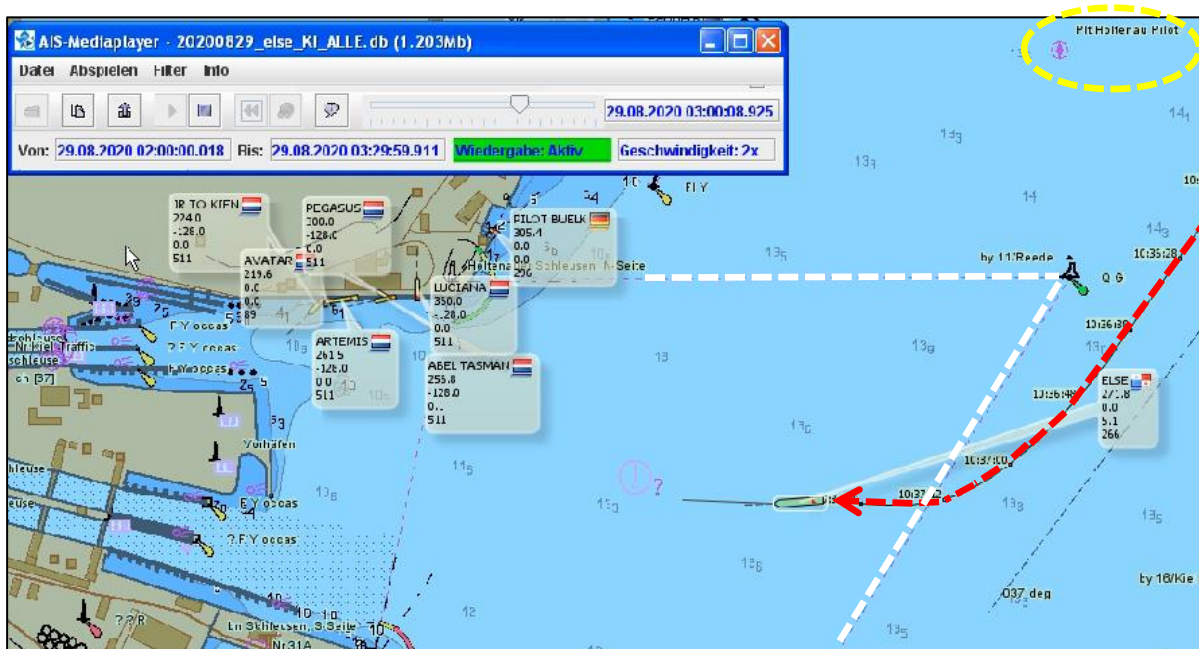
Figure 28: The ELSE alters course towards the entrance to the lock (track here until 0500)

Shortly afterwards (from about **045630**), the ship began to make a continuous course alteration to starboard, turning into VTS NOK's area of responsibility at about **0458** (see white boundary marking in **Figures 28 ff.**). The ELSE then maintained a more or less constant course (or rather even with minor course adjustments and at an unchanged speed) directly towards the entrance to the north chamber of the 'Neue Schleuse' lock. She inevitably sailed into the closed lock gate at **0507** (see **Figures 29 f.**).

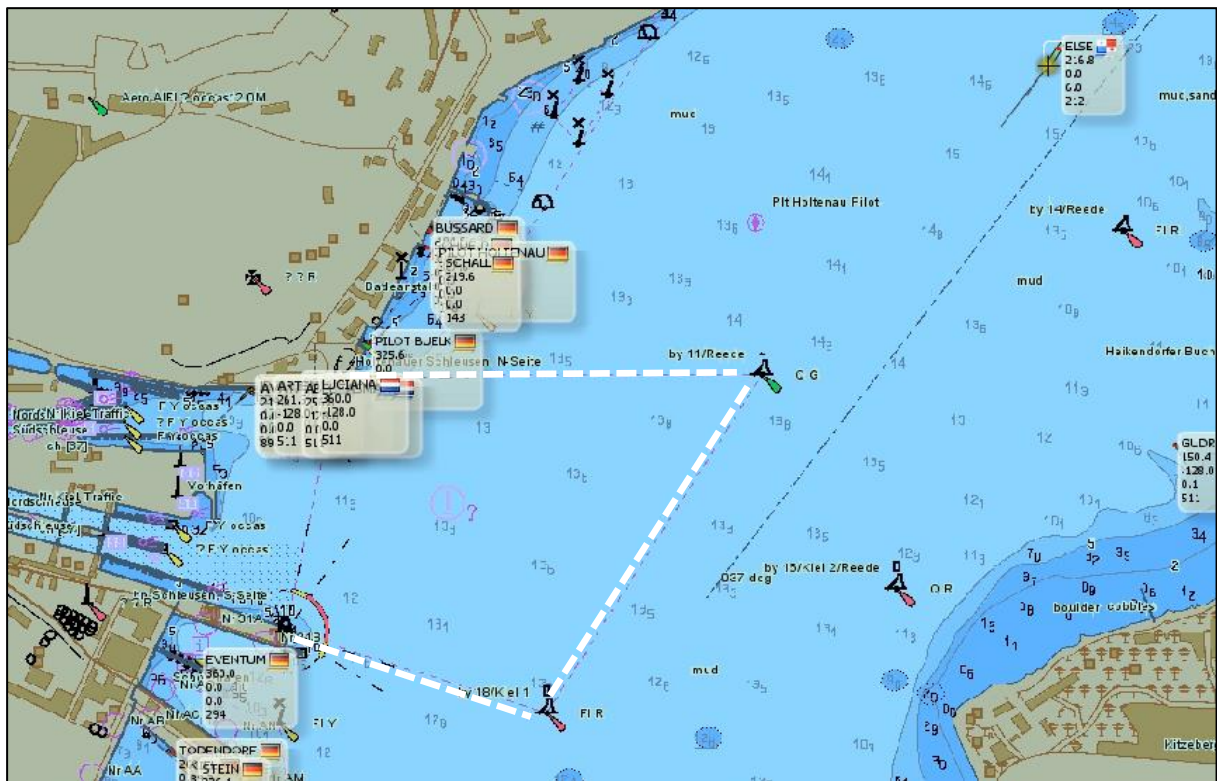
Figure 31: Entrance to the NOK lock facility at Kiel-Holtenau;
boundary of the areas of responsibility of the VTSS⁵²

5.) Accordingly, the following responsibilities apply to the navigation police control of traffic in the approach to the NOK (coming from the Baltic Sea; see the boundaries of the area of responsibility marked in white below in **Figure 31**):

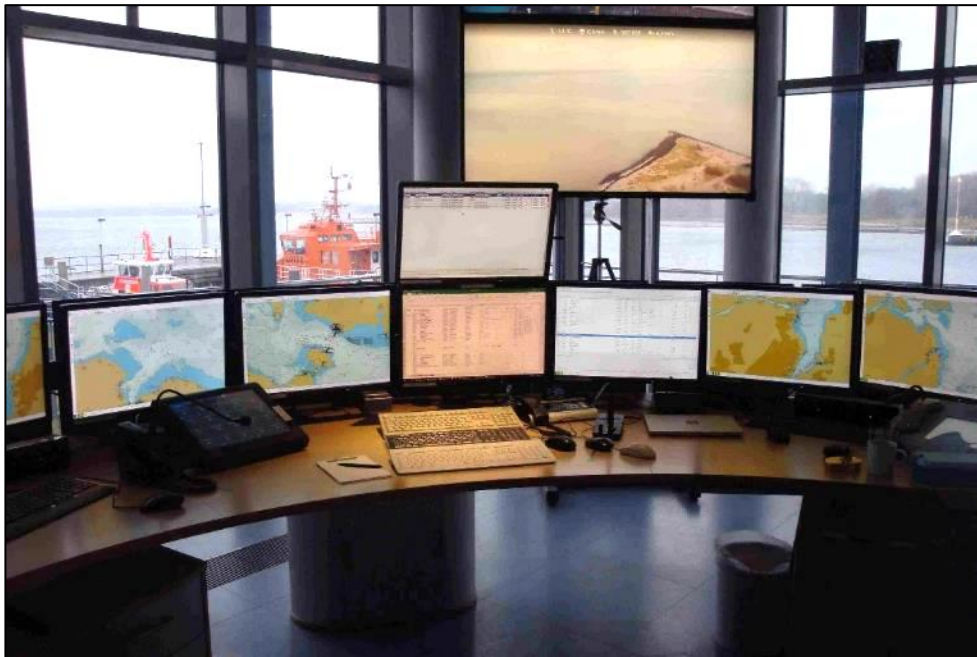
Figure 32: Kiel Traffic workstation at VTS Travemünde

8.) The then completed tour of the VTS's traffic control room provided an insight into the extremely spacious layout and modern technical equipment of the workstations of the nautical staff controlling traffic in the various sectors (see **Figure 32** below by way of example, which shows the workstation of the nautical staff responsible for Kiel Fjord).

b) Particular attention was given to the survey of the workstation of the nautical staff responsible for Kiel Fjord (see **Figure 32** above). The nautical staff on duty at that time provided information about his work and in this context explained that although he is usually aware of whether a vessel destined for the NOK has already requested a pilot via the information on his screen, which is linked to the ship data processing system, VTS Travemünde would not normally pay any particular attention to this question because direct contact between the pilot station and respective vessel is reportedly provided for.

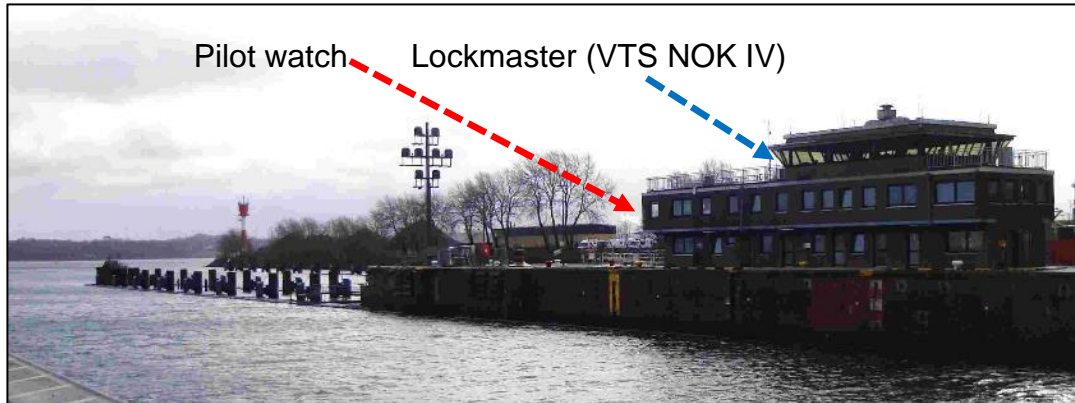
Figure 34: Lock control station on the middle wall of the lock in Kiel-Holtenau

a. The offices in question (or corresponding pilot coordination centre) are located at the seaward forward edge of the control station on the middle wall of the 'Neue Schleuse' lock at Kiel-Holtenau (**Figure 34**).

i. The pilot watch and VTS NOK IV (lockmaster) have their offices on adjacent floors of the control station (see **Figure 34** above). 'Barrier-free' communication, as would be possible if they were in the same room (or an open-plan room), is therefore out of the question.⁶⁰

12.) During the survey of the lockmaster's workroom, the investigation team was able to view its spacious layout and modern equipment. The room takes up the entire top floor of the control station and has window fronts on all four sides (see **Figure 34** above). These allow for a panoramic view of the lock facility.

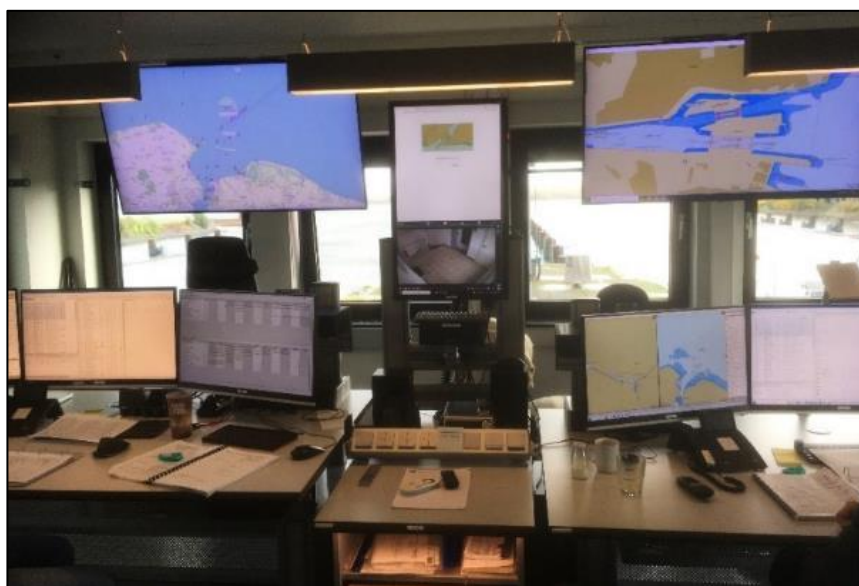
Figure 35: Workstations of the watch supervisor and his assistant (Kiel-Holtenau pilot watch)

The second room contains the watch station (see **Figure 35** below). The room has window fronts on three sides, which allow for a reasonably good view of the lock entrance area (and with certain restrictions also of the actual lock chambers and walls). There are also two large monitors above the forward window front. They map the traffic situation in the lock entrance area and in the area of Kiel Lighthouse/Fjord.

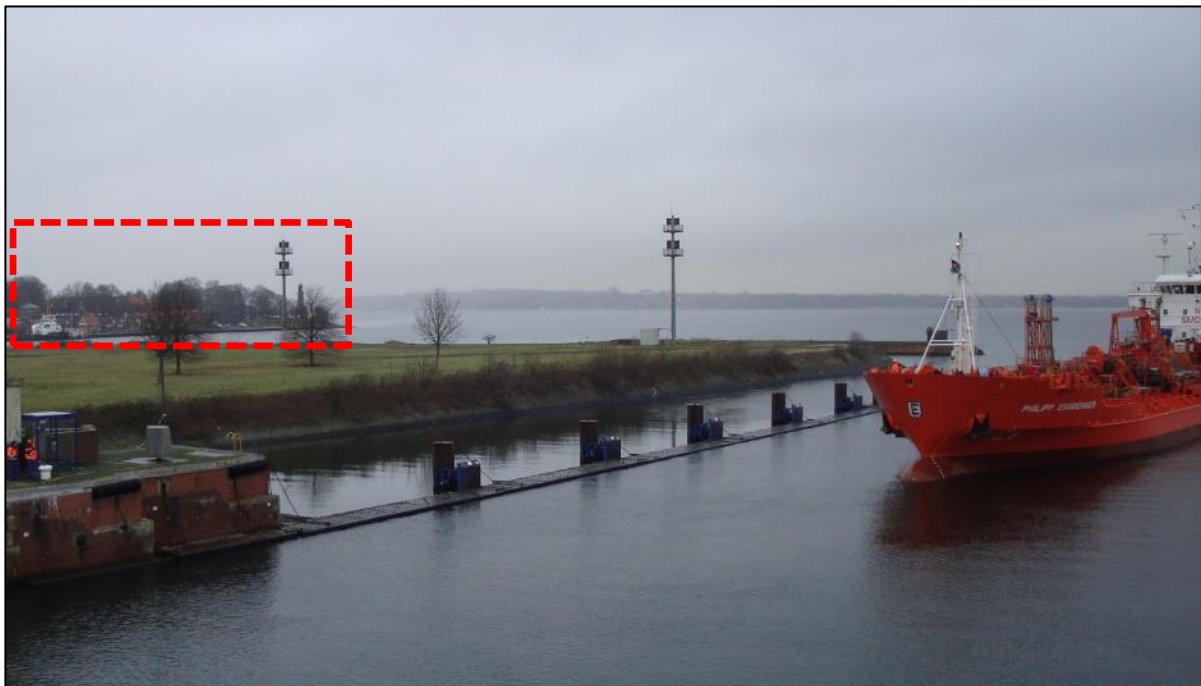
Figure 36: View from the lock control station in Kiel-Holtenau towards Kiel Fjord

However, the view of the approach to the canal on the Baltic Sea side is significantly restricted by Kiel Fjord's western shore area in the vicinity of Holtenau. A direct view of the pilot boarding point at a distance of 1 nm to the north-east or even of the area of Kiel Fjord situated to the north of it is impossible due to the geographical conditions (see the headland highlighted red below in **Figure 36**, which prevents the view of the pilot boarding point and course of Kiel Fjord there).

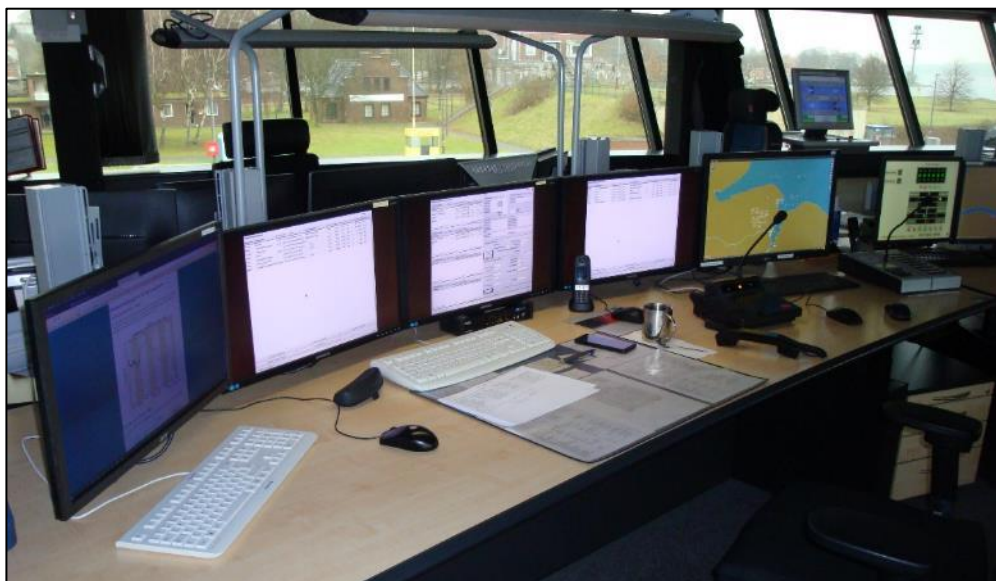
Figure 37: Chief lockmaster's workstation in the lock control station at Kiel-Holtenau

14. The workstations of the chief lockmaster and his assistant are equipped with various screens. One monitor shows the traffic situation on the fjord on an electronic chart, thus providing an overview of the vessels in the approach. The other screens illustrate the traffic in the canal (in the form of a distance-time diagram), the lock approach (in tabular form, canal- and sea-side), the lock signals (lights) and the occupancy of the lock chambers (see **Figure 37**).

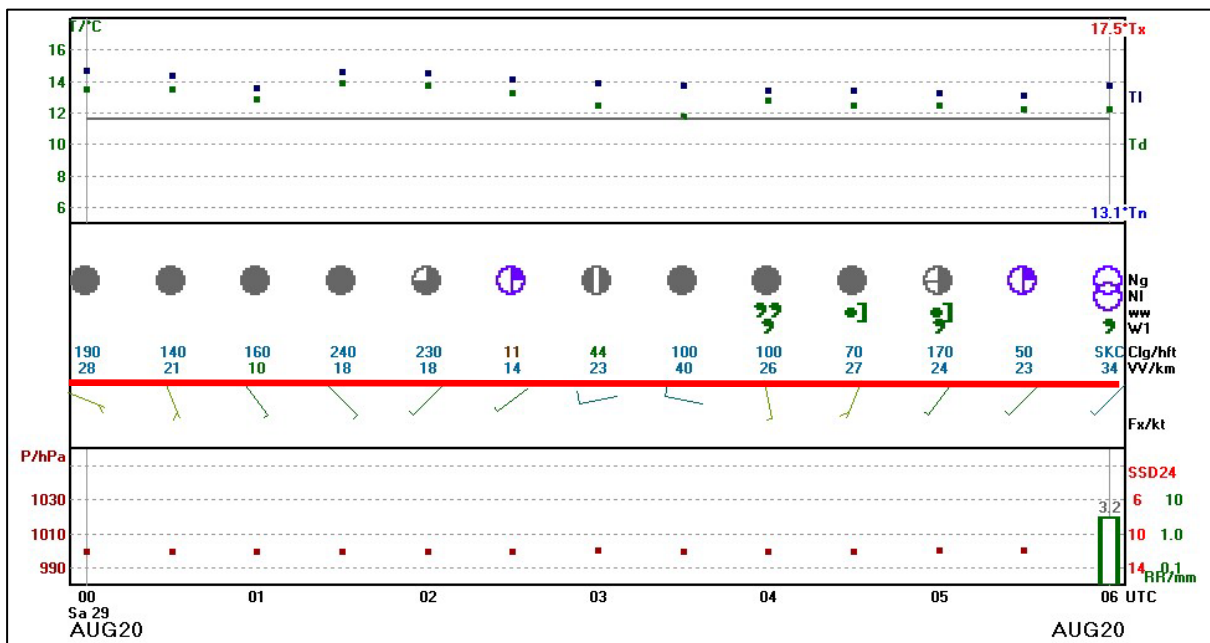
Figure 38: Ground weather reports for Kiel-Holtenau on 29 August 2020 (DWD)

The overview taken from the official report (see **Figure 38** below) contains the ground weather reports from the Kiel-Holtenau weather station on the day of the accident for the period 0000 to 0600 UTC. It also shows that the weather conditions were benign. In particular, good visibility prevailed at the time of the accident (see the red underlined row in the overview with visibility figures in km).

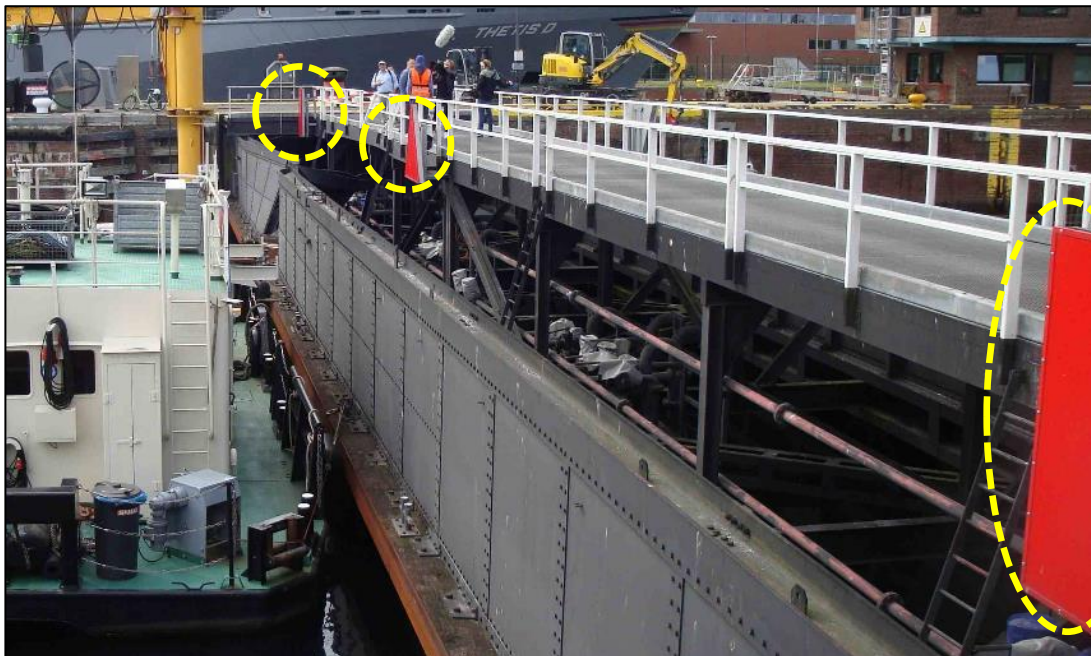
Figure 42: Position of the three warning lamps at the top edge of the closed lock gate

In addition to the traffic control signal installations, three large red warning lamps are mounted on the upper edge of the respective lock gate on its right-hand side, in the middle and on the left-hand side (left and right in the form of a rectangle in vertical format and in the middle in the form of a triangle; see **Figures 41 f.**). This warning system informs ship's commands and pilots clearly and unambiguously that the lock gate is closed if, for example, the above-mentioned signal installations have failed and/or the closed gate's contours cannot be clearly identified in the dark or due to other visual restrictions.
