Issued October 27, 2022

MIR-22/27

Collision Between Liquefied Petroleum Gas Carrier *Gas Ares* and Moored Tug *Sabine*

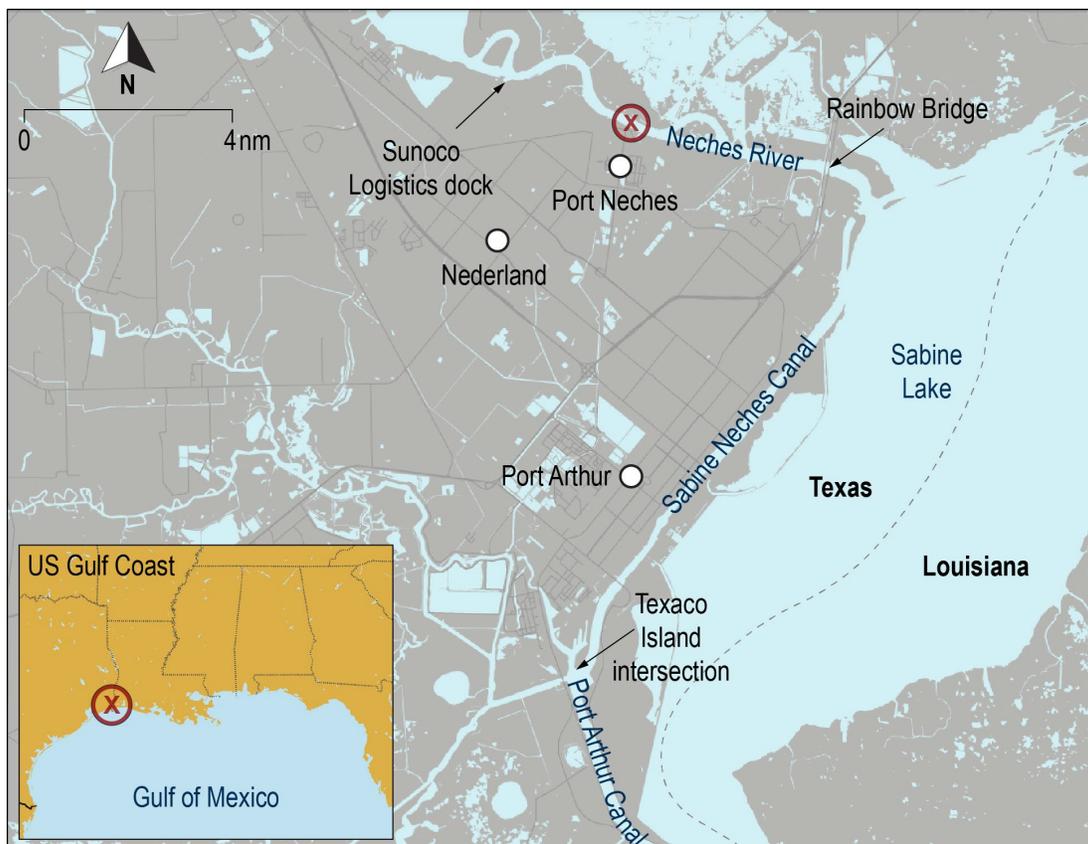
Figure 2. Area of Neches River where the *Gas Ares* collided with the moored tug *Sabine* as indicated by a red X. (Background source: Google Maps)
