MIR-22-29

## Collision between Yacht *Utopia IV* and Tank Vessel *Tropic Breeze*

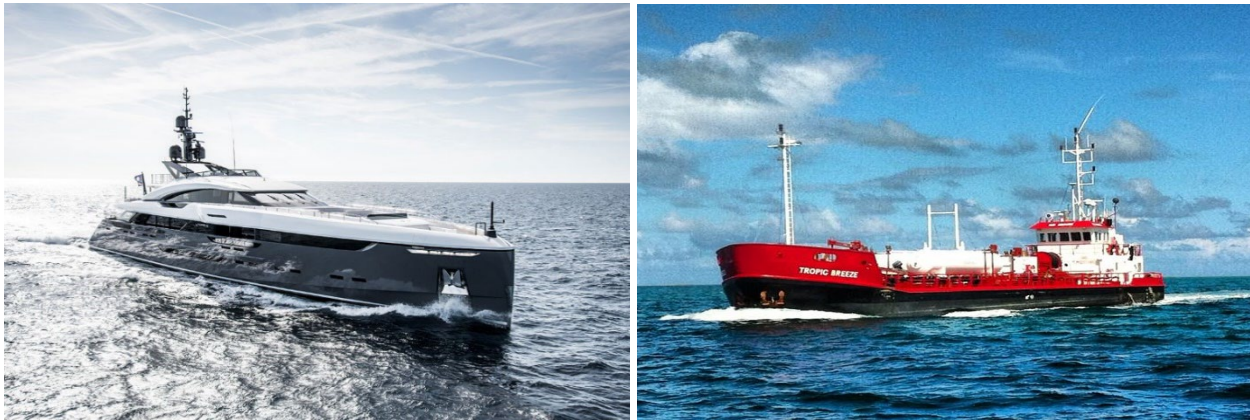
**Figure 1.** *Utopia IV* (left) and *Tropic Breeze* (right) before the casualty. (Sources: Rossinavi [left]; Capt. Chris Knowles [right])
