Issued January 12, 2023

MIR-23-01

# Contact of Offshore Supply Vessel *Elliot Cheramie* with Oil and Gas Production Platform EI-259A

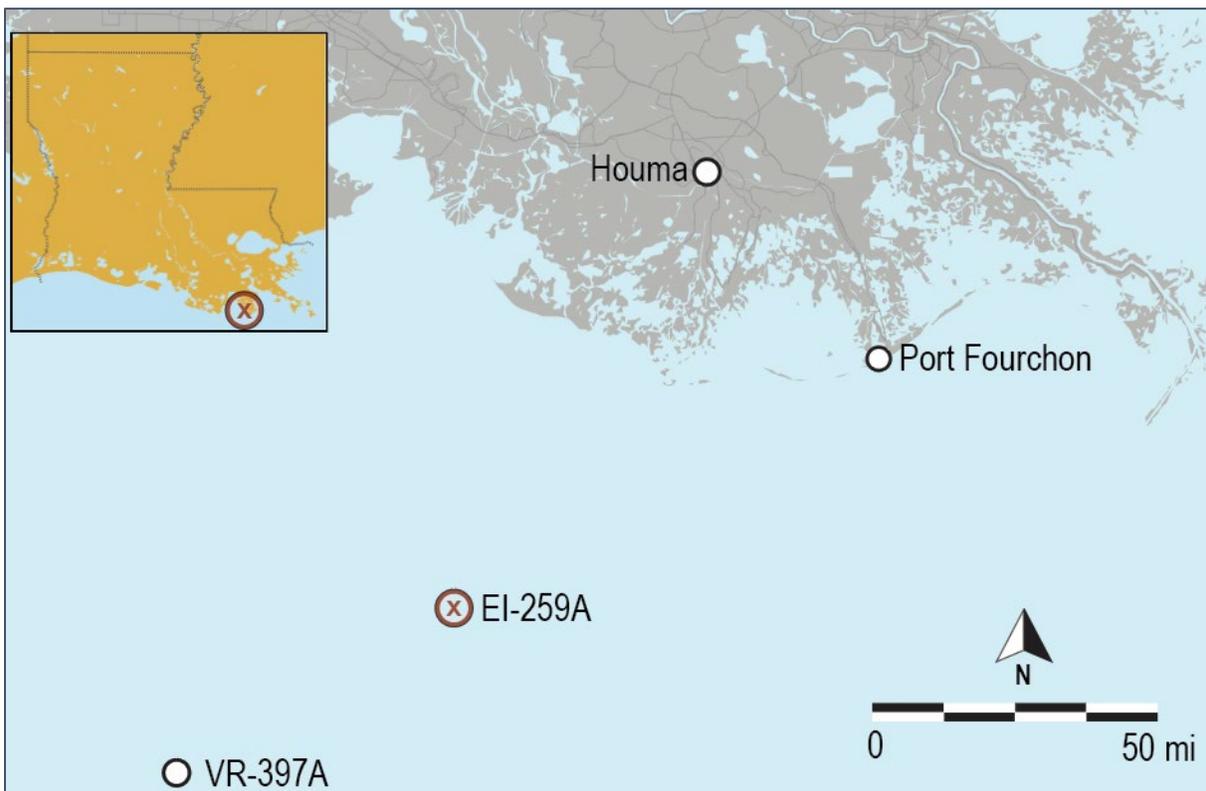
**Figure 2.** Area where the *Elliot Cheramie* contacted platform EI-259A, as indicated by a red X. (Background source: Google Maps)

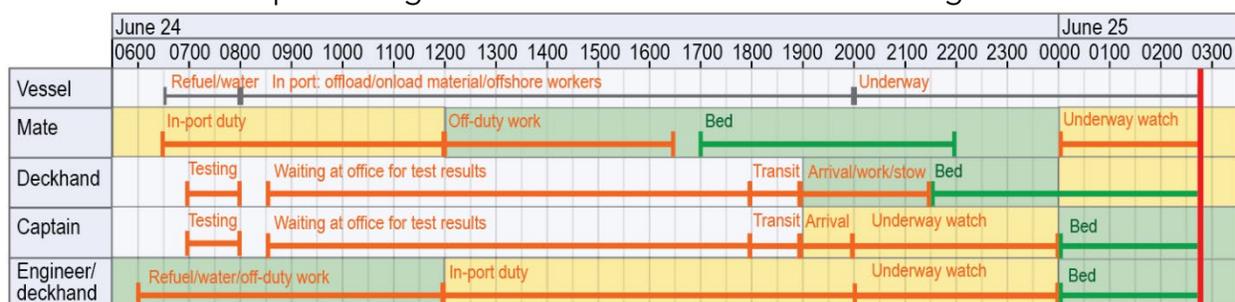
**Figure 3.** Timeline of crewmember watches and activities. Yellow shaded times are watches, and green shaded times are off duty, while orange text indicates work activities and green text indicates rest.

The *Elliot Cheramie's* mate on the 00-12 watch (when the casualty occurred) was likely fatigued. In the 4 days leading up to the casualty, he had consistently worked for periods longer than the 12 hours recommended by the owner/operator's *Fatigue Management* document. The day before the casualty, the mate reported being awake for 19 hours straight and working for the last 17 hours, with most of the work in port requiring high levels of physical exertion such as offloading and loading material and provisions. The extended work hours outside of the mate's normal schedule reduced the opportunity to receive sufficient sleep before assuming the 00-12 watch. The mate reported receiving only 5 hours of sleep in his 7 off-work hours before the casualty watch—less than the SMS-recommended 7-8 hours—using the remaining 2 hours to prepare for his scheduled 00-12 watch. Acute fatigue can occur when individuals receive less than the recommended 7-8 hours of sleep during a 24-hour period. Performance effects of fatigue include diminished alertness and decision-making, and a reduction in operator vigilance. Having received only 5 hours of sleep in the previous 24 hours, and, given the physical nature of work performed the previous afternoon, the mate was likely experiencing the effects of acute fatigue. He reported that he felt groggy on his watch and fell asleep when he sat in the wheelhouse chair.
