Investigation report

Report	
Report title Report of the investigation of the fire at Mongstad on 3 July 2022	Activity number 001902062

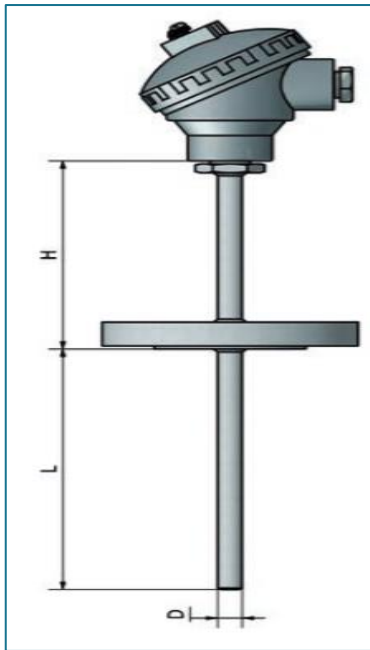
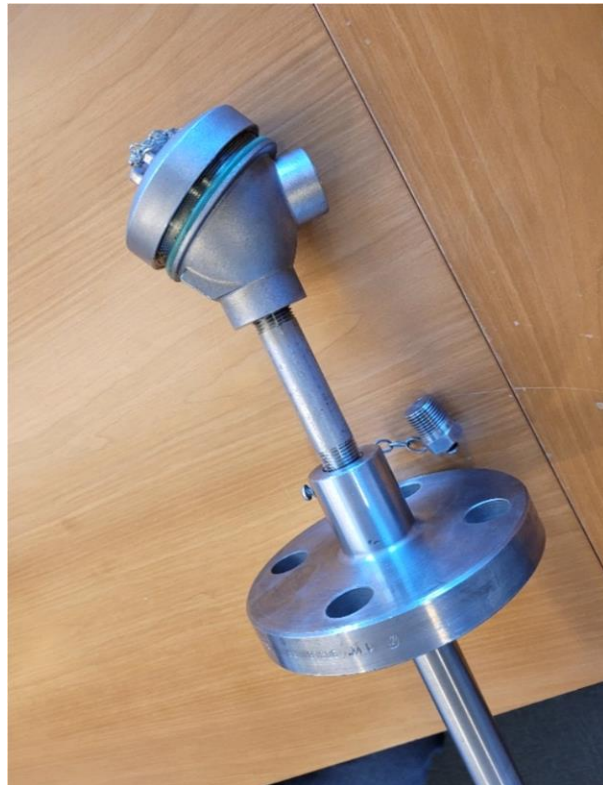
*Figure 5 Schematic of the thermowell and photograph of a one-inch thermowell taken from store at Mongstad.
Photo: PSA*

The thermowell on the relevant pipe was a two-inch flanged type with eight ASTM A193 B16 stud bolts, dimensions $\frac{5}{8}$ inch \times 90 mm. A flat spiral-wound gasket installed between the flanges had disintegrated in the wake of the fire and only parts of it were found. According to the applicable specification (TR2000 MDS PG601), the spirals/windings, inner ring and centring ring in this type of gasket must be in austenitic stainless steel (AISI 316/316L) and have graphite between the windings. However, Mongstad has reported that it still uses seals with the centring ring in carbon steel. (Source: *Report on material technology investigations of components involved in the Mongstad fire*).

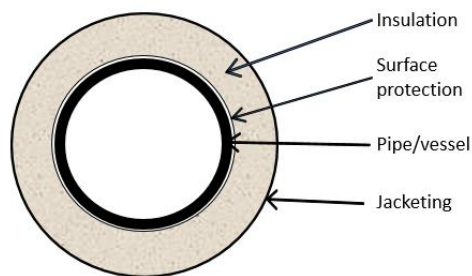
Figure 6 Schematic of an insulated pipe. Insulation on the main pipe involved in the fire was 180 mm thick.

If the insulation experiences moisture intrusion and the temperature is unfavourable, the speed at which piping and bolts corrodes can increase dramatically. This is known as corrosion under insulation (CUI).

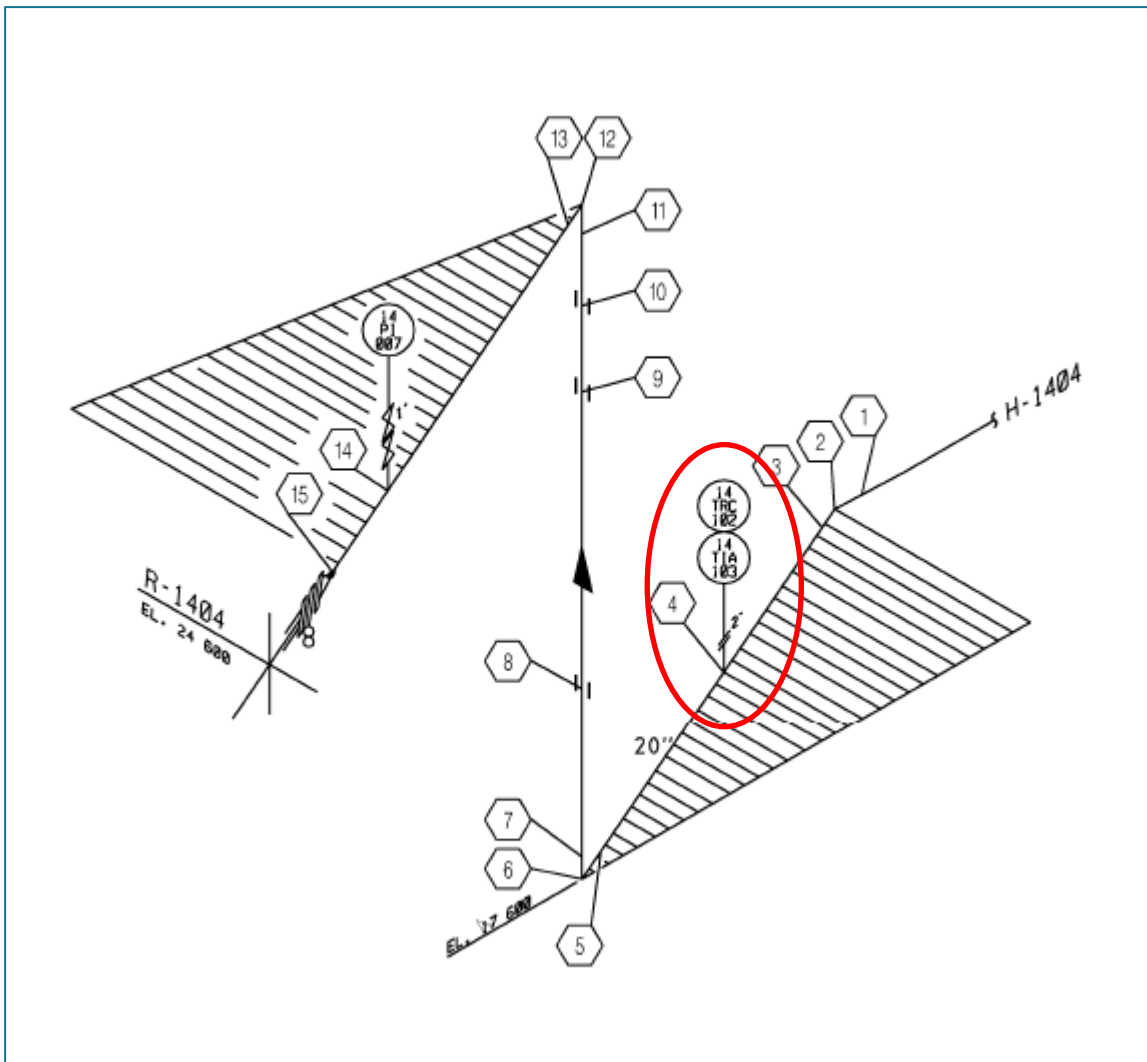
The information section on insulation notes that the pipe is 20-inches, has three bends, a 16-metre straight section, must be heat-insulated (insulation class H), and must have 18 mm of three-layer rock wool insulation plus an SS316 mantle. No details are provided about the thermowell flange (zero T joints). However, the drawings in the work package show the thermowell projection (14TRC102/14TIA103).

Figure 8 Extract from a drawing in the work package. Thermowell flange marked. Source: Equinor

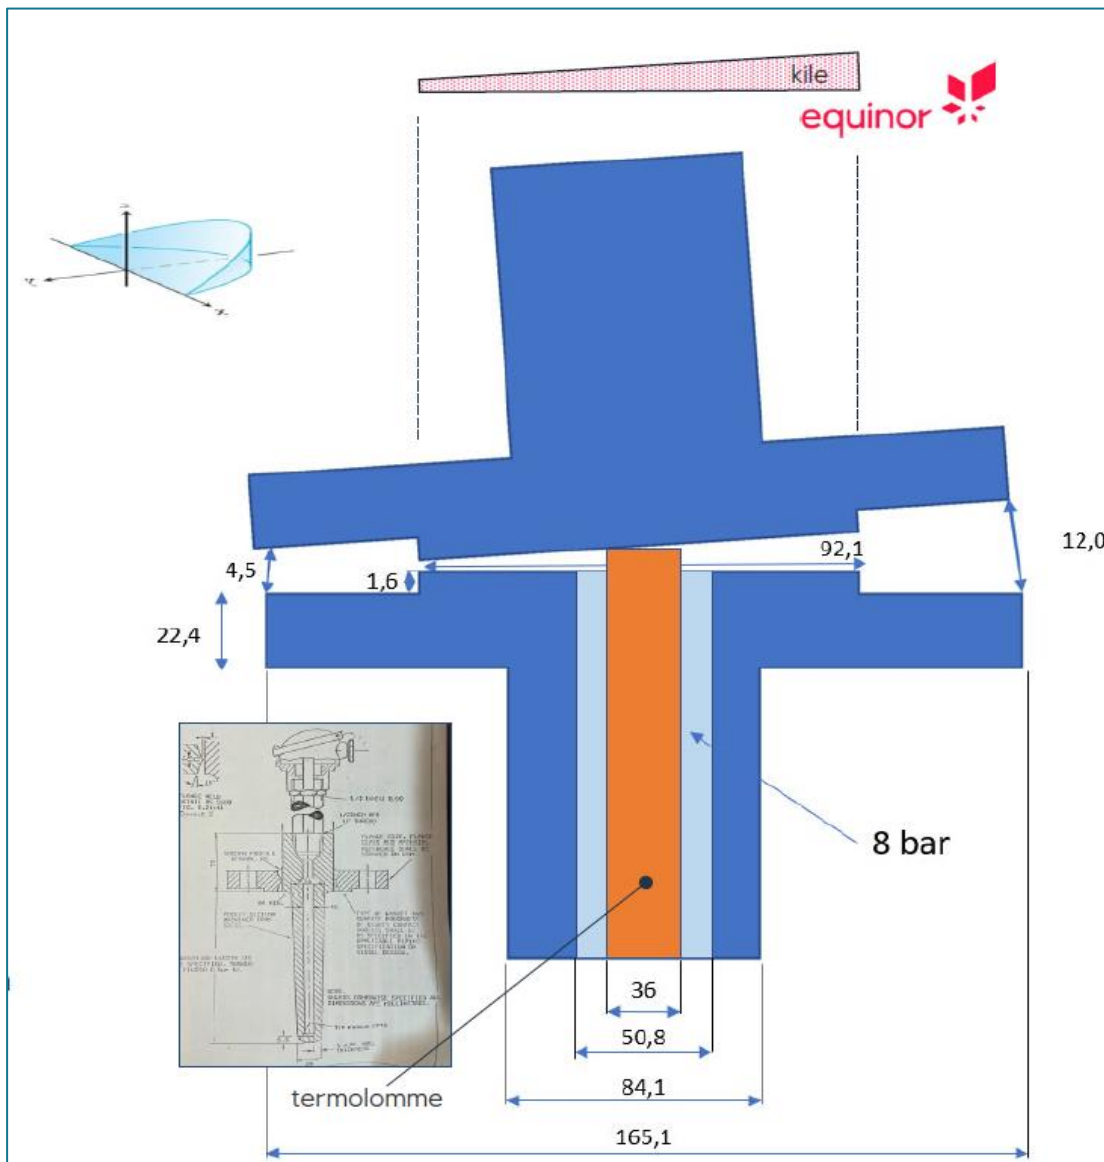
The PSA team has rested its assessments on calculations performed by Equinor's safety department at Rotvoll. These are based on leakage from a distorted flange with a wedge-shaped opening. See figure 16. The Phast programme developed by DNV has been used to calculate leak rate and gas dispersion.

Figure 15 The basis for the leakage calculations. Produced by Equinor's technology centre
Key: termolomme = thermowell

Equinor has not considered the possibility that the bolts failed so that the joint was left fully open. It justifies this on the grounds that the pressure was low (eight bar initially) and would have fallen as soon as the leak occurred. Equinor concluded that the rate may have been a little higher, but that full opening is unlikely to occur. The PSA team supports this assessment on the basis of the report from Equinor's material technology lab at Rotvoll on its investigation of components involved in the Mongstad fire.

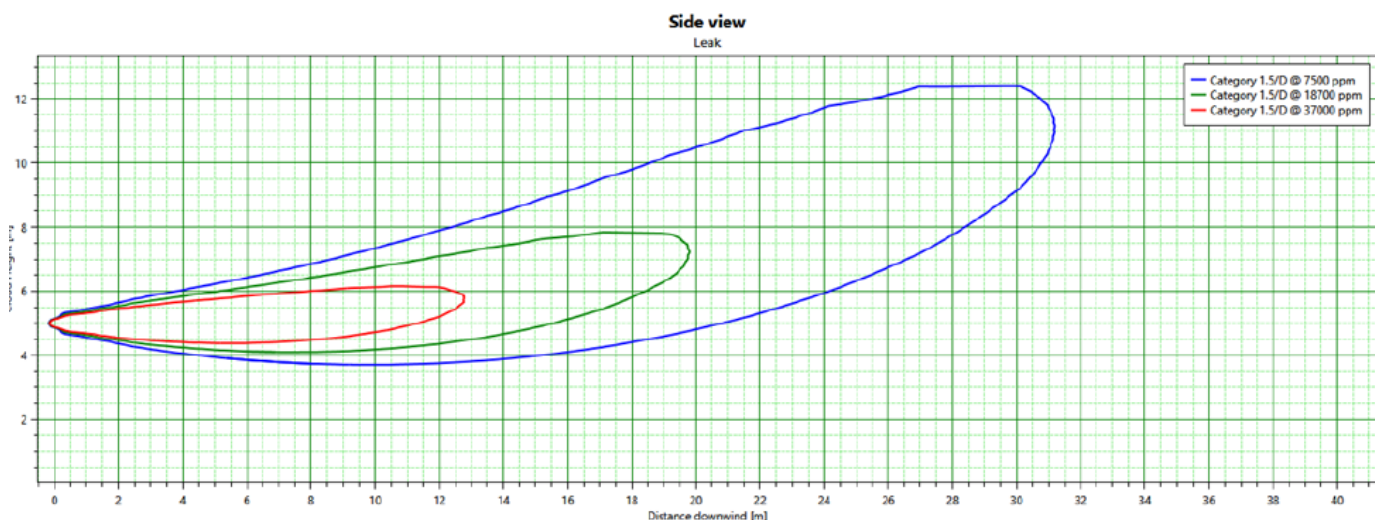
Figure 17 presents a side view of the concentration in an *unignited* unimpeded gas cloud. Blue=20% LEL, green=50% and red=100%, where the lower flammable limit of mixing in air is 100% LEL.

Figure 16 Gas dispersion – for comparison. Source: Equinor technology centre

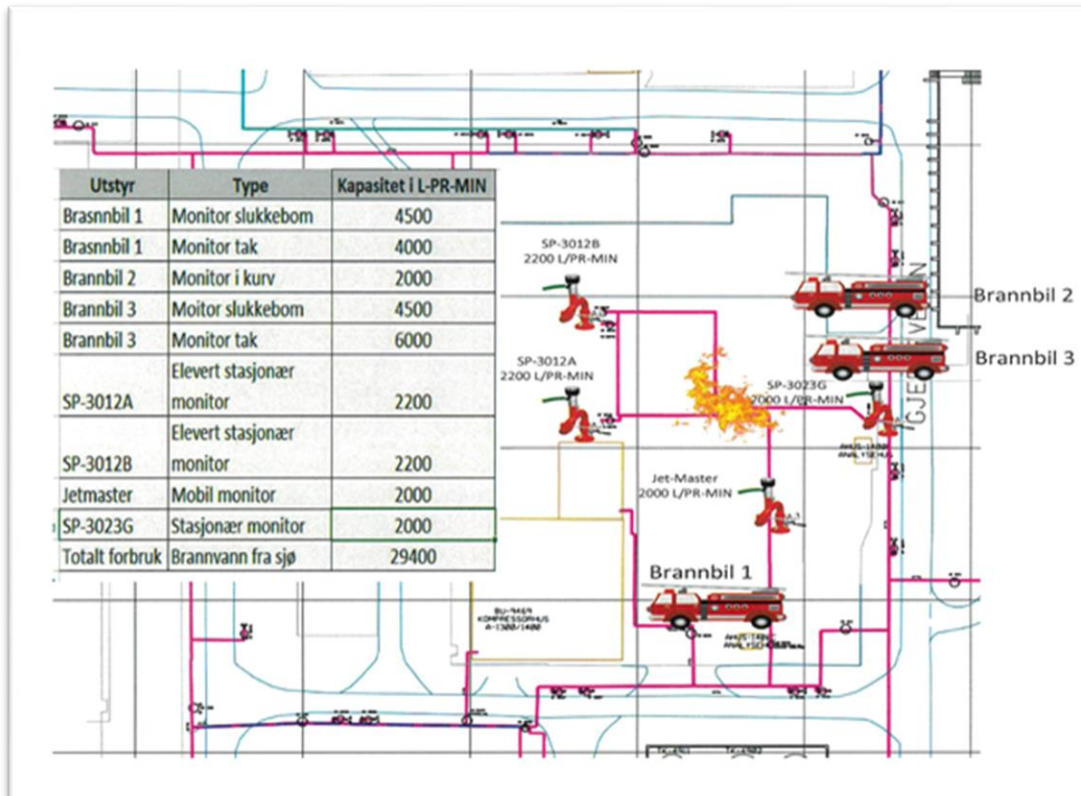
The application of fire water was eventually concentrated on cooling surrounding piping, equipment and supporting structures. In consultation with the head of the first line ERT, the on-scene commander decided to allow the fire to continue in a controlled manner in order to avoid uncontrolled gas dispersion in the area.

Figure 20 Fire-appliance disposition at the fire site and water capacity. Source: Equinor/Mongstad
