Report on the investigation of
the failure of a towline pennant
and injury to the crew on board the tug

Svitzer Mercurius

in Southampton, England

REPORT NO 15/2022

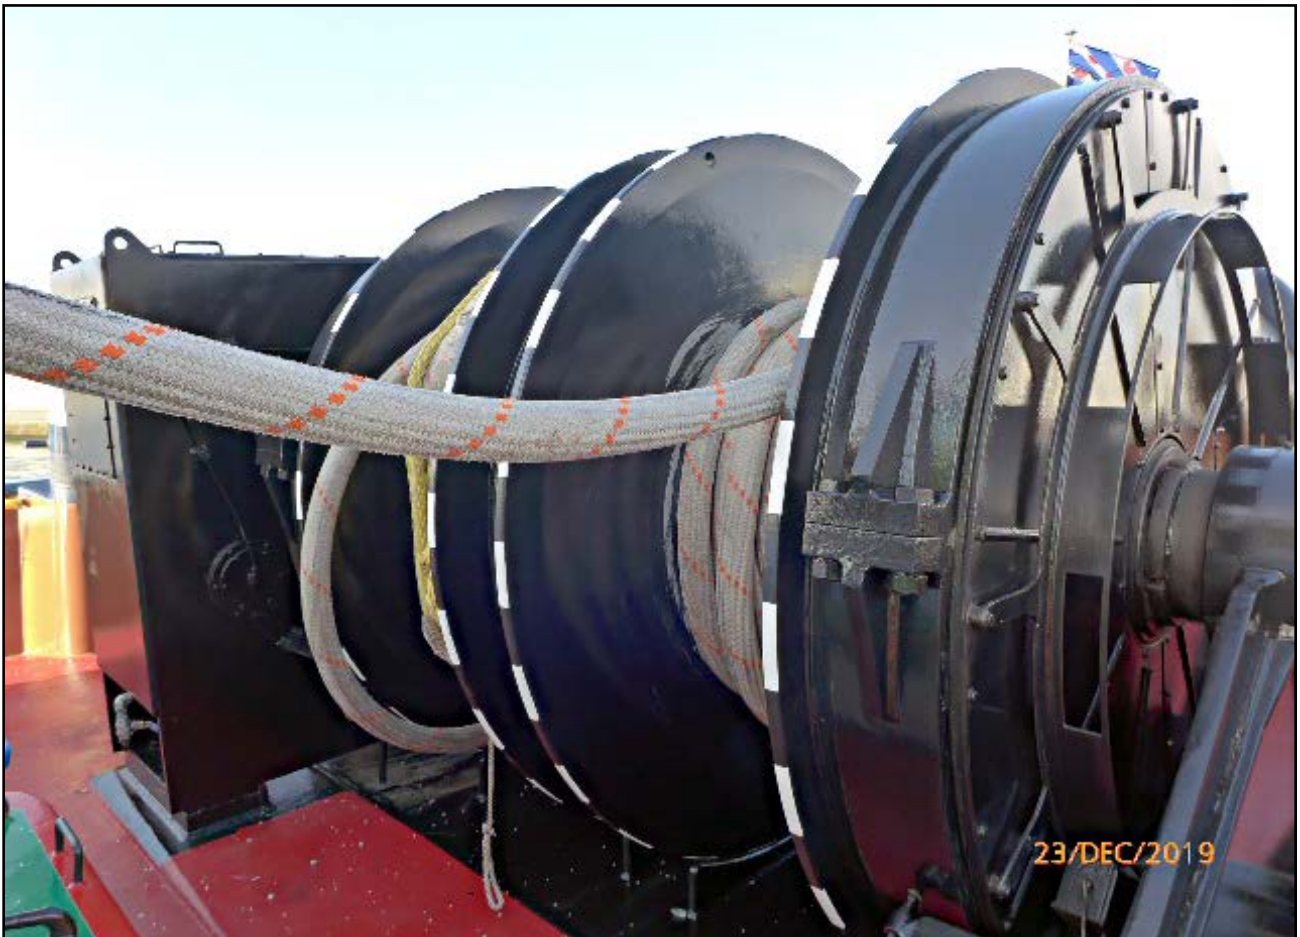
Figure 11: Forward towing winch

The tug's towing winch was manufactured by DMT Marine Equipment and installed by Damen at build. It was a two-speed hydraulically driven winch and had a split double drum arrangement. The drums were designed for storing up to 150m of 80mm towline. The winch (**Figure 11**) had the following operating characteristics:

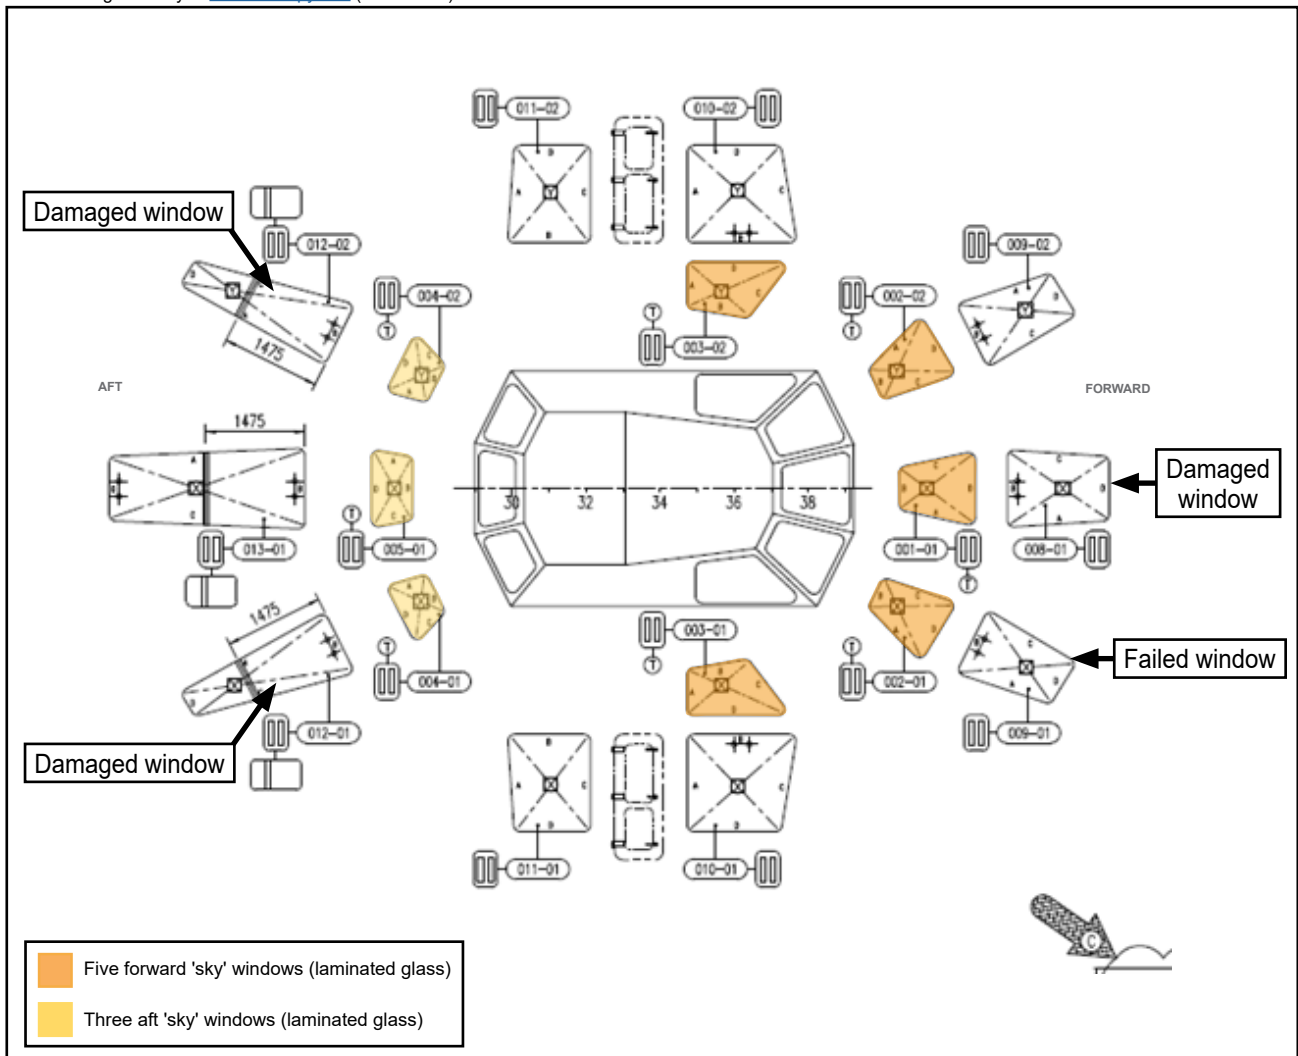
Figure 13: Wheelhouse windows configuration

Svitzer Mercurius had six forward, six side and six aft-facing tinted double-glazed wheelhouse windows (**Figure 13**). The window panels were constructed of toughened safety glass fitted within steel frames. The larger tapered lower windows were designed to provide unobstructed views fore and aft, while the smaller sky windows allowed an optimal view of the assisted vessel.

The outer and inner panes of the lower window panels were 15mm and 6mm thick respectively and had a 15mm argon-filled gap between them. The outer and inner panes of the forward and side-facing sky window panels were 16mm and 6mm thick respectively; the 16mm panes were of laminated construction and comprised glass panes with a thickness of 10mm and 6mm. The glass panes used to construct all the windows were thermally hardened and had a minimum tensile strength of 180N/mm².

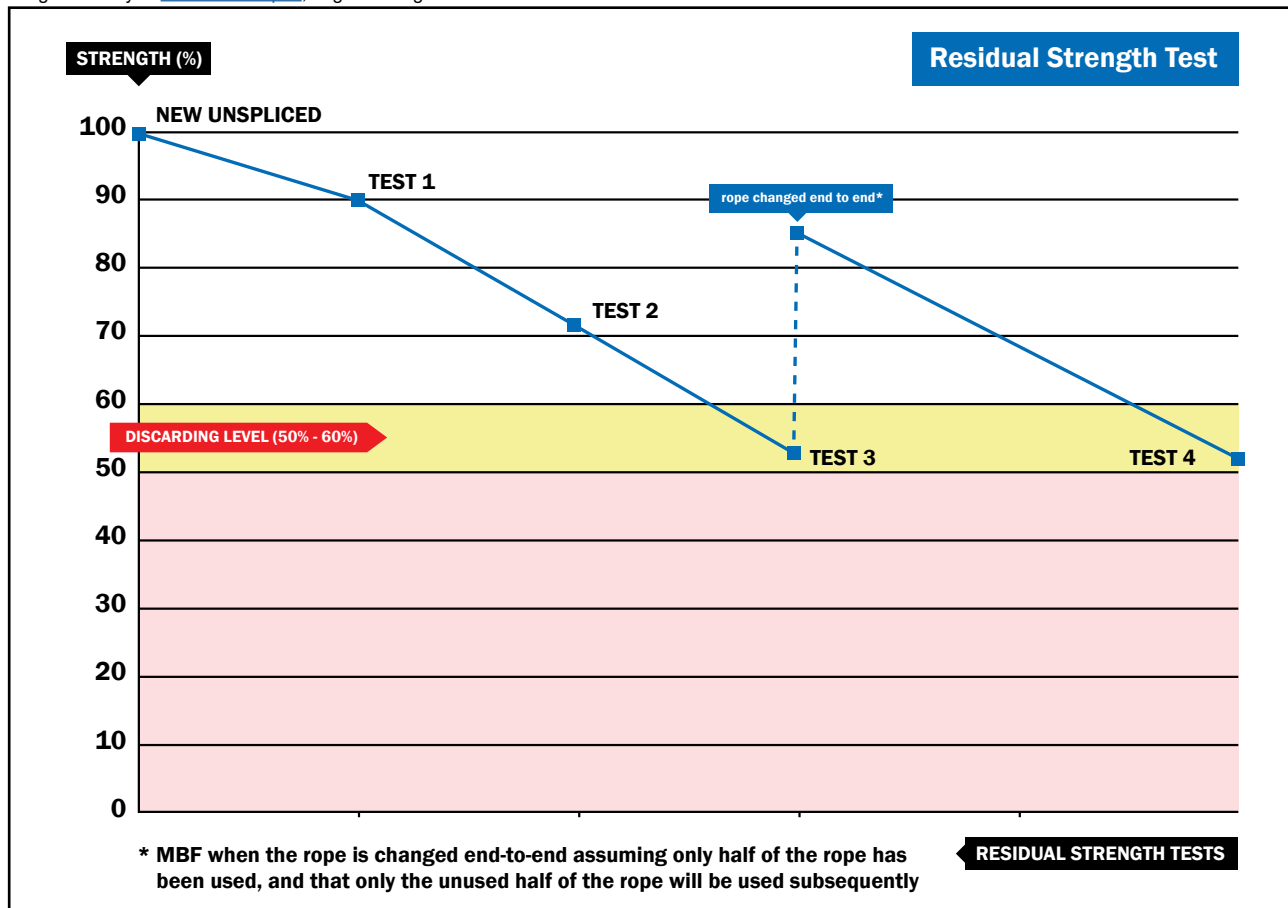
Figure 14: Lankhorst Ropes Residual Strength Test diagram

A further Lankhorst publication, *Tug & Towing*, provided similar information for tug operators and included a residual strength test diagram that indicated the strength degradation of a used tow rope and the point at which it should be discarded; approximately 50-60% of the MBL (**Figure 14**). No specific guidance was provided on pennant inspection and replacement.

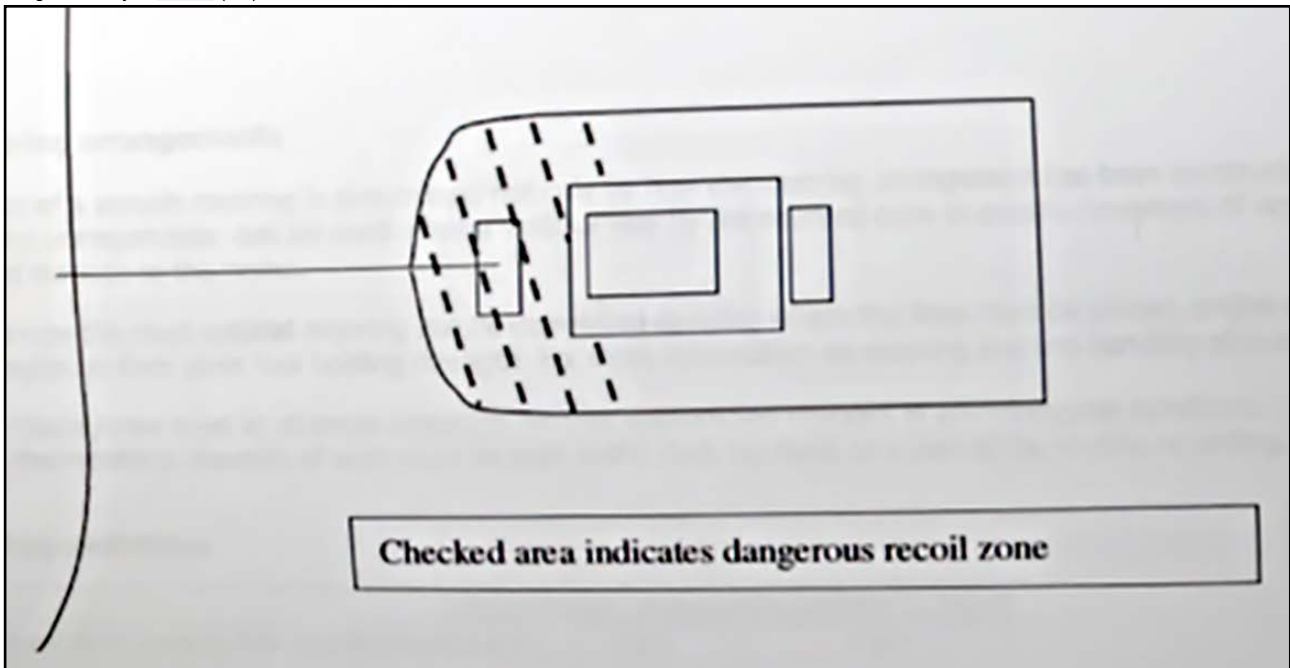
Figure 16: Svitzer tug towline snapback zone illustration

Svitzer applied a 'master's discretion' or 'local operations' policy for towline replacement and discard, which was dependent on inspection results. However, the overarching requirement for Southampton operations was that main towlines be end-for-ended after 1000 jobs and replaced after 2000 jobs. Pennants were to be replaced after 1000 jobs and not end-for-ended. In addition, the tug PMS included weekly and monthly visual inspections. For snapback, the procedures included tug foredeck danger zone illustrations (**Figure 16**).
