Issued March 7, 2023

MIR-23/05

Breakaway of Moored Mobile Offshore Drilling Unit *VALARIS DS-16* and Subsequent Collision with Cargo Vessel *Akti*

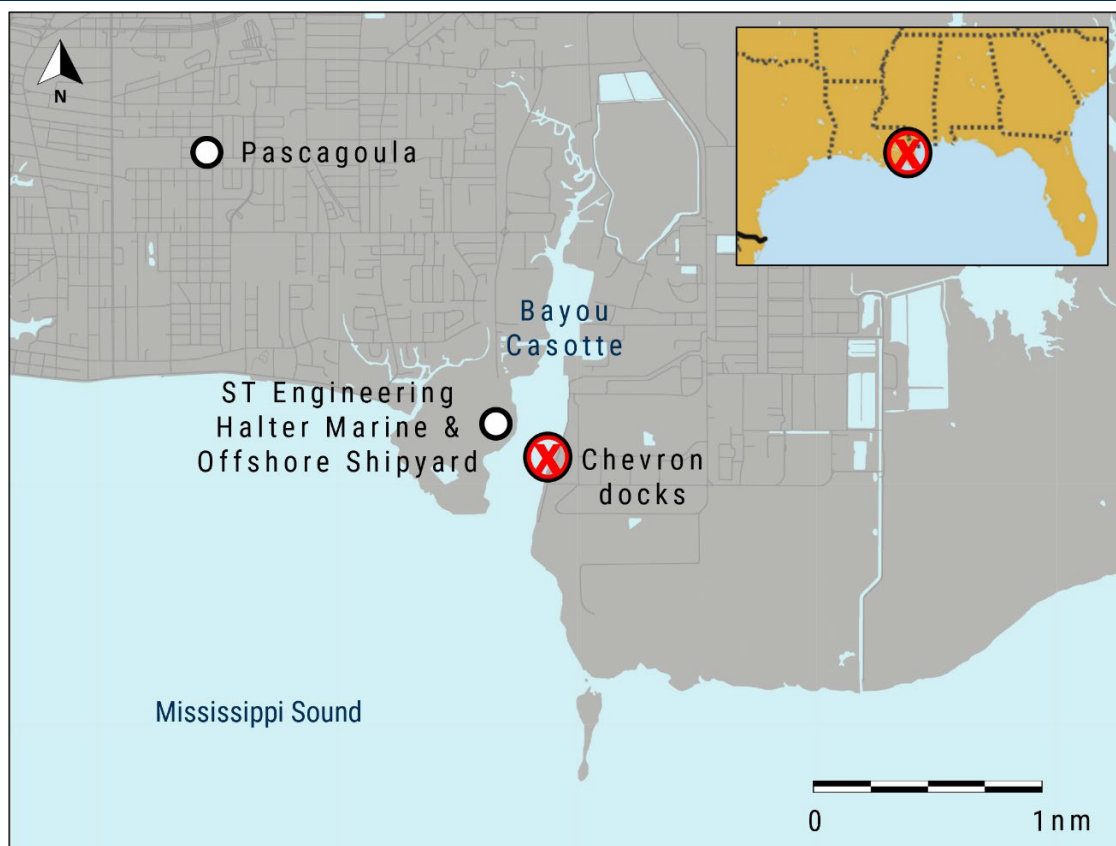
Figure 2. Area where the *VALARIS DS-16* collided with the *Akti* as indicated by a red X. (Background source: Google Maps)

At 0041, the starboard side of the *VALARIS DS-16* made contact with the starboard side of the moored *Akti* and came to rest alongside the cargo vessel. Crewmembers inspected their respective vessels for damage, sounded all tanks, and made required casualty notifications. The *VALARIS DS-16* remained alongside the *Akti* until the MODU could be safely moved back to the STEHMO dock later that afternoon.

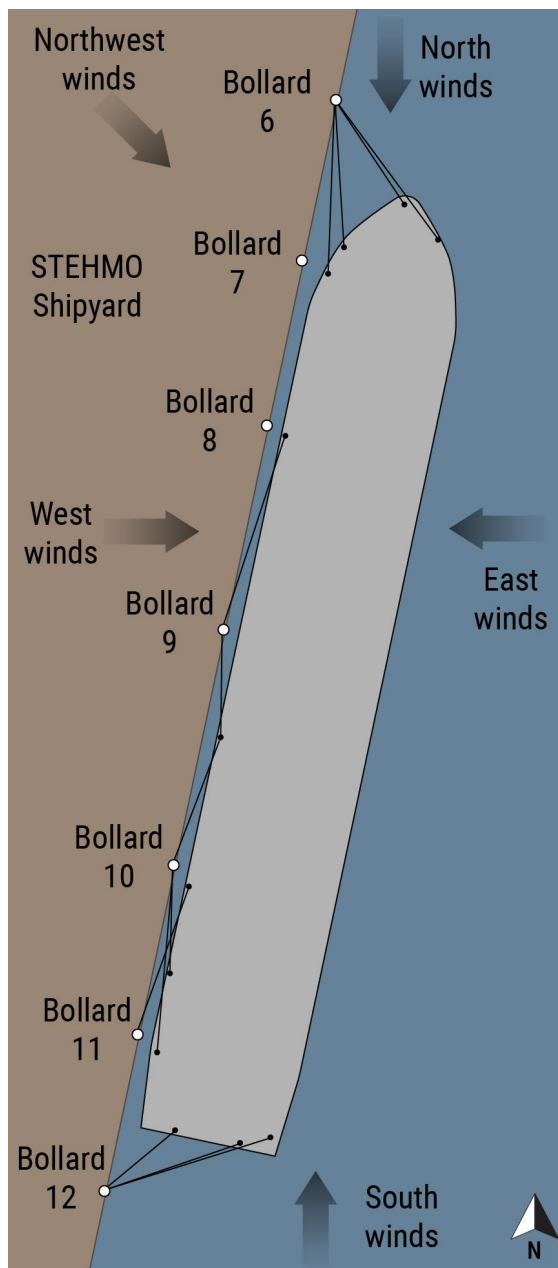
Figure 3. Representation of planned mooring arrangement for *VALARIS DS-16* used for mooring analysis with principal wind directions shown (scale approximate).

The operating company's mooring analysis identified critical components in the mooring configuration in an intact condition. For a north wind, bollard 6 was identified as a critical component; the limiting sustained wind speed was 60 knots, and the calculated load on the bollard was 61 metric tons (67.2 tons). Bollard 6 was also identified as a critical component for a northwest wind; the limiting sustained wind speed was 37 knots, and the calculated load on the bollard was 131 metric tons (144.4 tons). Additionally, the mooring analysis calculated the effects of a single damaged mooring line: with a north wind and a damaged forward-leading midship line connected to bollard 10, the limiting sustained wind speed remained at 60 knots, the critical component was bollard 6, and the calculated load on the bollard increased to 74 metric tons (81.6 tons). With a northwest wind and damage to a bow line, the limiting sustained wind speed was reduced to 34 knots, with 117 metric tons (130 tons) calculated on bollard 6.

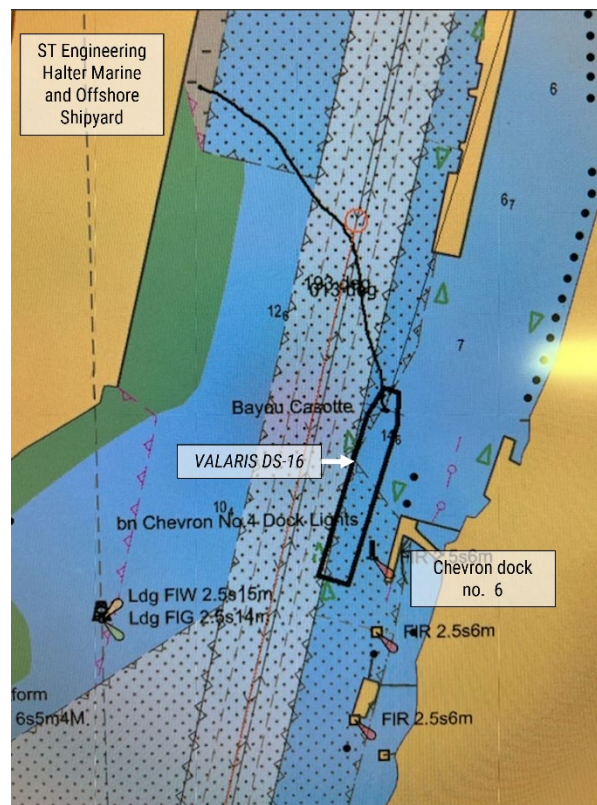
Figure 6. *VALARIS DS-16*'s path as it drifted across Bayou Casotte on March 12. (Background source: *VALARIS DS-16* electronic chart display and information system)

About 0035, the port anchor fetched up (dug into the seabed). A few minutes later, the crew lowered the starboard anchor, and it fetched up. The vessel's movement was slowed to the south-southeast toward Chevron dock no. 6, where the 623-foot-long, steel-hulled cargo vessel *Akti* was moored with its bow facing south (port side to the pier). The vessel had arrived in Pascagoula the previous day (March 11) to load petroleum coke; loading operations had begun at 1648 and ceased at 2205 due to rain.
