**Potential fire hazards from flexible hose installations  
identified following a fire on board  
the roll-on/roll-off cargo ship  
*Finnmaster*  
in Hull, England  
on 19 September 2021**

## MAIB SAFETY BULLETIN 1/2023

The Marine Accident Investigation Branch is carrying out an investigation into the fire on board the roll-on/roll-off cargo ship *Finnmaster* in Hull, England, on 19 September 2021.

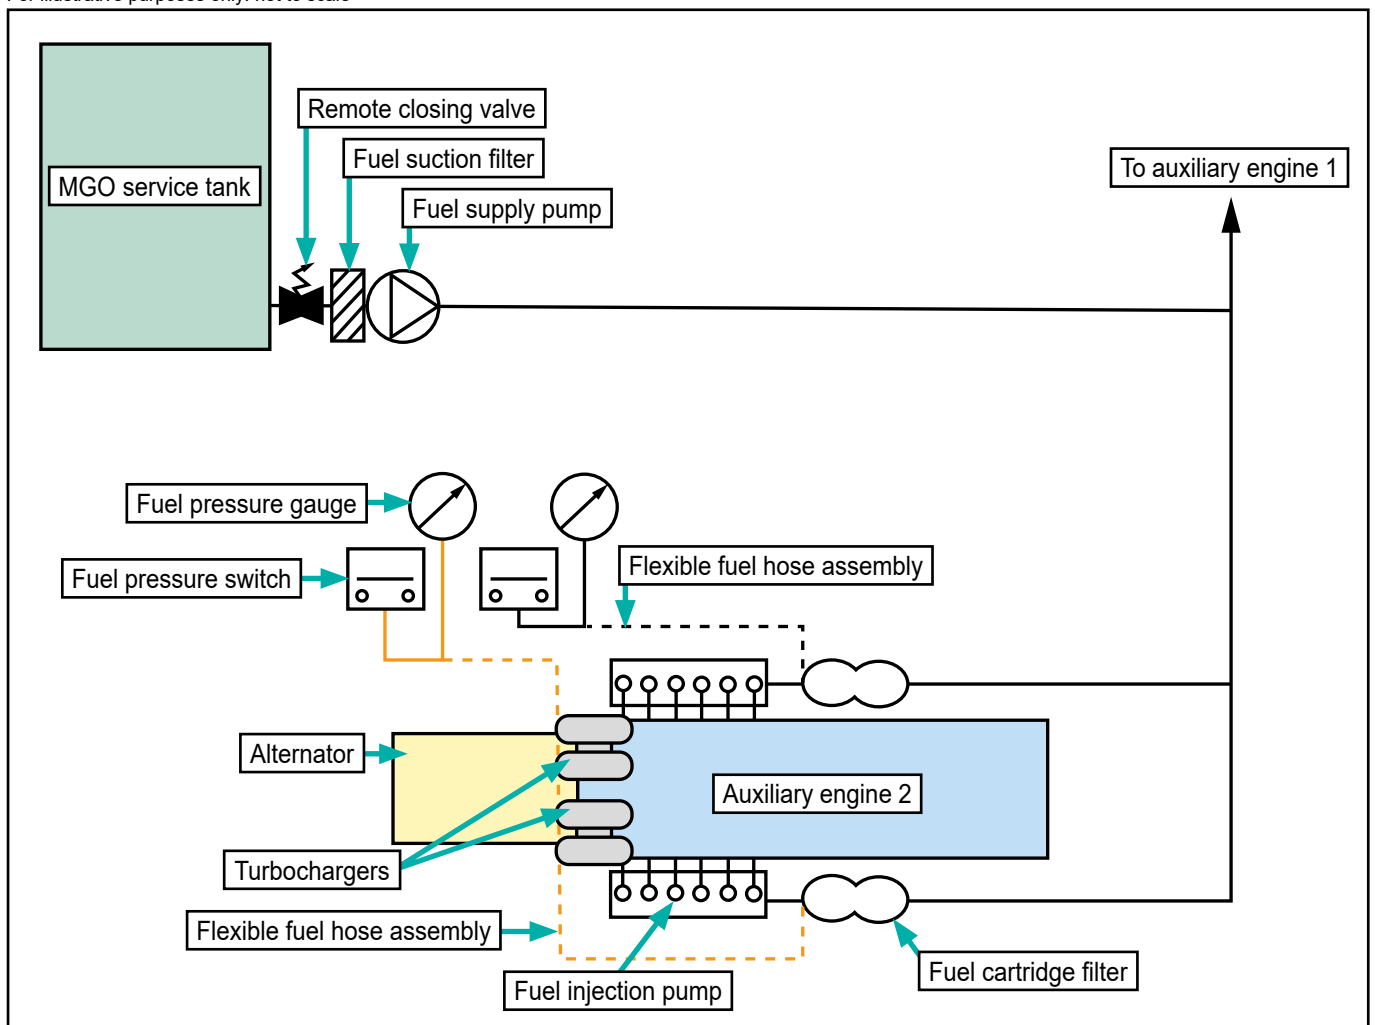
**Figure 2:** Schematic diagram of auxiliary engine fuel supply system

A fuel supply pump supplied the MGO to both auxiliary engines. The fuel supply pipe was then routed to an inboard and outboard set of cartridge filters<sup>2</sup> and a high-pressure fuel injection pump, which were mounted on either side of each engine (**Figure 2**).
