**REPORT: M/V “WAKASHIO”**  
**IMO: NO. IMO 9337119**  
**R-029-2021-DIAM**  
**Casualty Date: JULY 25, 2020**

**SAFETY INVESTIGATION REPORT**  
**OF**  
**THE GROUNDING**  
**OF**  
**MV "WAKASHIO" IMO: 9337119**  
**VERY SERIOUS MARINE ACCIDENT**  
**INCIDENT OCURRED**  
**ON JULY 25, 2020**  
**AT 1925 ON THE SOUTHEAST COAST**  
**OF BLUE BAY IN FRONT OF POINTE D'ESNY ON**  
**THE ISLAND OF MAURITIUS**

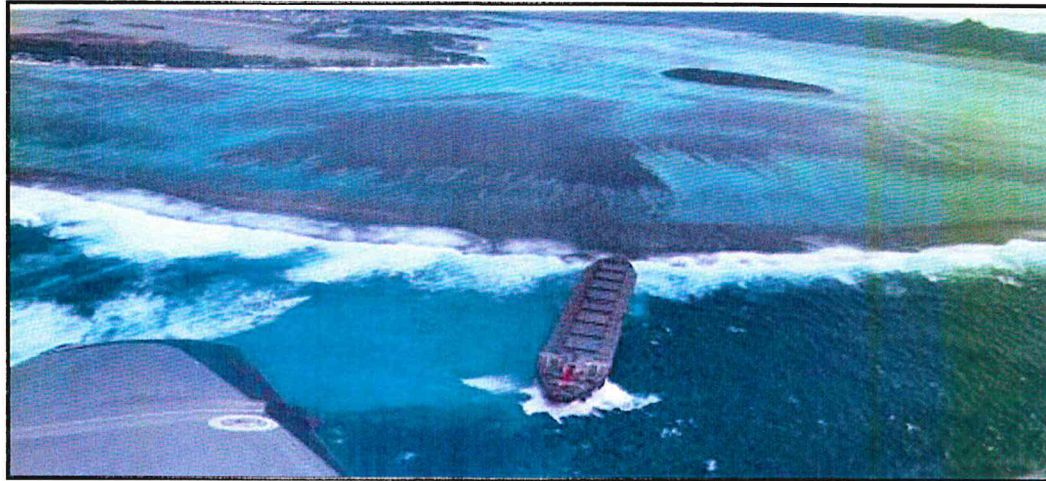
*Figure No.1 Aerial view of the vessel "Wakashio"*

Later, according to images and news published in the different international media that detail that the ship "Wakashio" with IMO 9337119; It was still stranded since July 25, 2020; being 12 days after the first events of the maritime accident have been reported; occurred on the southeast coast specifically in the Blue Bay in front of "Pointe d'Esny", on the island of Mauritius.

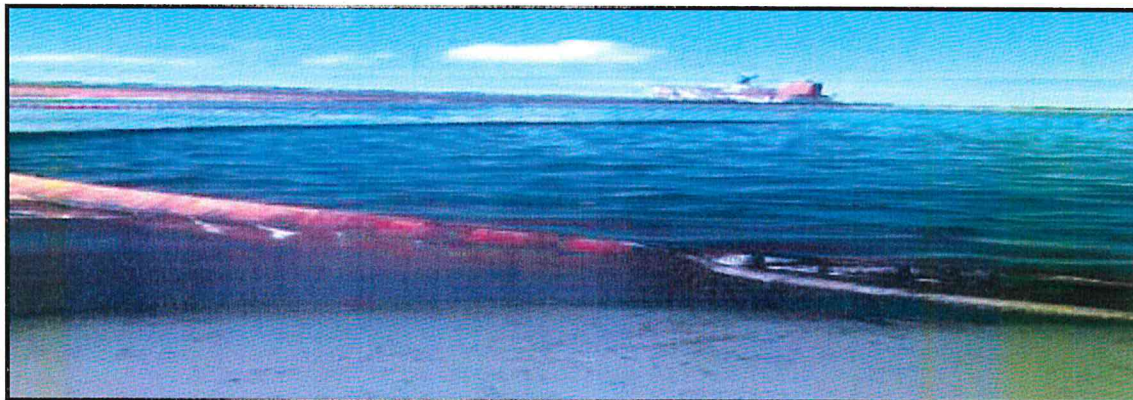
*Picture No.1 Containment barriers placed in the Blue Bay beach area of Mauritius.*

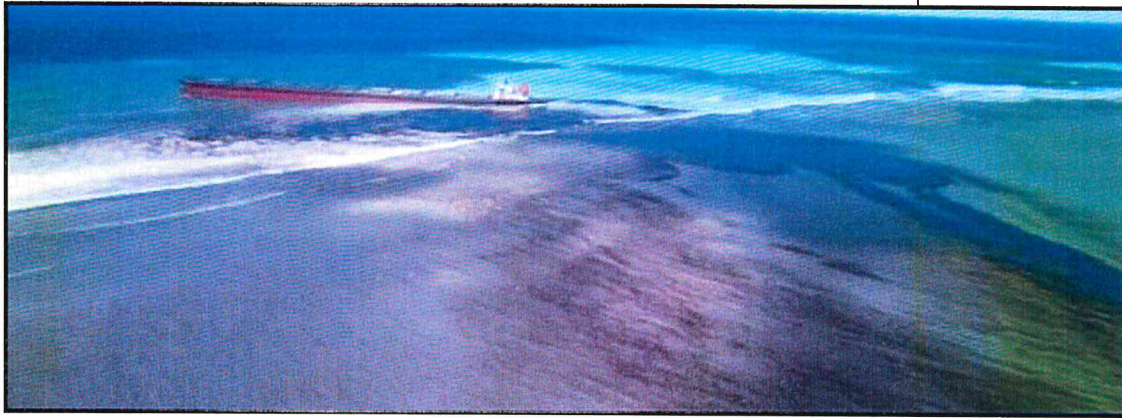
*Picture No.2 The ship “Wakashio”, aground on the area of its stern, on the coast of the Blue Bay in front of “Pointe d'Esny”, Mauritius.*
