MIR-23-14

Collision between US Coast Guard Cutter *Winslow Griesser* and Center-console Boat *Desakata*

Near Dorado, Puerto Rico

August 8, 2022

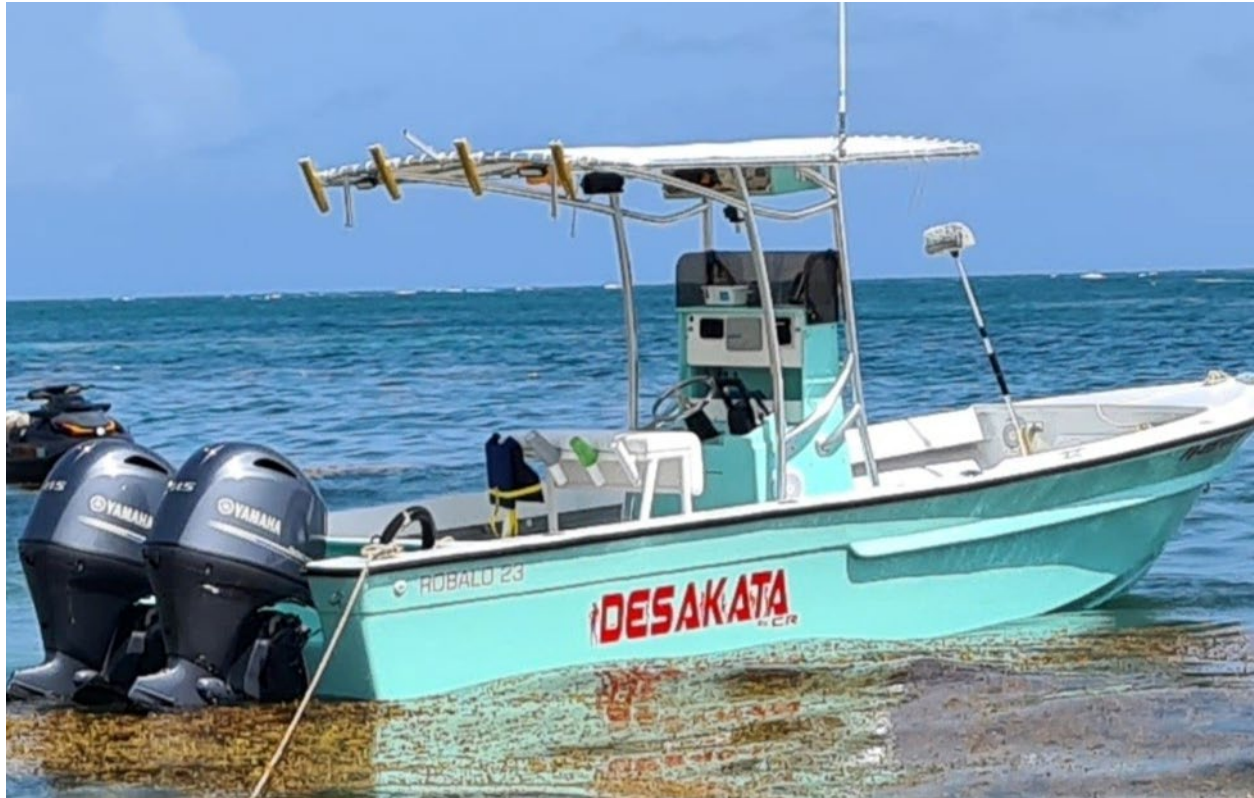
Figure 2. Center-console boat *Desakata* before the collision. (Source: Samuel Rosario)

The *Desakata* was a total loss; its bow later washed ashore (see Figure 6). The vessel and fishing gear were valued at an estimated \$55,600 and \$3,200 respectively. The *Winslow Griesser* sustained cosmetic damage to its hull coatings.
