Marine Investigation Report MIR-23-22

Engine Room Fire Aboard Passenger Vessel *Spirit of Norfolk*

Elizabeth River
Norfolk, Virginia
June 7, 2022

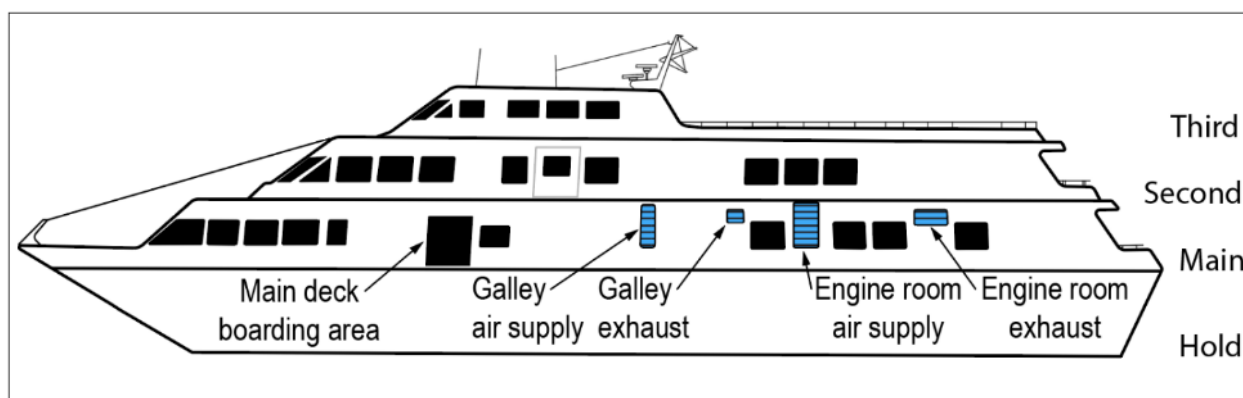
Figure 3. Profile view of the *Spirit of Norfolk*. Ventilation openings are shaded blue.

The *Spirit of Norfolk's* engine room ventilation system had one electrically driven air supply fan in the forward section of the engine room on the port side, and two exhaust ventilation ducts (see Figure 3). Although the electrically driven fan motors could be secured remotely from the pilothouse, none of the ventilation trunks were fitted with dampers (closures within the trunk), nor was the vessel designed or equipped with a means to close the ventilation openings to the engine room, such as via the use of fitted covers, or manually operated louvers.

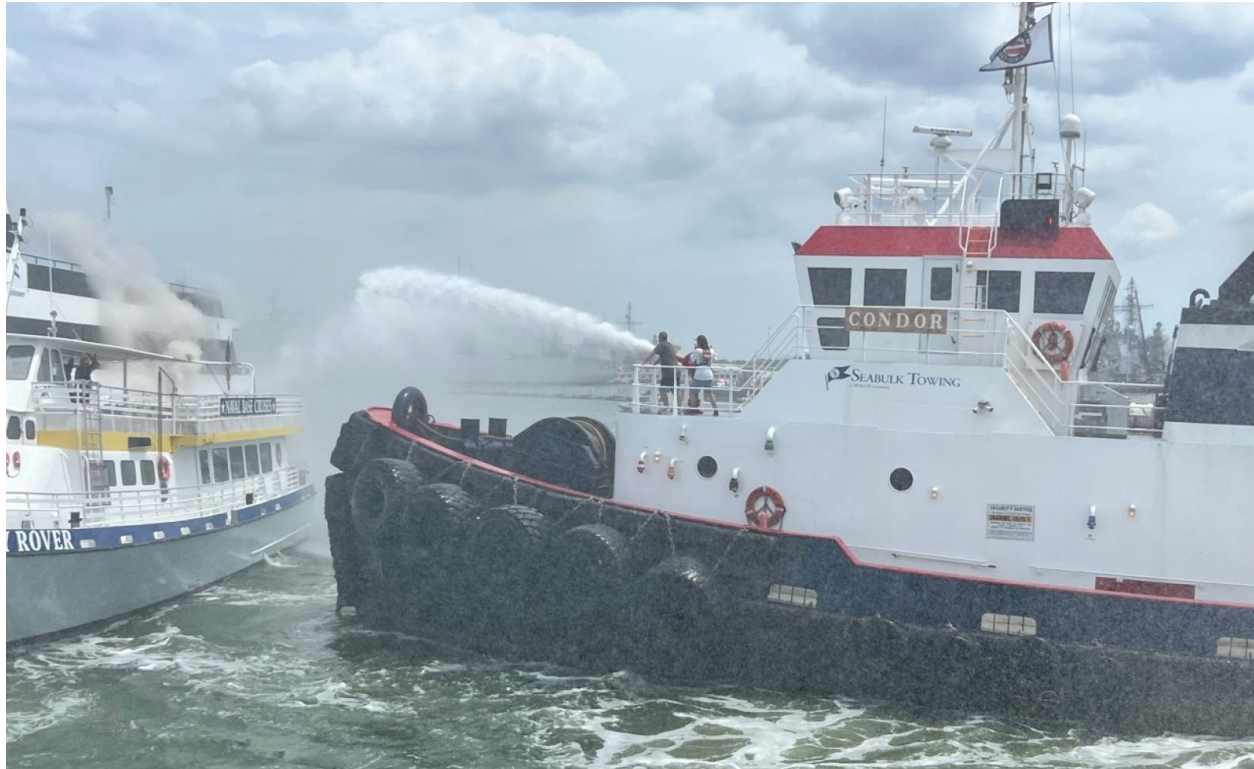
The *Challenger* sprayed water into the engine room exhaust ventilation opening on the starboard side, and the *Condor* captain used his fire monitor to put water onto the port side of the vessel by the engine room and create a mist to cool the air near the engine room (see Figure 4).

Figure 4. The *Condor* spraying water to cool the *Spirit of Norfolk*. (Source: Coast Guard)

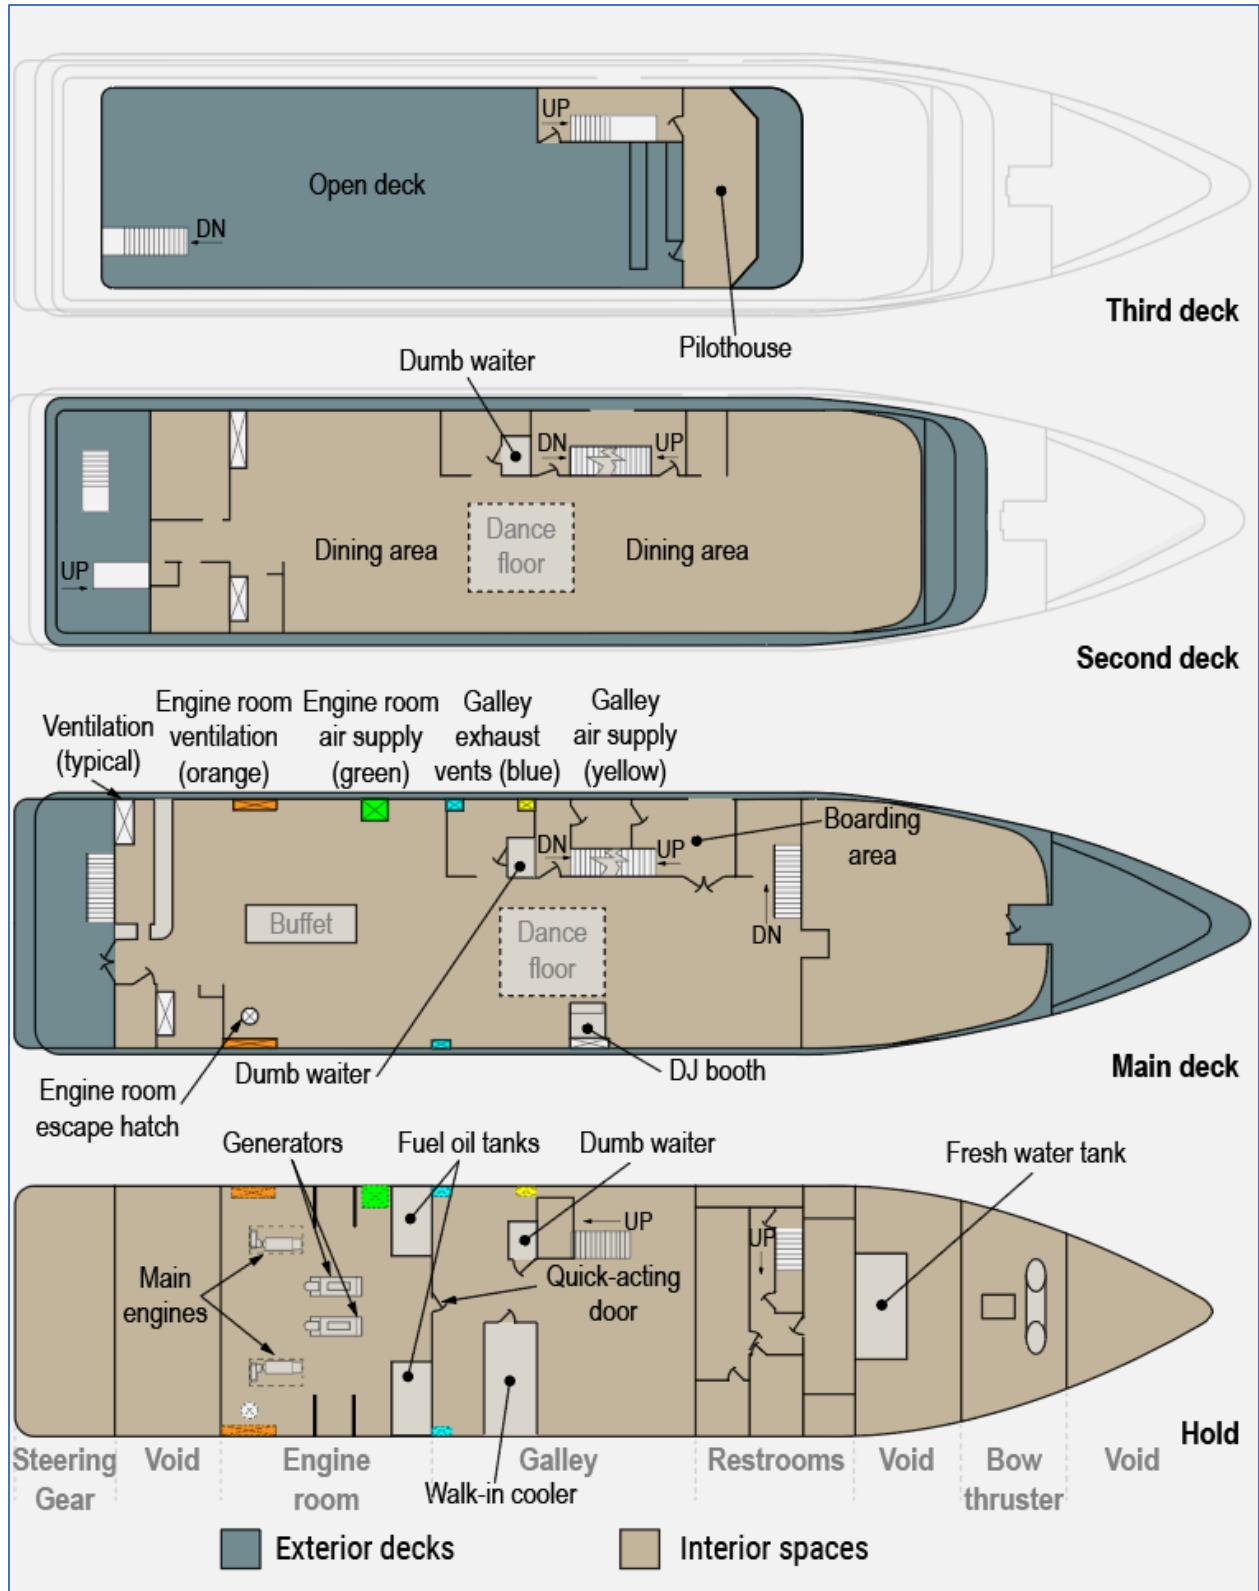
Figure 7. General arrangement plan of the *Spirit of Norfolk*.

The *Spirit of Norfolk's* engine room was located below the main deck of the vessel. It was typically accessed through a watertight door from the galley. The engine room also had an escape hatch in the overhead of its aft starboard corner that led to the interior of the main deck starboard of the buffet area. The engine room had two partial transverse bulkheads extending from the port and starboard sides of the hull (see Figure 7).
