NATIONAL TRANSPORTATION SAFETY BOARD

2022

# SAFER SEAS Digest

Lessons Learned from  
Marine Investigations

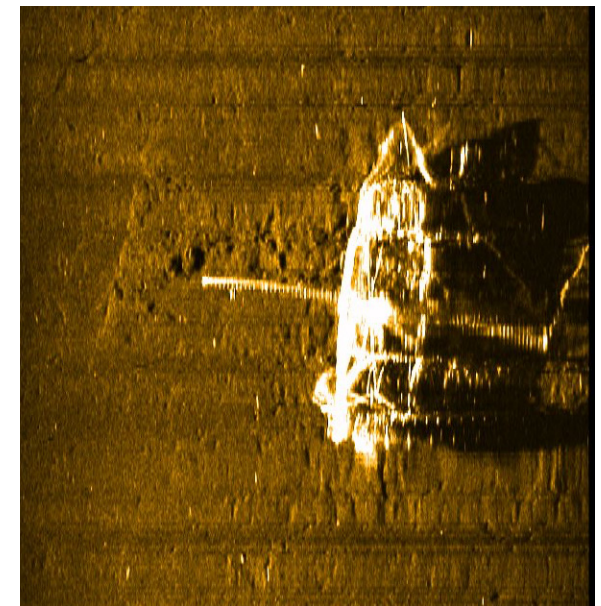
**Figure 4.** Side scan sonar image of *Emmy Rose* from 246 feet above at 600 kilohertz.

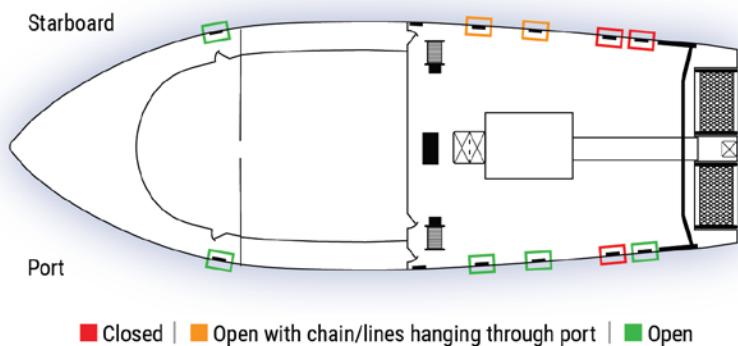
**Figure 6.** Status of *Emmy Rose* freeing ports during ROV survey.

We found that at the time of the sinking, the *Emmy Rose*'s freeing ports did not meet regulatory requirements for freeing port area and freeing port cover design, thus making the vessel more susceptible to accumulating water on deck. Additionally, we found that the vessel's lazarette hatch had a nonwatertight cover that had no securing mechanism, which meant the *Emmy Rose* was not being operated in accordance with its stability instructions and fishing vessel regulations, and water likely began flooding the vessel through the hatch that was likely opened by the sloshing seawater on the stern. As a result, we **recommended** that the Coast Guard increase the scope of commercial fishing vessel safety examinations to include inspections of freeing port covers and hatch covers.

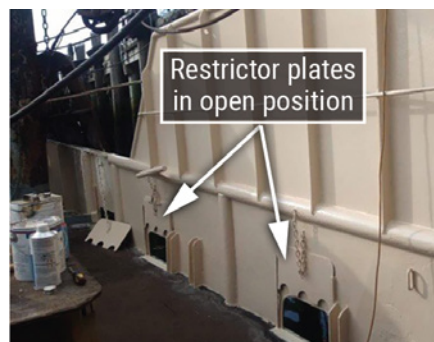
**Figure 7.** Freeing ports on portside bulwarks.

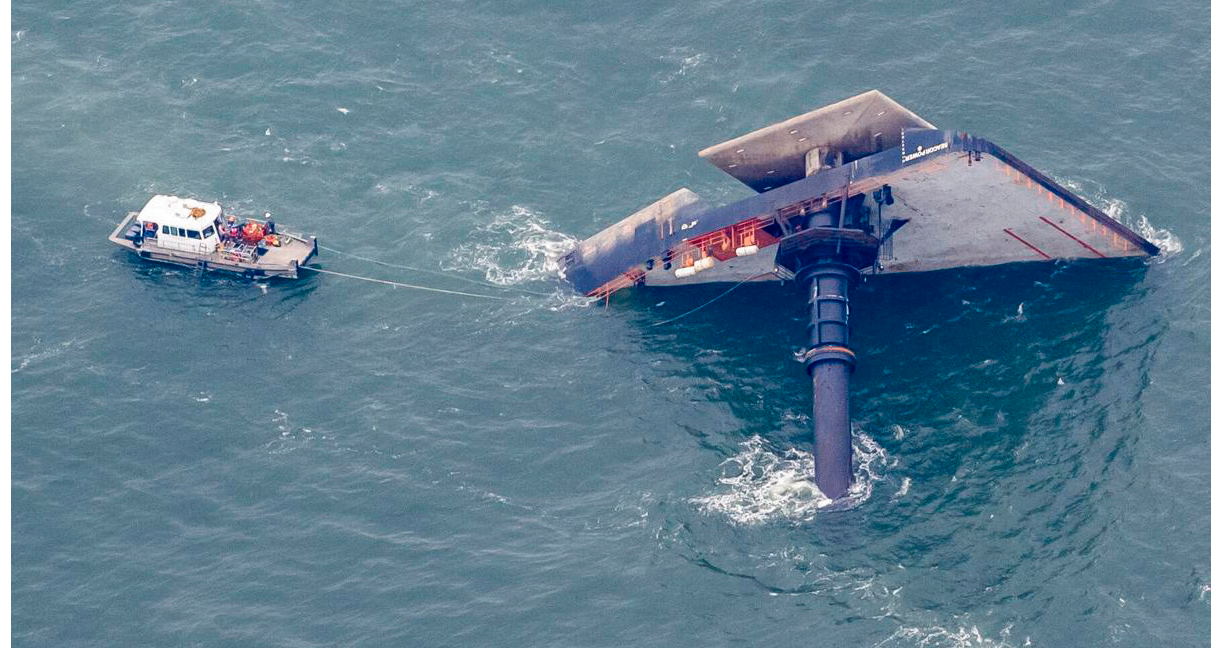
**Figure 10.** *SEACOR Power* after capsizing in the Gulf of Mexico when struck by severe thunderstorm winds.

**THE PROBABLE CAUSE** of the capsizing of the liftboat *SEACOR Power* was a loss of stability that occurred when the vessel was struck by severe thunderstorm winds, which exceeded the vessel's operational wind speed limits. Contributing to the loss of life on the vessel were the speed at which the vessel capsized and the angle at which it came to rest, which made egress difficult, and the high winds and seas in the aftermath of the capsizing, which hampered rescue efforts.

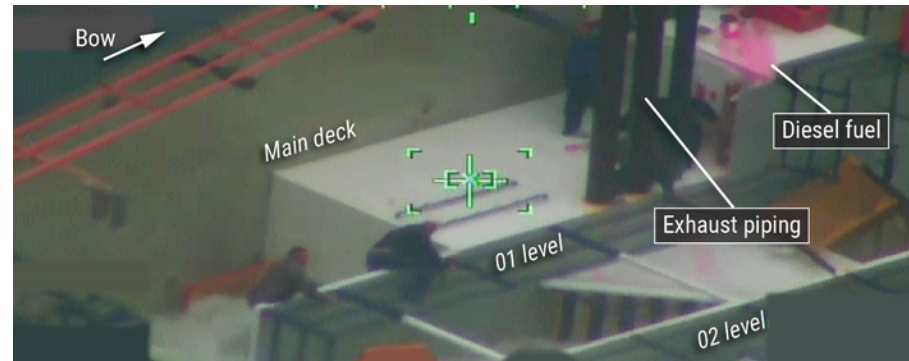
**Figure 13.** Left: Port side of the capsized hull about 1755. Some personnel are visible.

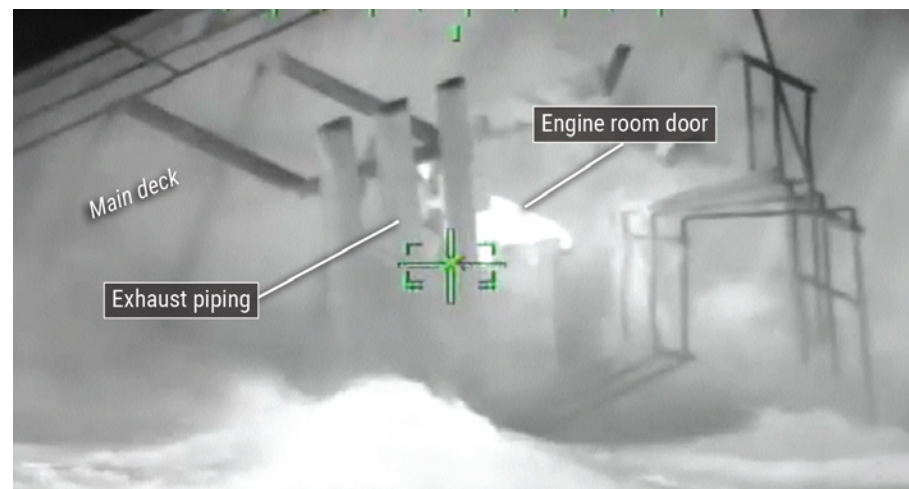
**Figure 14.** Door to engine room as it was opened at 2153, as seen by the Glen Harris.

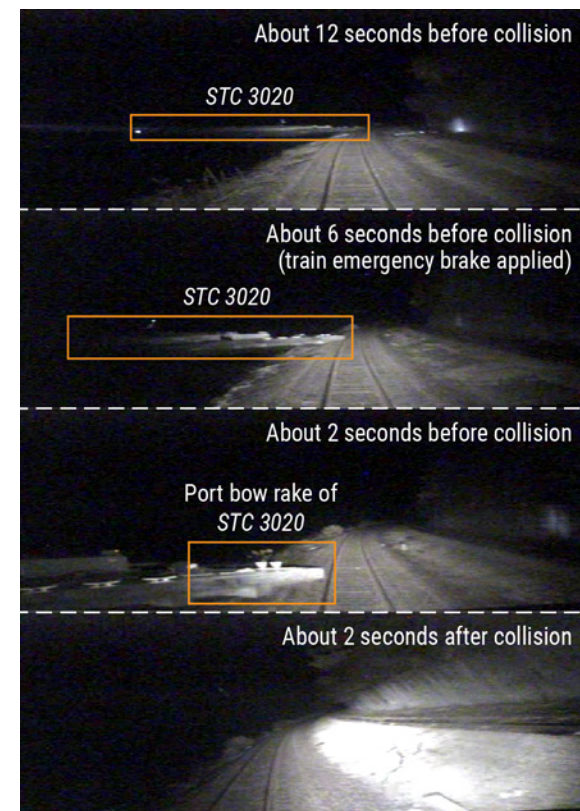
**Figure 22.** Still images of video footage from locomotive BNSF 9251's recorder as the train approached the barge and derailed after hitting the barge. The forward barge of the *Baxter Southern* tow is outlined in orange.

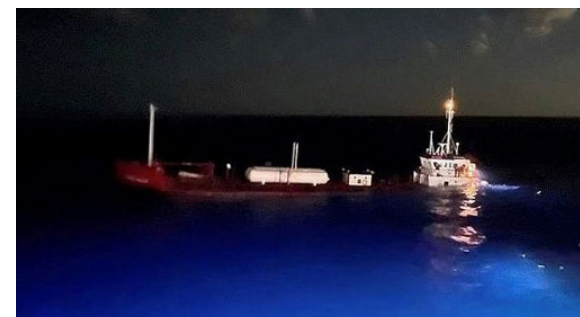
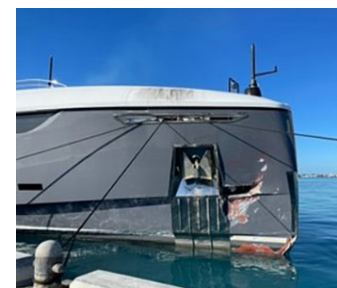
**Figure 31.** *Tropic Breeze* sinking by its stern about 15 minutes after the collision. SOURCE: AMARA

**Figure 32.** Damage to *Utopia IV*'s bow. SOURCE: COAST GUARD

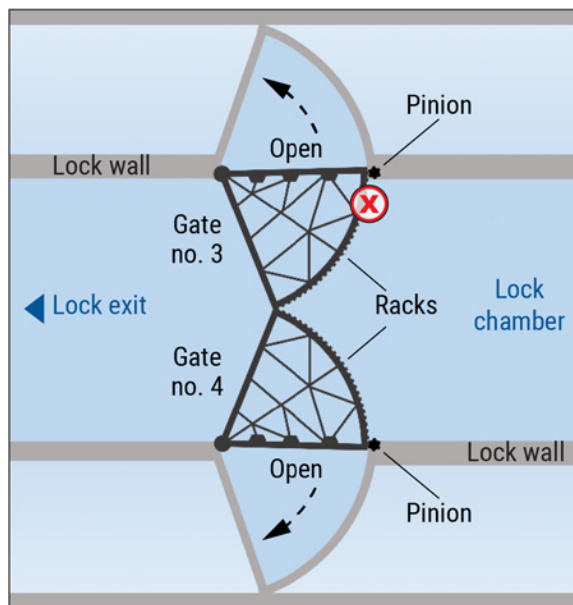
When the tow was about 200 feet from the gates, the captain put the engines at full astern. The tow continued to slow but did not fully stop before the starboard bow of the *HFL 439* struck gate no. 3 on the northwest side of the lock at 0522. The tow's speed when it contacted the gate was 1.2 mph.

**Figure 37.** Left: Simplified illustration of Leland Bowman Lock western gates showing the point of contact by barge *HFL 439*, as indicated by the red X.

**Figure 38.** Below: Damaged steel plating and rack on gate.

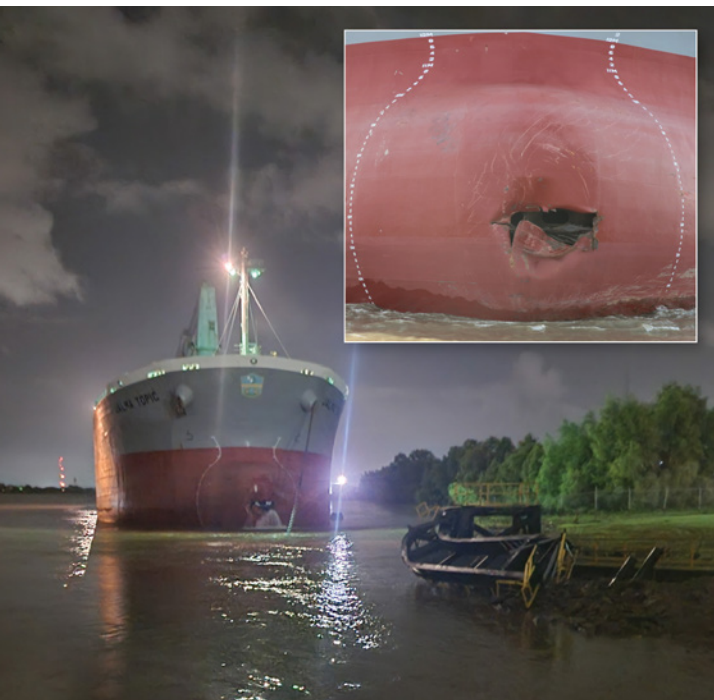
**Figure 44.** *Jalma Topic* down river of the office barge at 0328 with its port anchor out. Inset shows a close-up of the damage to the vessel's bulbous bow.

**Figure 45.** Postcasualty damage to office barge moorings, catwalks, and gangways.

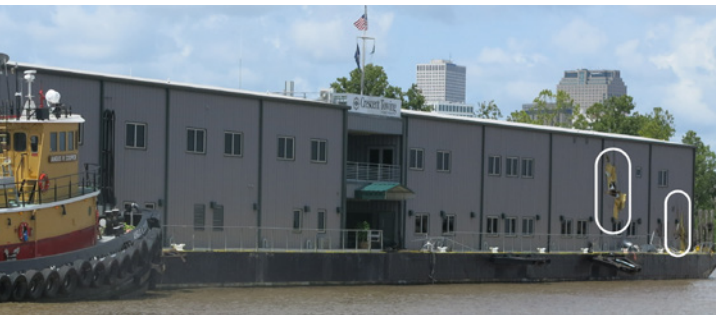
As the two dispatchers aboard the office barge were attempting to evacuate, one dispatcher heard the blast of the ship's whistle, and shortly after, the bulbous bow of the *Jalma Topic* struck the downriver corner of the office barge at 0322:40, at a speed of 6.2 knots, breaching the *Jalma Topic*'s bulbous bow and breaking the barge from its permanent moorings. The two dispatchers and a cleaner were later able to exit the barge to the shore.

**Figure 47.** Office barge with detached mooring apparatus and structural penetrations (outlined in white).

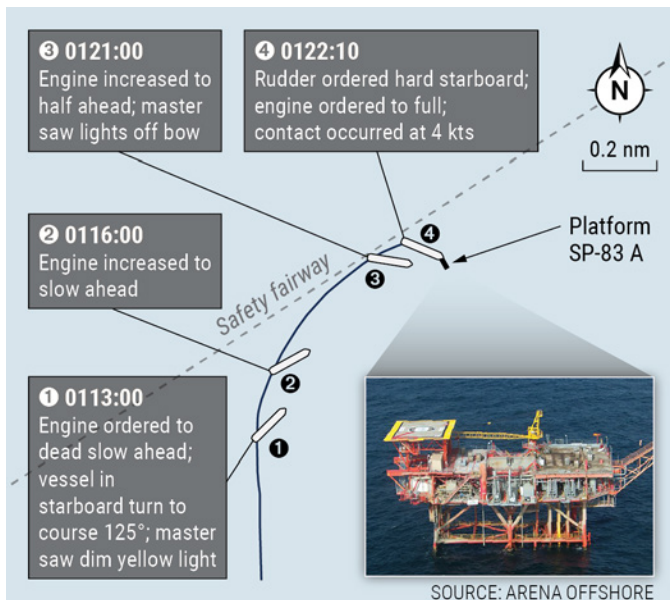
**Figure 53.** The final events leading up to the *Ocean Princess* contact with platform SP-83A (inset).

**Figure 54.** Knocked down mast and damaged bulwark, anchor windlass, and handrails on the *Ocean Princess* following the casualty. SOURCE: BUREAU OF SAFETY AND ENVIRONMENTAL ENFORCEMENT

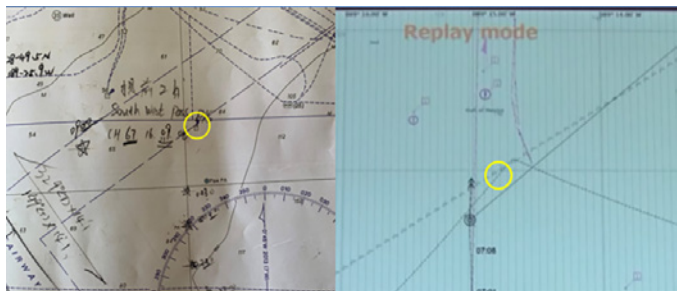
Although SP-83A was depicted on the British Admiralty paper chart on the bridge, it nor other nearby platforms were marked as obstacles as required by the company's SMS. The mate was aware of the platform when he plotted fixes on the paper chart nearly an hour before the casualty but did not think it was of concern. He also did not tell the master about the platform on the chart and assumed the master was aware of it.

**Figure 56.** Navigation aids used by the *Ocean Princess* bridge team, with the location of platform SP-83A shown annotated by NTSB with a yellow circle (images are at different scales). The British Admiralty chart 3857 (left) and ECDIS screenshot from the *Ocean Princess* fed by NOAA ENC (right), which were up to date at the time of the casualty. The British Admiralty chart shows SP-83A while the ECDIS image does not.

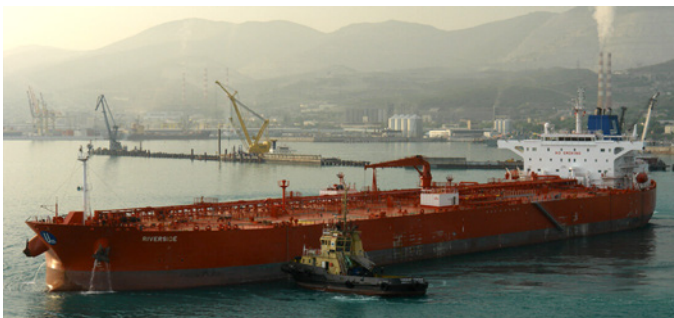
**Figure 58.** Damage to the no. 4 Moda dock catwalk (left) and the *Riverside* (right, circled). SOURCE: COAST GUARD

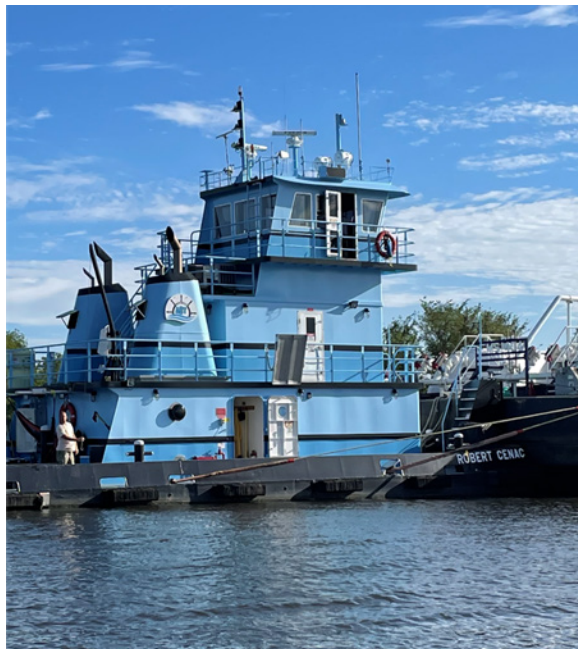
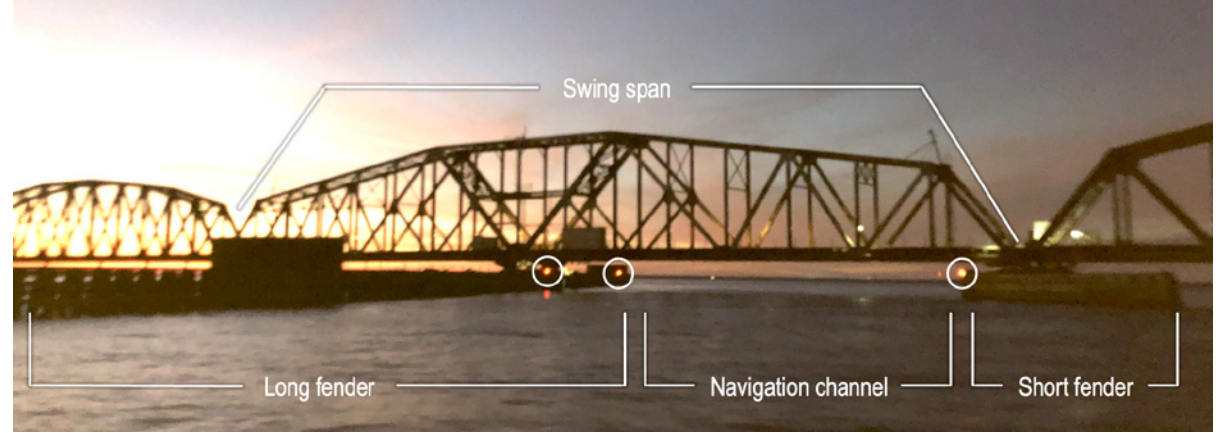
Figure 62. January 29, 2021, post-casualty photo of the Rigolets Bridge (in the closed position), as it would have been approached from the south, heading north. Red navigation lights on the long and short fenders are circled. Note there are no navigation lights at the top of and each end of the swing span, and there are no red navigation lights at either end of the short or long fenders, nor anywhere on the south side of the bridge on the short or long fenders.

The captain and pilot stated it was difficult to see the channel through the bridge fenders, and investigators determined that required navigation lights were not located at the fender ends. Investigators also found that the swing span was not fitted with any navigation lighting, as required by regulation, to indicate that it was in the open or closed position. Had the swing span been lighted as required, the captain would likely have been able to visually determine the position of the swing span throughout its opening sequence.

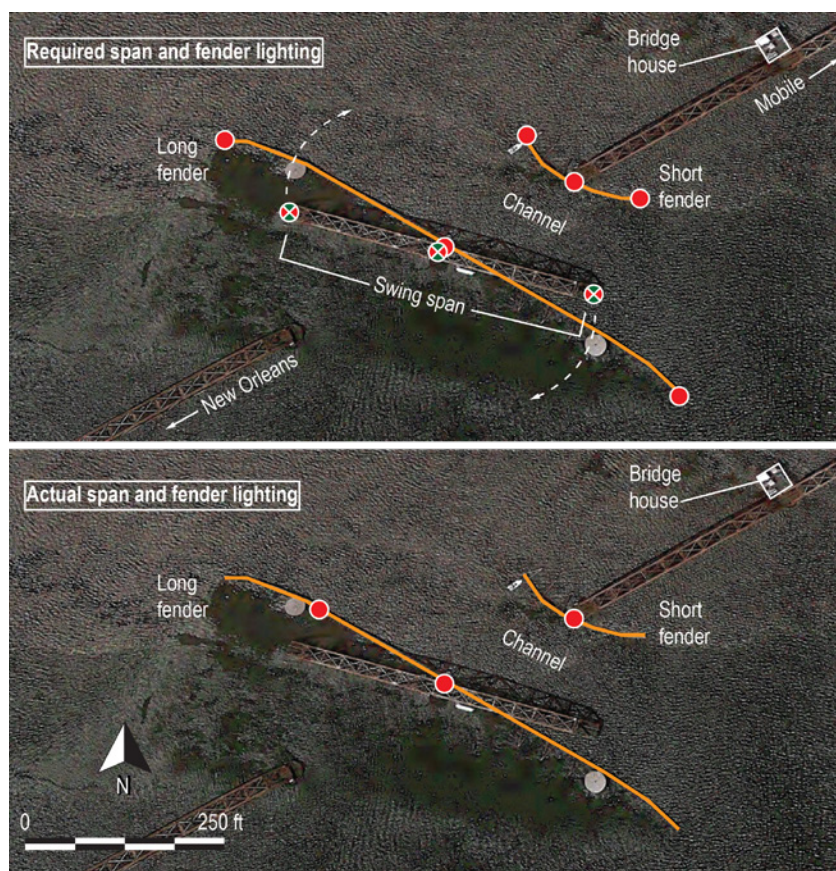
**Figure 64.** August 2015 images of the Rigolets Bridge channel and fendering with the swing span about three-quarters of the way open. BACKGROUND SOURCE: GOOGLE EARTH

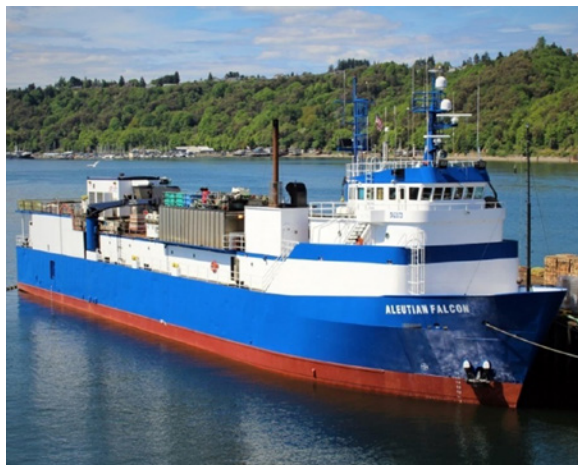
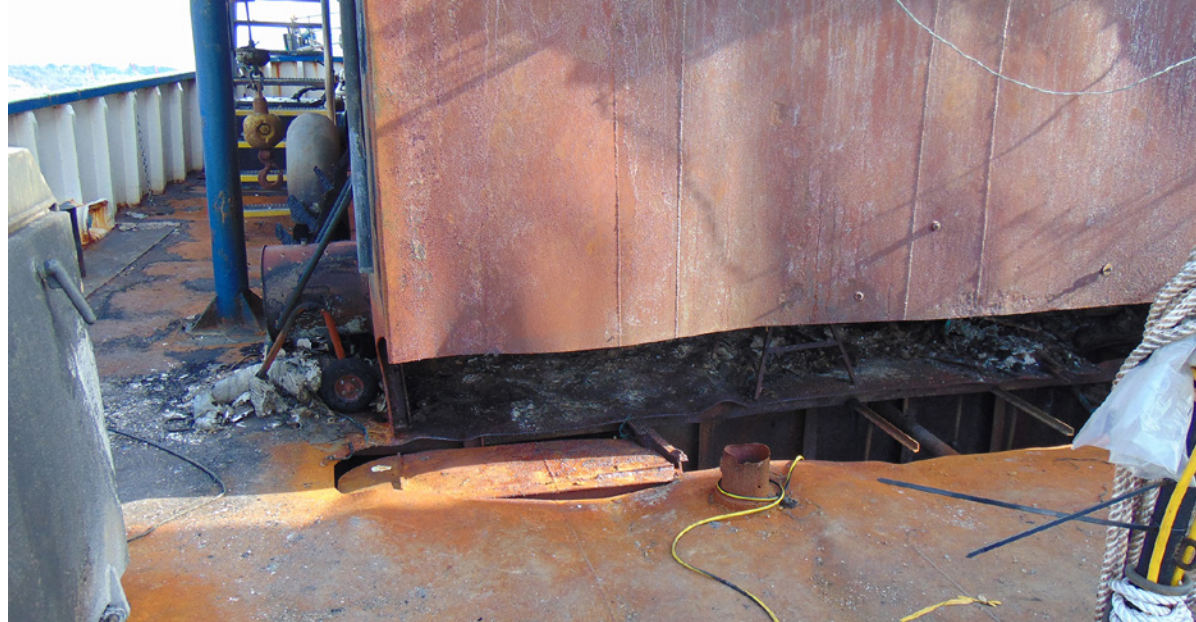
**Figure 66.** *Aleutian Falcon* bridge deck post-fire, depicting hot work area on the day of the casualty.

On February 17, 2021, workers planned to continue ongoing hot work by removing corroded steel deck plating located on the bridge deck above the pantry, dry stores area, and walk-in refrigerator. Because the work was in an area that adjoined foam insulation below, a marine chemist had previously been brought

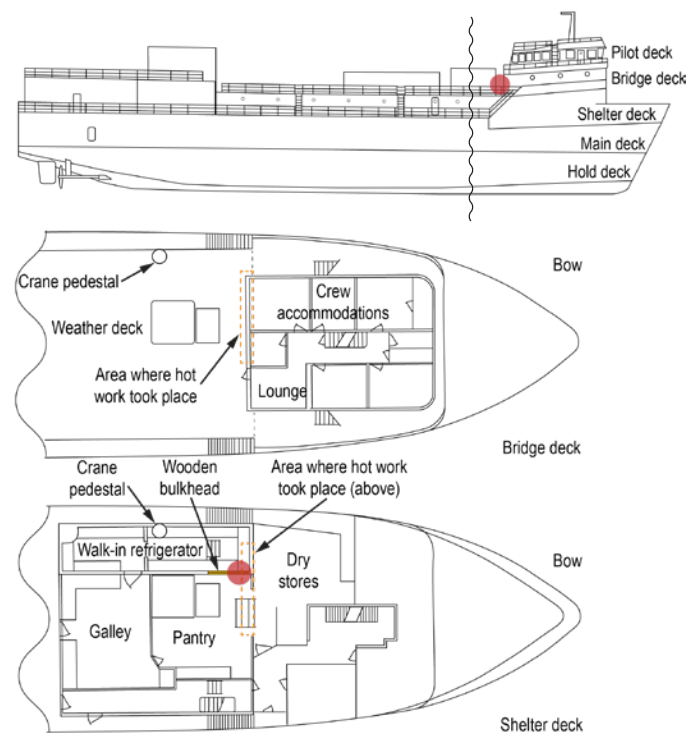
**Figure 67.** Profile (top) and bridge and shelter deck arrangements (bottom) of *Aleutian Falcon*. The area where the fire began on the shelter deck is indicated by a red circle. The area of the bridge deck where the deck was being cut is highlighted with orange dashed lines.

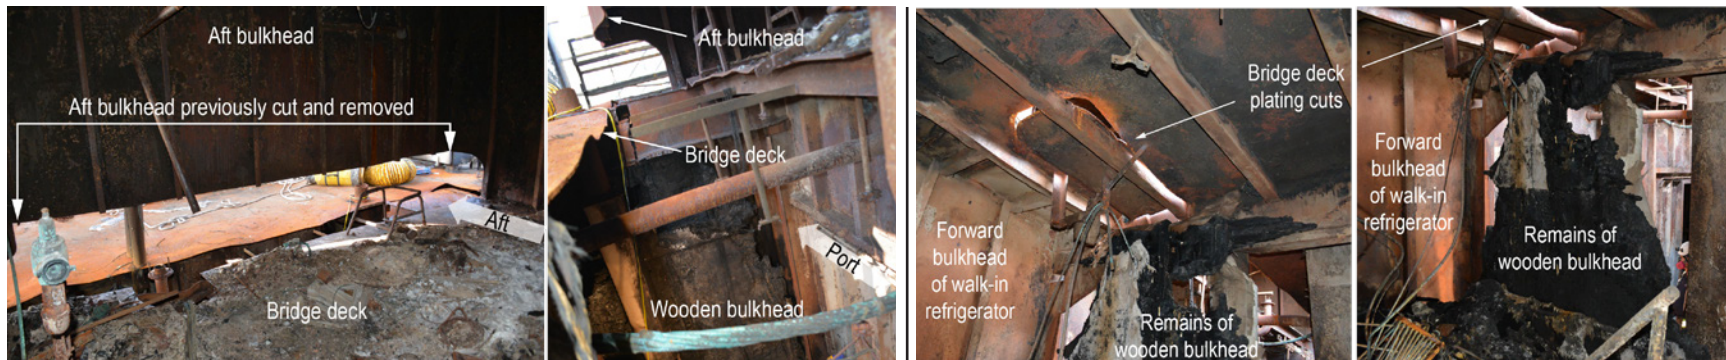
**THE PROBABLE CAUSE** of the fire aboard the fish processor *Aleutian Falcon* was the company's supervisory personnel inadequately planning for hot work, as well as shoreside workers' inadequately protecting hot work areas, allowing slag from hot work to ignite combustible material near an insulated wooden bulkhead of a walk-in refrigerator that had not been removed or sufficiently protected. Contributing to the casualty was the ineffective communication between the supervisory personnel, marine chemist, and workers.

**Figure 68.** *Aleutian Falcon* post-fire, depicting hot work area on the day of the casualty. The bridge deck (left two photos) and forward end of walk-in refrigerator on the shelter deck (right two photos).

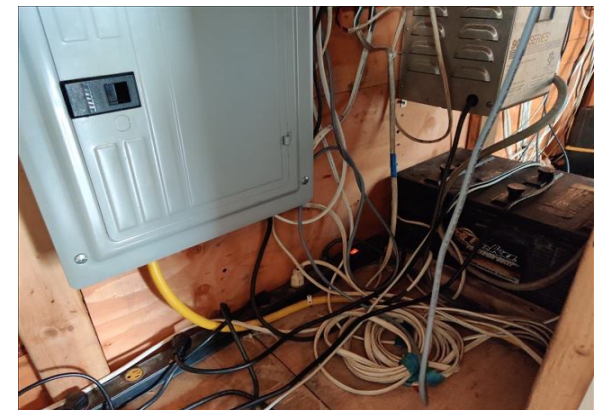
**Figure 72.** *Blue Dragon II* pilothouse console wiring.

(*Blue Dragon II*) and found wiring that did not meet typical marine standards (improper connections, loose, disorganized, and bare wires) under the wooden wheelhouse console, as well as computer equipment and batteries. Such substandard electrical outfitting can result in an electrical fault, which can serve as a source of ignition for a fire. Given that both vessels were owned and operated by the same company and were designed with similar console equipment, the condition of the *Blue Dragon's* wiring was likely comparable to the *Blue Dragon II's*. Additionally, because there was similar electrical equipment stowed under both consoles, it is likely the fire started from an electrical source.

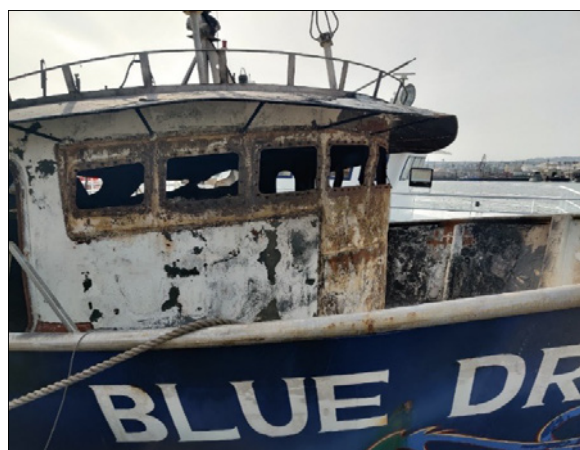
**Figure 73.** *Blue Dragon* wheelhouse exterior (top) and interior looking forward (bottom), following the fire. The framing of the false deck below indicates the location of what was the wheelhouse deck. SOURCE: COAST GUARD

**THE PROBABLE CAUSE** of the fire aboard the fishing vessel *Blue Dragon* was from an unknown source, likely electrical in nature, which ignited the wooden wheelhouse console. Contributing to the extent of the fire damage was the substantial use of combustible materials in the joinery, outfitting, and furnishings in the wheelhouse and accommodation spaces.

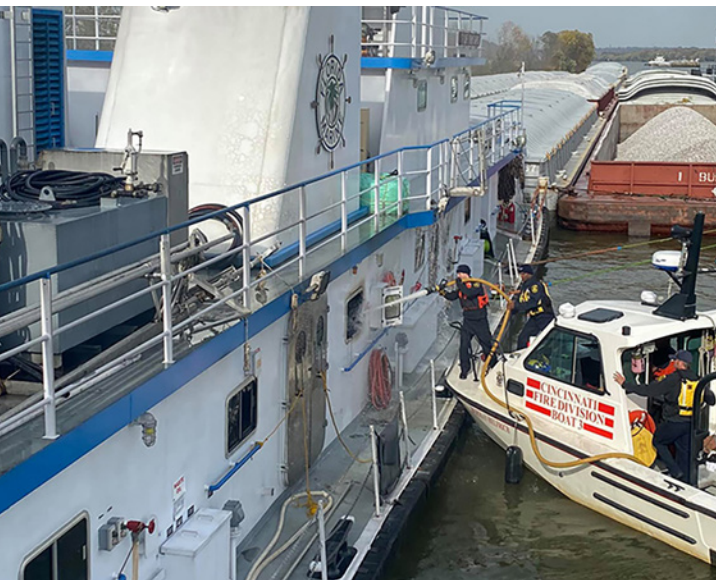
**Figure 75.** Firefighters deploying water into the engine room of the *Capt. Kirby Dupuis* through an open window.

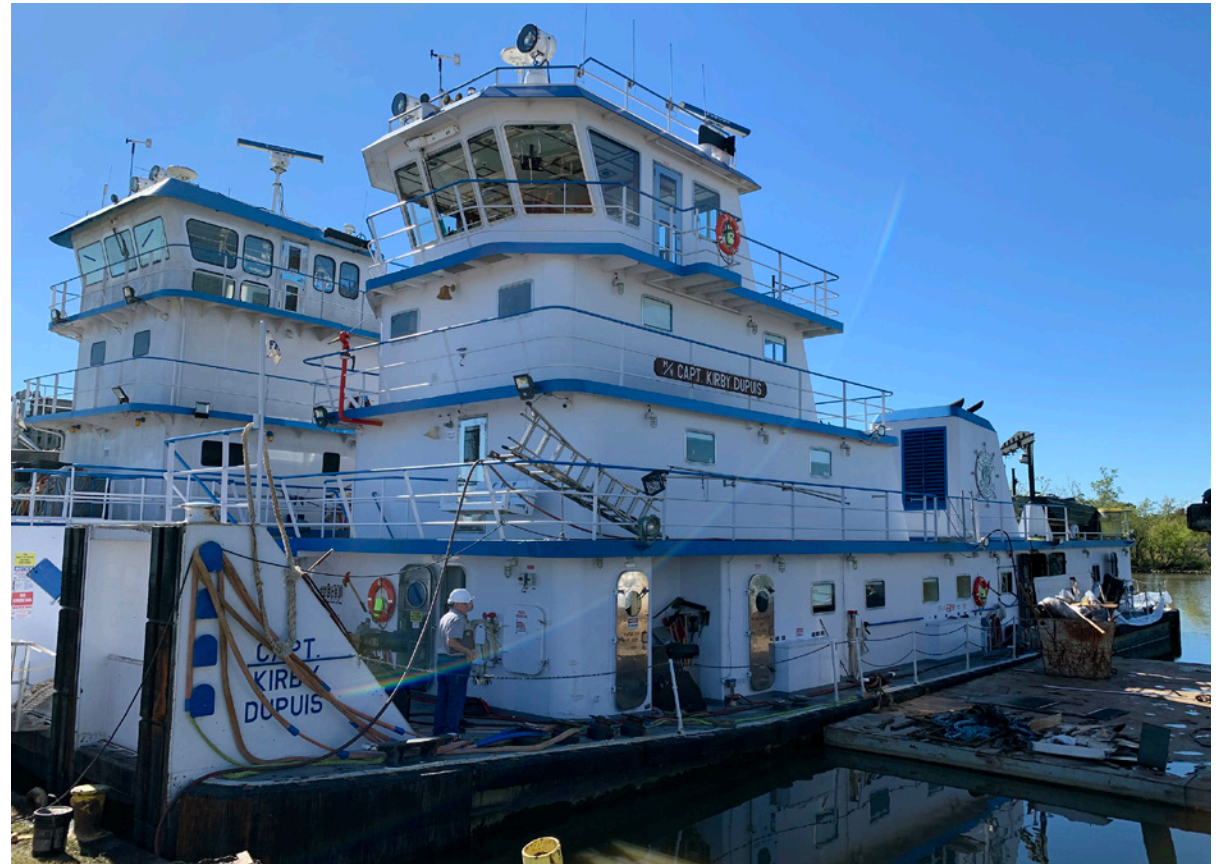
**Figure 76.** *Capt. Kirby Dupuis* docked following the casualty.

Post-casualty, a service manager from Louisiana Cat (Caterpillar) determined that a broken O-ring was missing from a lube oil tube on the port engine. The tube was also missing a retaining ring and supporting hardware. A sheared bolt indicated that the supporting clips and hardware had originally been installed on the engine but had failed at some point. Without the clips and hardware, the tube was unsupported and more susceptible to vibration and associated movement. It is unknown how long the engine had been operating without the retaining ring, supporting clips, and hardware on the lube oil tube. The technician concluded that the cause of the fire was "a severe oil leak" that sprayed onto the exhaust manifold and ignited.

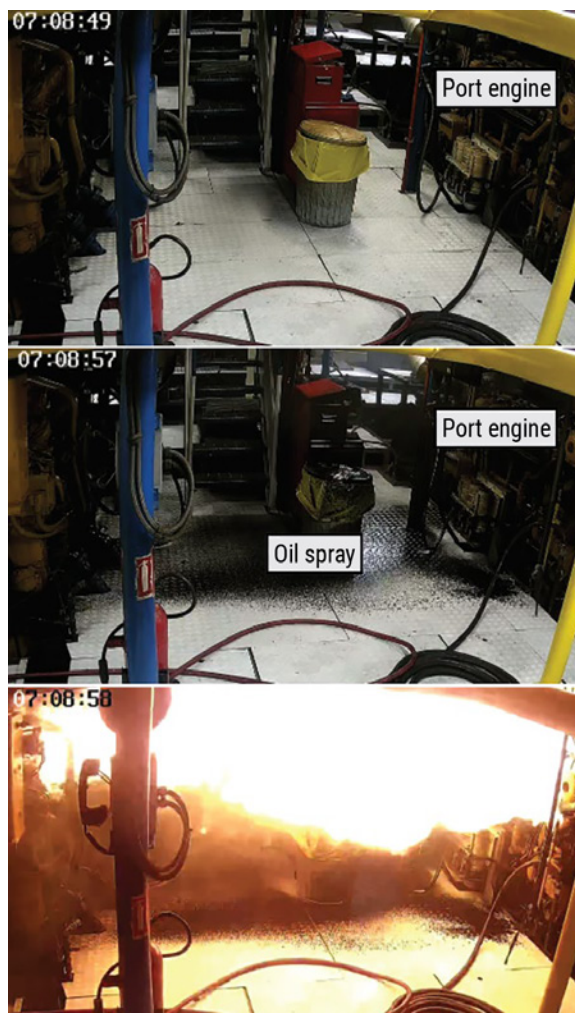
**Figure 77.** Screenshots from the *Capt. Kirby Dupuis* engine room video camera (looking aft).

However, investigators determined that the system was not activated during the fire. The deckineer did not hear the system's sirens nor product discharging into the engine room. After the fire, both suppression fluid cylinders were full, and the nitrogen pilot cylinder lever was found in the "set" position with its cylinder still fully charged.

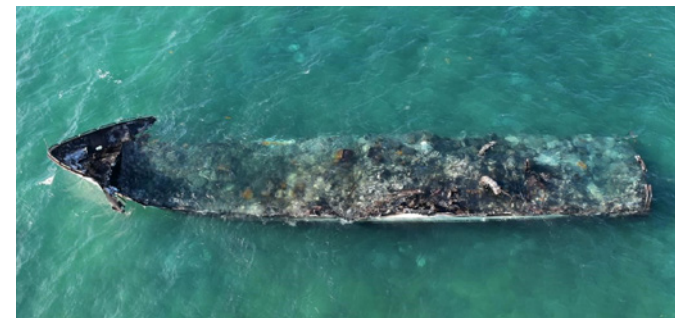
**THE PROBABLE CAUSE** of the engine room fire aboard the yacht *La Dolce Vita* was an undetermined electrical source within the sound enclosure for the starboard generator. Contributing to the severity of the fire and total loss of the vessel was the inability to secure ventilation to the engine room, which reduced the effectiveness of the yacht's fire extinguishing system and allowed the fire to spread beyond the engine room.

**Figure 80.** After-fire remains of *La Dolce Vita* before salvage operations. SOURCE: COAST GUARD

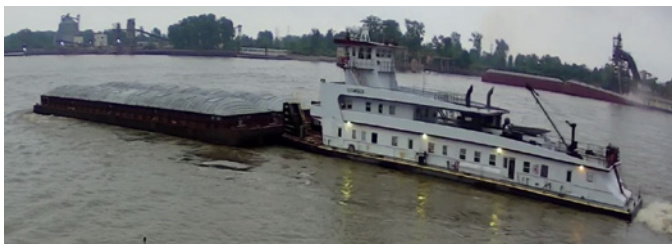
**Figure 82.** Above: *Mary Lynn* underway at 0652 on May 18, 2021, about a minute before the fire broke out. Below: *Mary Lynn* at 0652:40 (left) when the first open flame, circled in yellow, was visible on the second deck port side exhaust stack, and at 0652:45 (right).

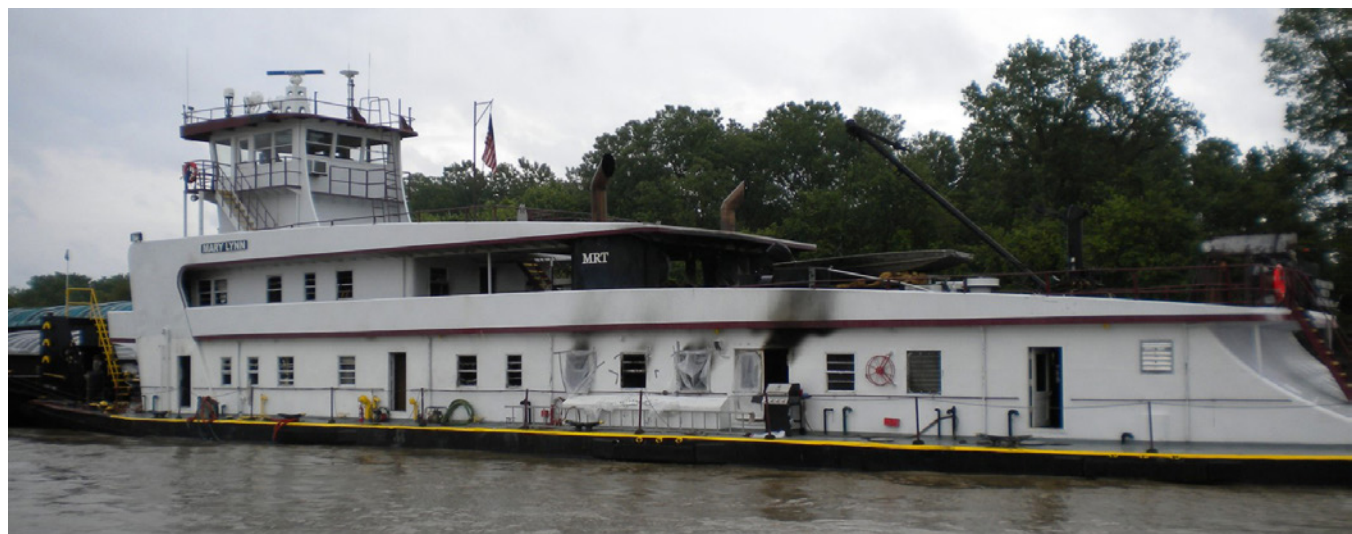
**Figure 83.** *Mary Lynn*'s port side, postcasualty, with some of the plastic window coverings remaining over the engine room windows. SOURCE: COAST GUARD

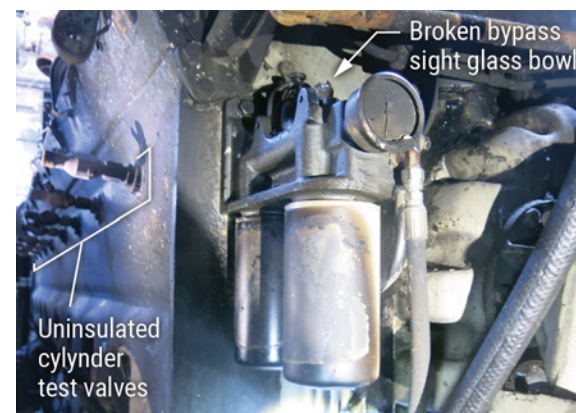
The pressure increase caused the weakest part in the system, the fuel supply bypass sight glass bowl on the port main engine spinon fuel filter assembly, to fail, causing atomized fuel to spray and ignite. The design of the *Mary Lynn's* fuel system allowed for the potential pressurization of the day tank to exceed atmospheric pressure if a crewmember secured valves on other tanks. Had the *Mary Lynn's* day tank been fitted with its own vent line, even with the fuel return lines inadvertently left closed, the overpressurization of the return line would have not occurred.

To prevent combustible liquids, such as marine diesel fuel, from contacting hot piping and machinery components, regulations require that such components be insulated. Investigators found a section of exhaust header with no thermal protection. The nearby cylinder test valves were also uninsulated. The investigation determined that the fire likely originated where these uninsulated components were located.

**Figure 85.** Inboard side of the port main engine showing the uninsulated cylinder test valves and their proximity to the broken sight glass bowl.

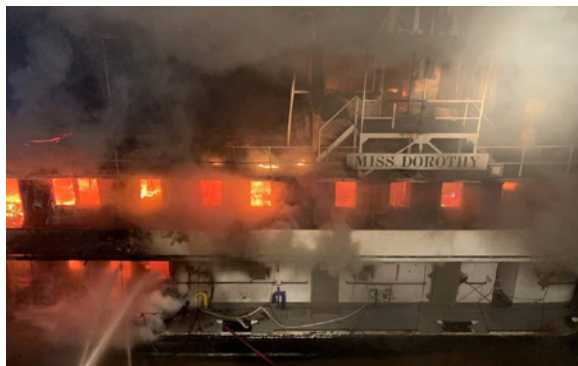
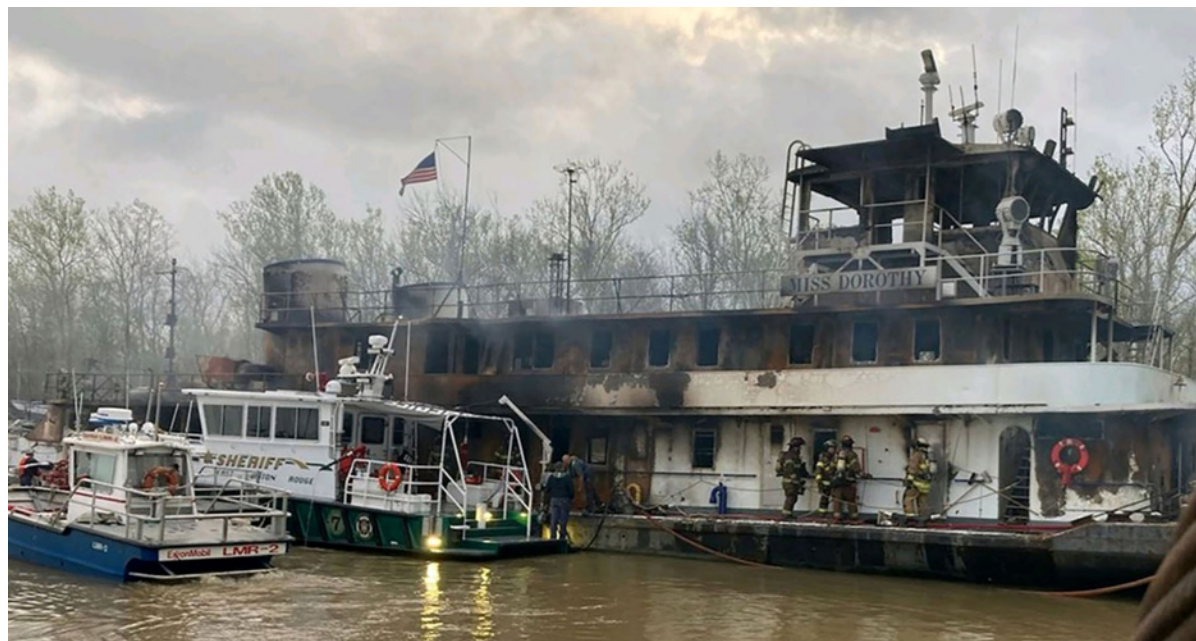
**Figure 89.** East Baton Rouge Sheriff's Office and ExxonMobil fire boats alongside the burned-out *Miss Dorothy* after the fire had been extinguished. SOURCE: WESTERN RIVERS BOAT MANAGEMENT INC.

To fight the fire, the crew used handheld extinguishers and water hoses, but these did little to suppress the well-established diesel fuel fire. The vessel's two semiportable extinguishers and two stationary CO<sub>2</sub> cylinders fitted with a hose reel were inaccessible due to their location in the engine room. The crew secured the engine room's mechanical ventilation, but this action was ultimately futile due to the uncontrolled amounts of oxygen being drawn in through open engine room doors and open or broken windows.

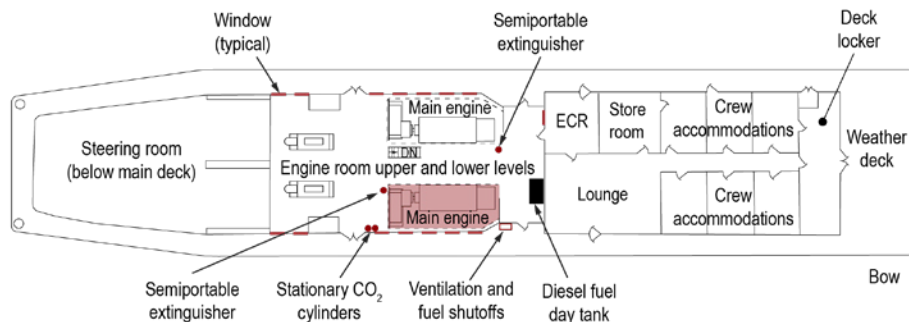
**Figure 90.** *Miss Dorothy* main deck layout. The area where the fire was discovered is highlighted in red.

**THE PROBABLE CAUSE** of the engine room fire aboard the towing vessel *Miss Dorothy* was the ignition of spraying diesel fuel from a main engine's fuel system onto an uninsulated section of the engine's exhaust system. Contributing to the severity of the fire and damage to the vessel was the inability to effectively secure ventilation to the space and fuel to the affected engine.

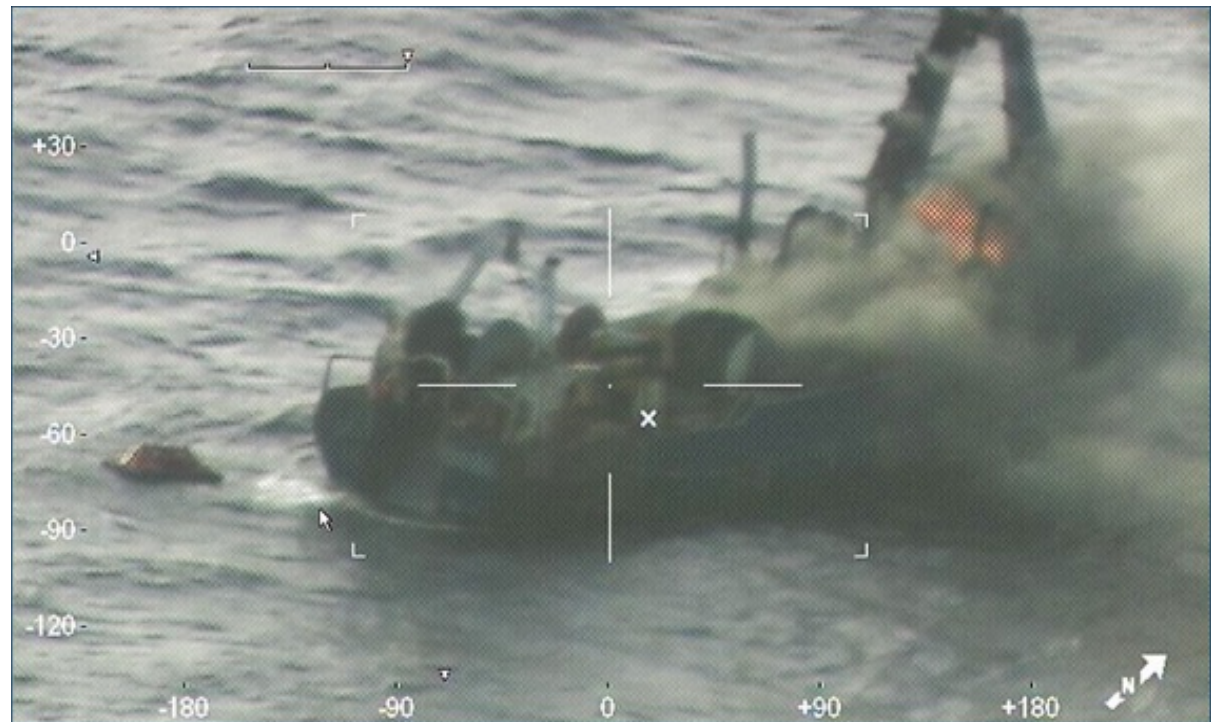
**Figure 93.** Photo taken from the Coast Guard HC-144 aircraft at 1827 shows the bow of the *Nobska* on fire before the rescue. The deployed liferaft appears on the left. SOURCE: COAST GUARD

The crew discovered that the fire was the result of the failure of a deck winch's hydraulic hose located near the bottom of the pipe/hose tunnel that ran vertically from the overhead in the engine room up to the wheelhouse. The leak of hydraulic fluid from the 0.25 inch-diameter hose had sprayed onto the exhaust pipe lagging of the main diesel engine, 2 feet away, until it was soaked with enough fluid to cause it to ignite from the heat developed by the engine's exhaust gases.

**THE PROBABLE CAUSE** of the fire aboard the fishing vessel *Nobska* was a failure of a hydraulic hose within the engine room that allowed hydraulic fluid to spray onto a hot surface, likely the exposed main engine exhaust pipe. Contributing to the failure of the hydraulic hose was possible heat damage from a fire that occurred earlier in the day.

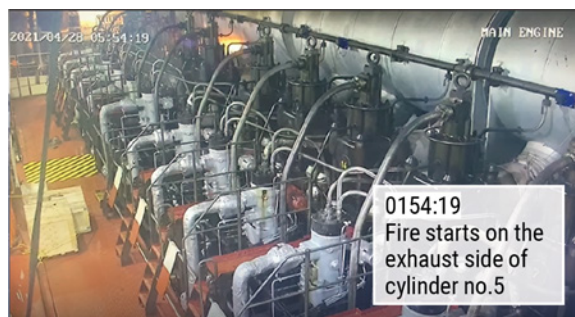
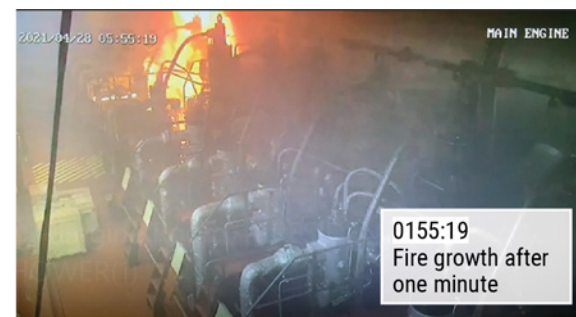
**Figure 96.** Top to bottom: CCTV screen captures of the main engine showing fuel spray in the area around the no. 5 cylinder the moment the fire started, and the progression (*time stamps are 4 hours ahead*). SOURCE: APL MARITIME

CCTV footage showed that about 0124, on April 28, ultra-low sulfur diesel fuel began spraying in the area around the main engine's no. 5 cylinder. The engine room was unattended at the time, and the leaking fuel went unnoticed. The *President Eisenhower* did not have CCTV video analytic technology integrated into the existing system to identify fuel mist in real time and alert the crew.

Investigators found that an exhaust valve compensator flange on the no. 5 cylinder—which was subject to internal engine exhaust temperatures greater than 428°F (often as high as 600°F)—near the disconnected fuel return tubing end was exposed and not insulated (as was required by SOLAS regulations). Therefore, it is likely that the unshielded and uninsulated exhaust valve compensator flange acted as an ignition source for the spraying diesel fuel.

**THE PROBABLE CAUSE** of the engine room fire aboard the containership *President Eisenhower* was a crewmember insufficiently swaging a compression fitting ferrule during the installation of fuel oil return tubing for a main engine's cylinder, allowing an end of the tubing to disconnect and spray fuel oil onto a nearby unshielded and uninsulated cylinder exhaust component.

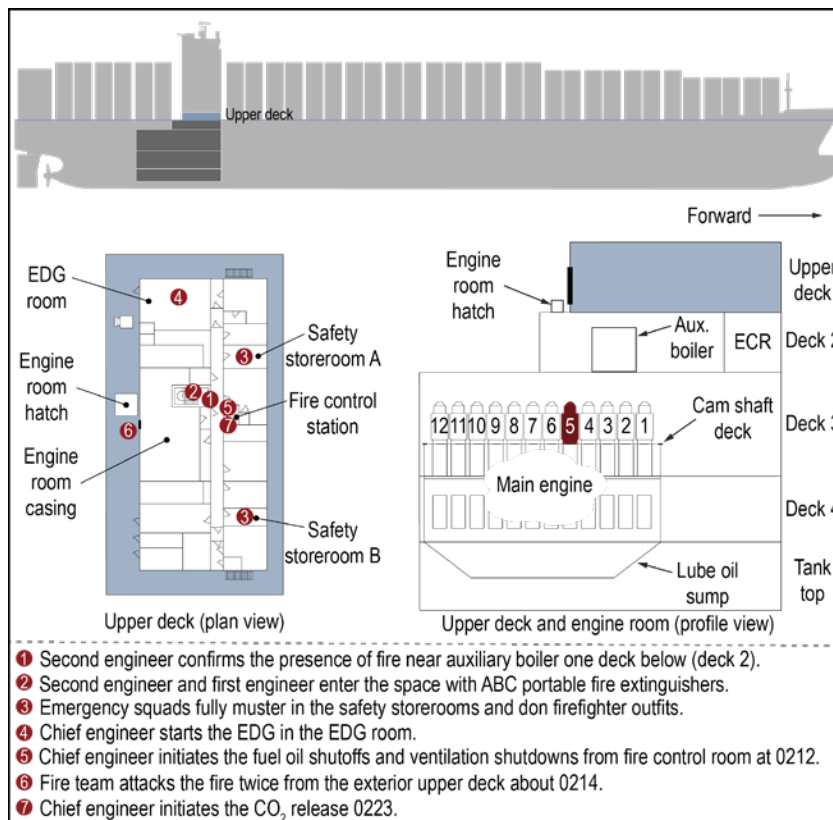
**Figure 97.** Profile view of the *President Eisenhower* (top). Plan view of the upper deck showing the sequence of events during the fire (left). Profile of the upper deck and engine room decks with the origin of fire highlighted (right).

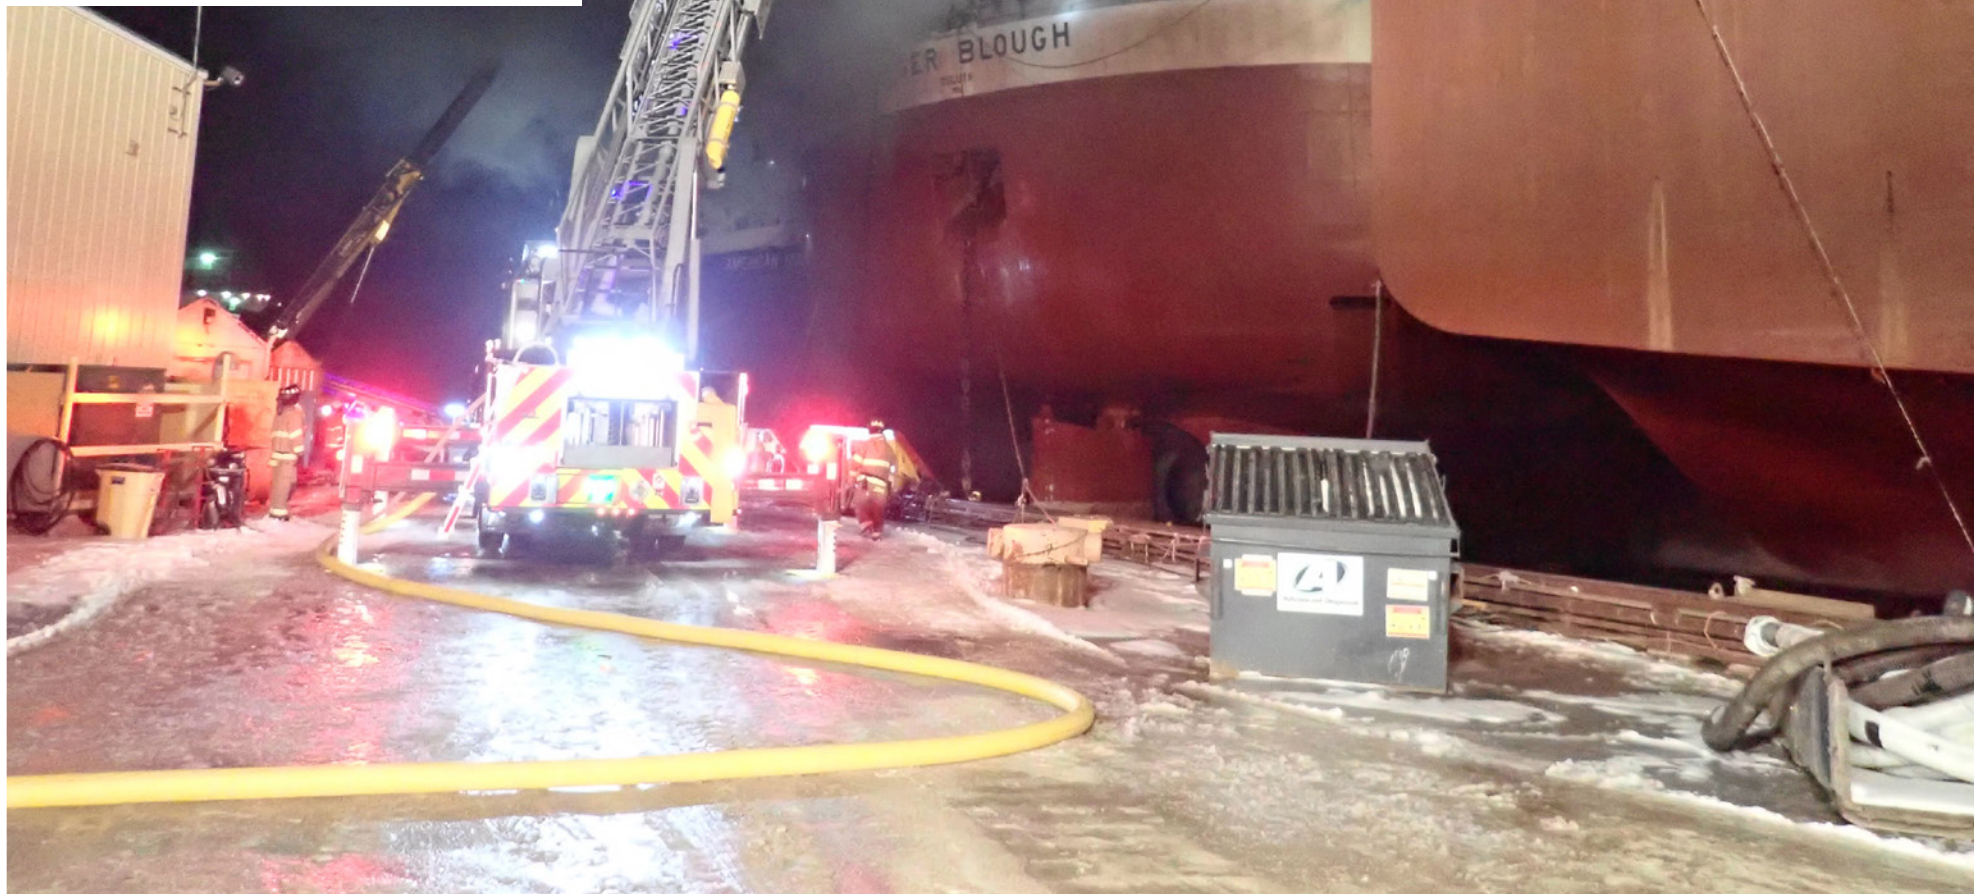
Figure 99. Stern of the *Roger Blough* during firefighting efforts. SOURCE: COAST GUARD

On February 1, 2021, about 0131 local time, a fire started in the engine room on the *Roger Blough* during the dry bulk carrier's winter layup at the Fincantieri Bay Shipbuilding facility on Sturgeon Bay, Wisconsin. The cargo-unloading conveyor belts subsequently ignited, causing extensive damage throughout the aft section of the vessel. The shipkeeper on board departed the vessel without injury. Firefighters extinguished the fire later that afternoon. No pollution was reported. Damage to the *Roger Blough* exceeded \$100 million.
