NATIONAL TRANSPORTATION SAFETY BOARD

2022

# SAFER SEAS Digest

Lessons Learned from  
Marine Investigations

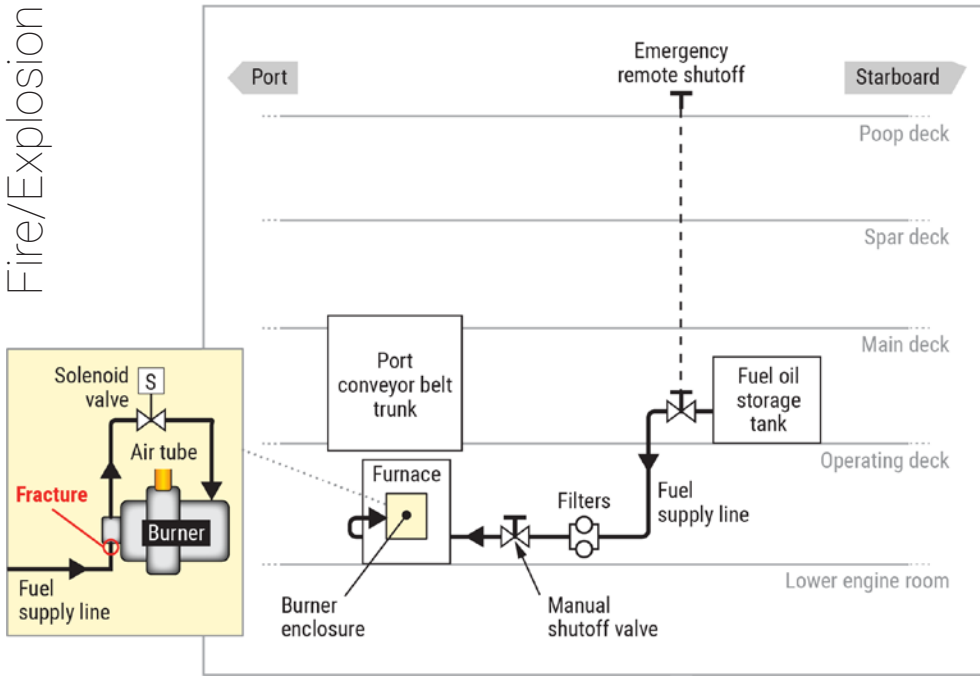
**THE PROBABLE CAUSE** of the engine room fire aboard the bulk carrier *Roger Blough* was likely the repeated removal and reinstallation of the furnace's burner that led to the failure of its mounting coupling, resulting in the operating burner dropping to the bottom of its enclosure and fracturing its fuel supply line, which allowed diesel fuel to ignite. Contributing to the casualty was the absence of a fire-activated automatic fuel oil shutoff valve on the fuel oil inlet piping before the burner, which would have stopped the fuel feeding the fire shortly after it started and limited the spread of the fire.

**Figure 102.** Simple section view of the *Roger Blough's* engine room with arrangement of the furnace's fuel supply (not to scale).

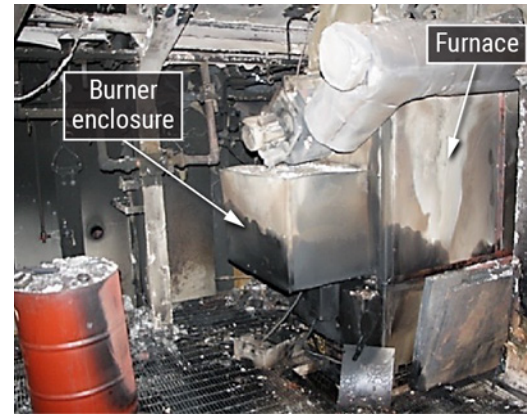
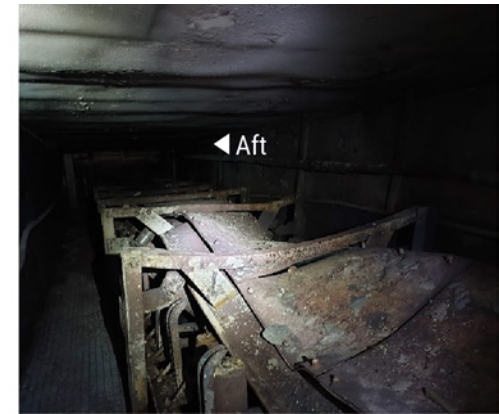
**Figure 104.** Left to right: Fire-damaged furnace and conveyor belt within the conveyor belt trunk above the furnace. SOURCE: COAST GUARD

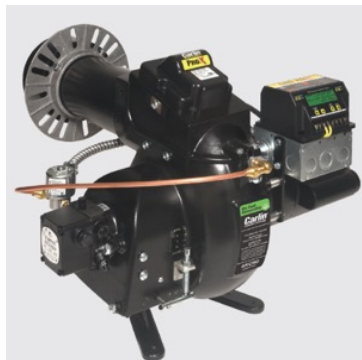
◆ **Lack of a fire-activated valve on the fuel oil piping to the burner on the furnace in the engine room.** The fire originated at the burner inside the diesel oil-fired furnace, which had been installed in the engine room to heat the space during the winter (to prevent piping and equipment from freezing). The 65-pound burner assembly, typically used in furnaces for heating shoreside buildings, was mounted onto the furnace's air tube with an aluminum coupling. Among the fire damage and debris, investigators found the burner assembly detached from the air tube and resting on the bottom of the burner enclosure. The fuel supply line to the burner was also found fractured. It is likely that, when the mounting coupling fractured, the furnace's burner assembly became detached from the air tube and fell, which likely bent and fractured the fuel supply line to the burner, thereby allowing fuel to spray onto the operating burner and ignite within the enclosure. The National Fire Protection Association recommends that burner assemblies like the type installed on the *Roger Blough* have a fire-activated quick-closing valve on the inlet fuel oil piping next to the burner. When installed, this type of valve has a thermally activated mechanism that shuts the valve in the presence of fire to stop further flow of fuel to the burner. Had the burner assembly on the *Roger Blough* been fitted with a fire-activated quick-closing valve on its inlet fuel oil piping, the fuel feeding the furnace fire would have been stopped and thus the fire likely would not have spread so rapidly.

**Figure 106.** Burner assembly with pedestal support.

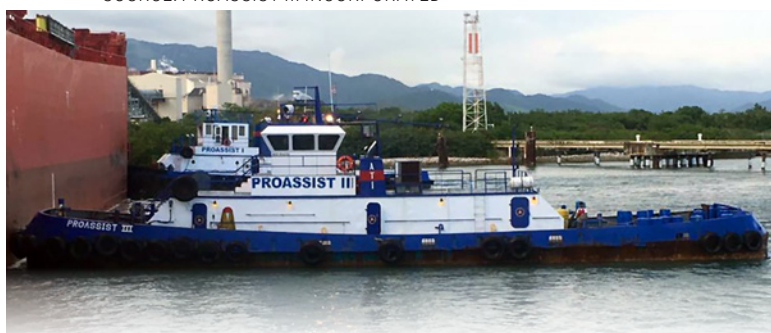
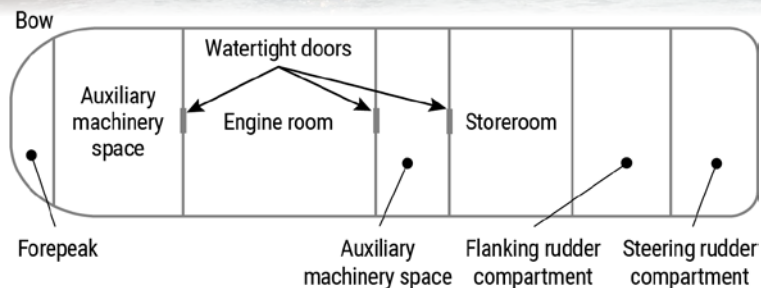
**Figure 108.** Compartments of the *Proassist III*, with approximate door locations (*not to scale*). SOURCE: DRAWINGS AND STATEMENTS BY *PROASSIST III* DECKHANDS

About 2.5 hours after departing, the crew noticed the vessel was down by the stern. They removed the flush access hatch to the flanking rudder compartment and found about 3 feet of water. A postcasualty examination of the vessel showed that portions of the transverse bulkhead between the flanking and steering rudder compartments were missing, and, therefore, the water that was found in the flanking rudder compartment would have also been in the steering rudder compartment at an equal level. Based on the approximate size of the two compartments, the volume of water accumulated in the spaces would have totaled roughly 36,500 gallons. Calculated from when the weather worsened, the average flooding rate would have been 304 gallons per minute.

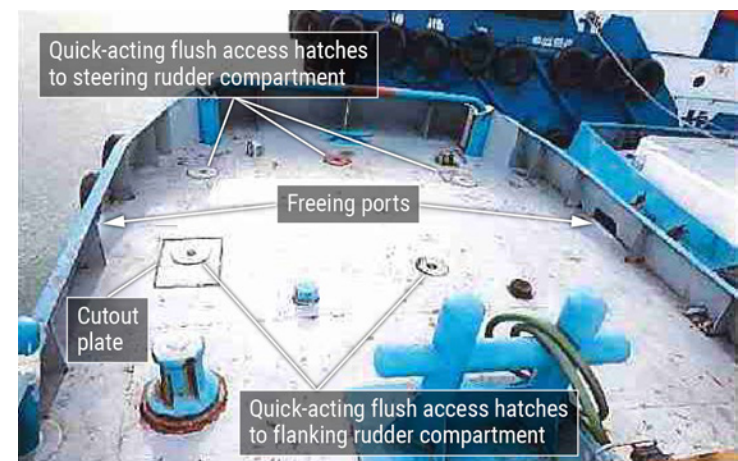
**Figure 109.** Main deck at the stern of the *Proassist III*.

Investigators found no structural hull defects that could have allowed for significant flooding; thus, the only other explanation would have been if a cover for one of the five aft main deck flush hatches were not in place. The crew told investigators that all deck hatches were closed when the vessel departed, but given the rate of flooding observed, at least one was likely not closed. With a reported 4–6 inches of water on deck, an open hatch would have allowed a significant amount of water to flood into the compartments below.

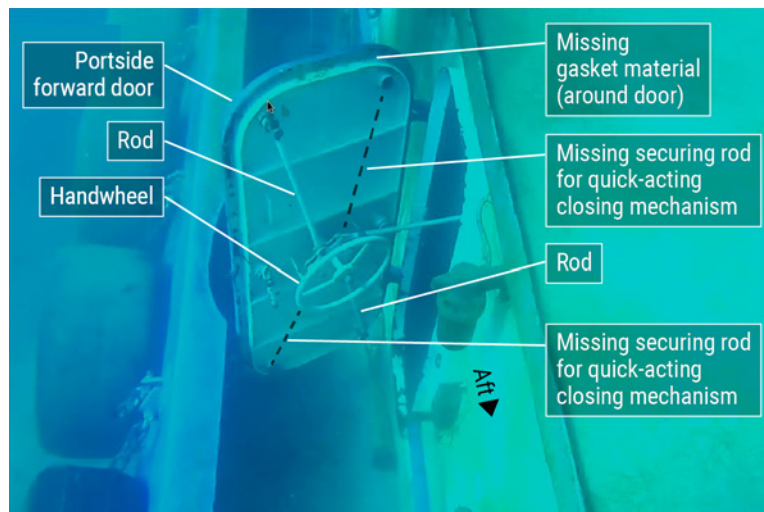
The postcasualty examination also showed lack of gaskets and securing mechanisms for the deck hatches. The watertight and structural integrity deficiencies identified showed that the vessel was not adequately maintained. Additionally, after the casualty, hull and deck integrity issues were identified on three of the *Proassist III* owner's other vessels,

**Figure 111.** Starboard-side cutout plate with missing quick-acting flush access hatch cover (left close-up) and unseated center quick-acting flush access hatch cover to flanking rudder compartment (right close-up).

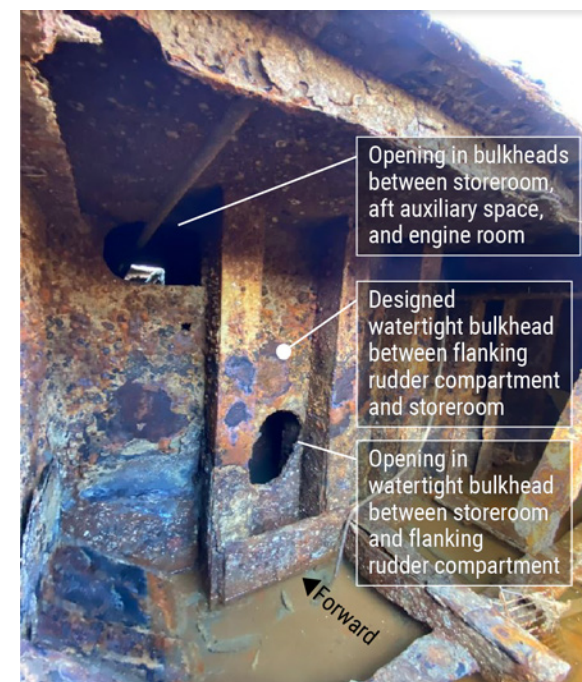
**Figure 112.** Flanking rudder compartment after recovery. Openings in bulkhead shown are also typical of other bulkheads below the main deck separating compartments. BACKGROUND SOURCE: COAST GUARD

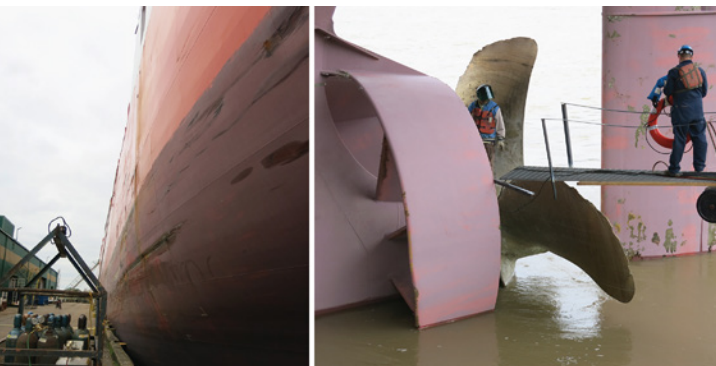
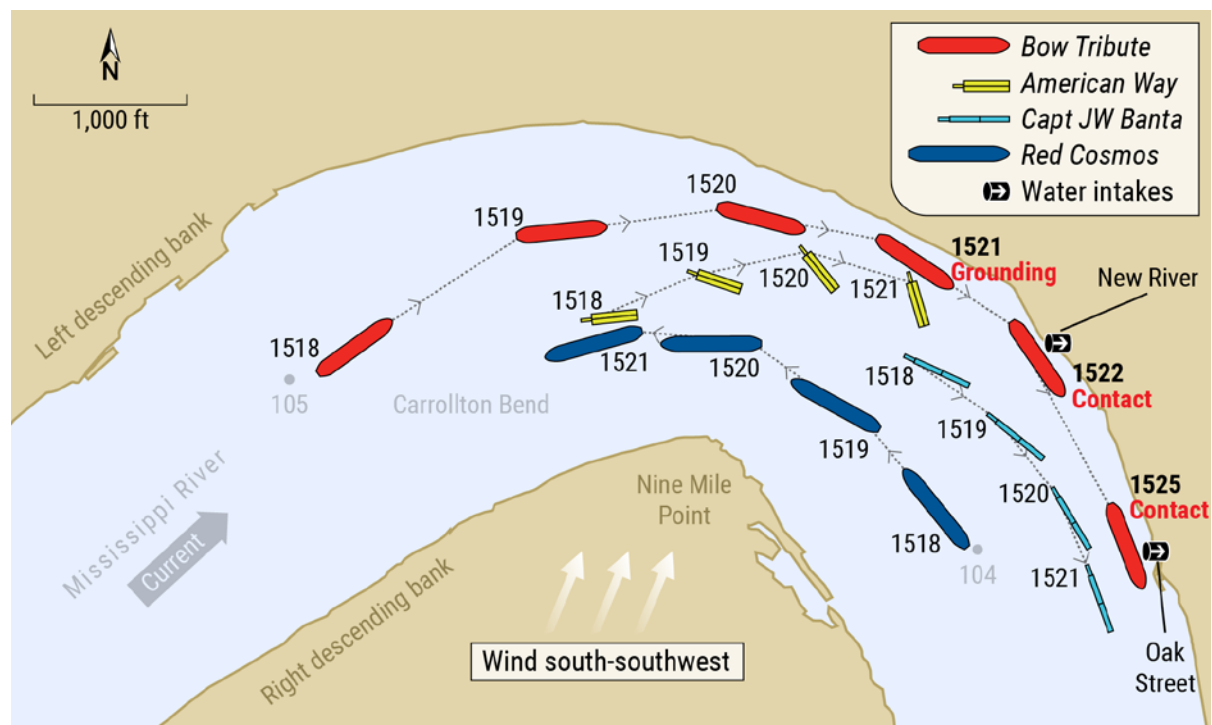
**Figure 114.** Below, left to right: Postcasualty damage to the *Bow Tribute*'s portside aft hull and propeller.

**Figure 115.** Positions of the *Bow Tribute*, *American Way*, *Capt JW Banta*, and *Red Cosmos* (approximate scale) in the Carrollton Bend in the minutes leading up to the casualty, based on automatic identification system data. The *Bow Tribute*'s subsequent contact at the two river intakes is also identified.

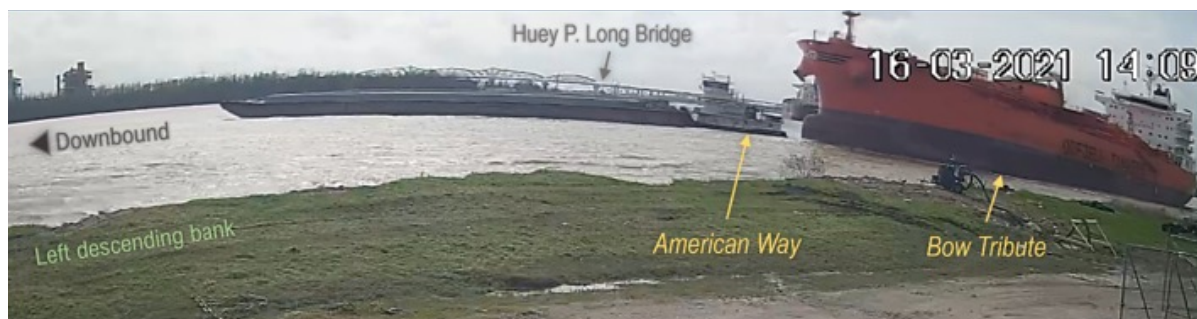
**Figure 116.** CCTV footage looking upriver at 1521 shows the *Bow Tribute* near the left descending bank with the *American Way* by the tanker's starboard bow. (Timestamp is 1 hour 11 minutes behind the actual time.) SOURCE: CROSBY DREDGING

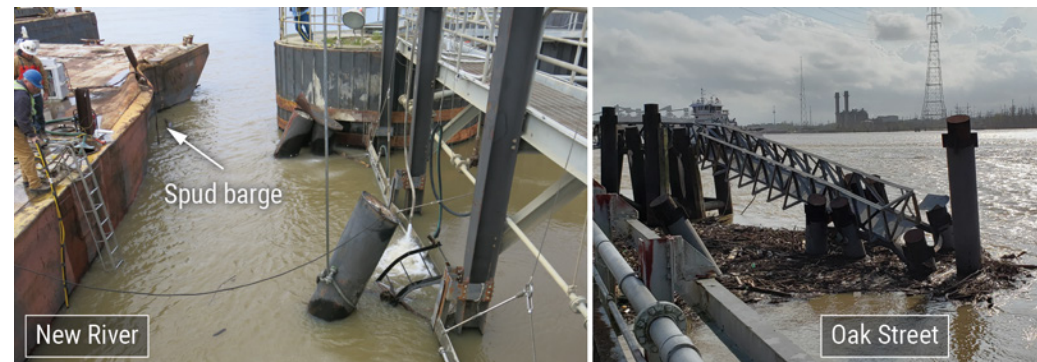
**Figure 118.** Left to right: Damage to the river intake fender systems: arrow shows damage to the spud barge at New River; damaged catwalk and dolphin piles at Oak Street.

At 1521:45, the stern of the *Bow Tribute* momentarily grounded on the left descending bank before it continued along the bank. Seconds later, at 1522:26, the port side of the *Bow Tribute* struck a spud barge, which was part of a fender system to protect the river intake pipes, moored at mile 104.1. After being struck, the barge broke free from its spuds and moorings and drifted downriver. At 1522:38, the pilot ordered the starboard anchor let go. At 1525, as the *Bow Tribute* slowed in the bend with its starboard anchor paying out, the tanker struck another protective spud barge for another set of river intake pipes, located at mile 103.8.

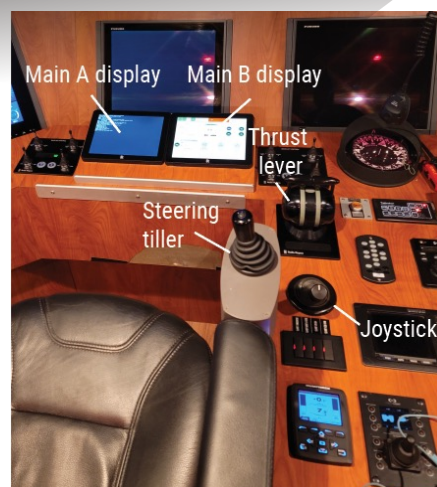
**Figure 121.** *Commodore's* main control station during postcasualty examination. Above: main A display screen's reboot failure (left) and the red failure log tab, red triangle over the port inner water jet icon, and the failure management pop-up screen on the main B display screen (right). Below: main control station's hand controls and water jet display screens.

The control system manufacturer concluded that a software problem led to a failed SD card for the touchscreen, causing a reboot failure, meaning that the touchscreen went blank and could not restart. This also resulted in the loss of the primary controls (thrust lever, joystick, and steering tiller) for the port hull's engines and water jets. The manufacturer later issued a service letter mandating that vessels with the same touch control system software receive an update.

The investigation found that the control system displays showed active failures for several days before the casualty. The vessel operating company's SMS

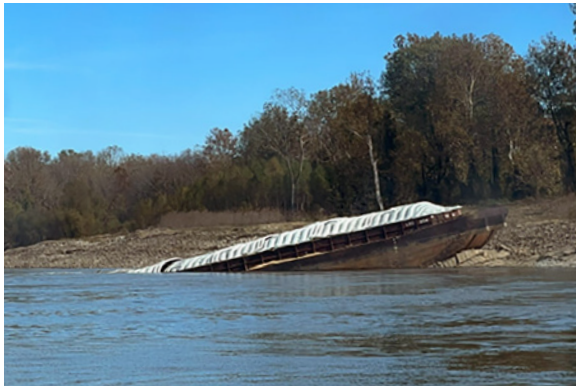
**Figure 122.** One of the *Marquette Warrior*'s barges that grounded and partially sank following the casualty.

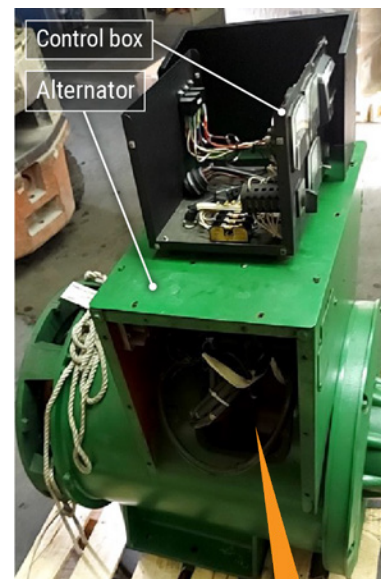
Following the grounding, the port genset's alternator was inspected by the towboat company's engineers and then a repair facility that had recently refurbished the unit. It was found that a ring terminal connection for one of the alternator's winding leads was burnt and had failed, causing the alternator to lose one of its phases—this would subsequently cause the towboat's steering pump motors (and all other 3-phase equipment) to stop due to a lack of available torque. Electricians also discovered arcing metal residue on three terminal block posts and a severed wiring harness. This indicated that the wiring harness had been lying across, rubbing against, and eventually arcing to the terminal block posts for a prolonged period. The way the alternator failed would have caused fluctuations in the alternator output voltage and amperage, and the vessel likely would have experienced flickering lights.

Recent preventive maintenance performed by the vessel's engineer required removing the genset alternator's cover panel to inspect all wires and connections for wire fray, chaffing, and loose connections. Electricians' analysis of the alternator following the casualty indicated that the most likely cause of the failure was rubbing or chaffing of the sensing wiring harness, which led to arcing between terminal block posts, heat buildup, insulation failure, and eventual winding ring terminal failure. Because the onboard engineer did not notice damage within the terminal box or to the sensing wiring harness during his inspection, it is likely the chaffing of the wiring harness took place over the 72 hours the genset ran between the November 7 maintenance inspection and the casualty on November 21. While the wiring harness could have shifted onto the terminal posts due to vessel vibrations, it is more likely that the wiring harness was inadvertently displaced during the vessel engineer's preventive maintenance inspection and went unnoticed during his reinstallation of the cover panel.

**THE PROBABLE CAUSE** of the grounding of the towing vessel *Marquette Warrior* was a loss of steering, likely due to a wiring harness within an electrical generator that was improperly positioned during a maintenance inspection, resulting in the harness contacting the terminal posts, eventually causing the loss of 3-phase electrical power to the steering pump motors.

**Figure 124.** Right: Port alternator with side cover removed, after being taken from the *Marquette Warrior* postcasualty. The control box (with cover removed) is mounted on the top panel.

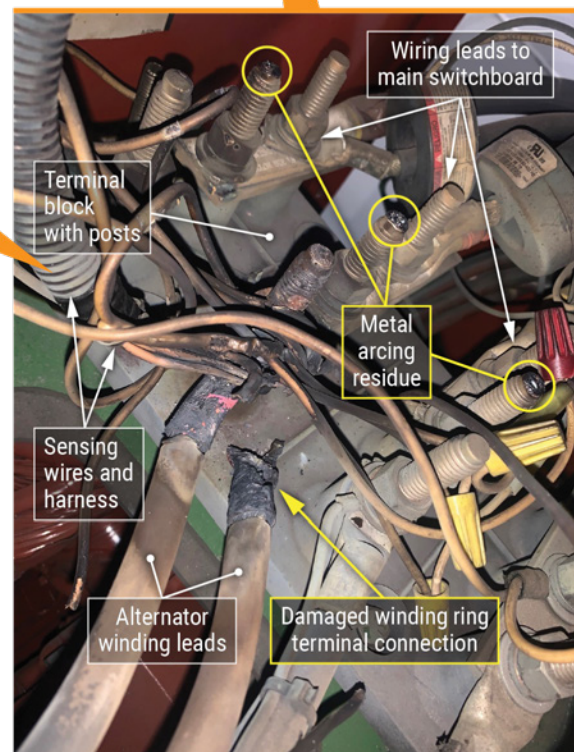
Because the alternator only had 675 hours (about 28 days) of operating time since being refurbished, it is unlikely that the genset's winding terminal connection that was burnt and damaged had become loose.

**Figure 125.** Below: Close-up of port alternator terminal block showing damaged connection and metal arcing residue accumulated on terminal block posts. Detail shows the severed wiring harness.

Proper operation and maintenance of electrical equipment is required to avoid damage to vessel-critical systems and prevent potentially serious crew injuries, particularly for electrical systems with high and medium voltage and equipment with uninsulated and exposed components. Electrical equipment should be installed, serviced, and maintained by qualified personnel familiar with the construction and operation of the equipment and the hazards involved.

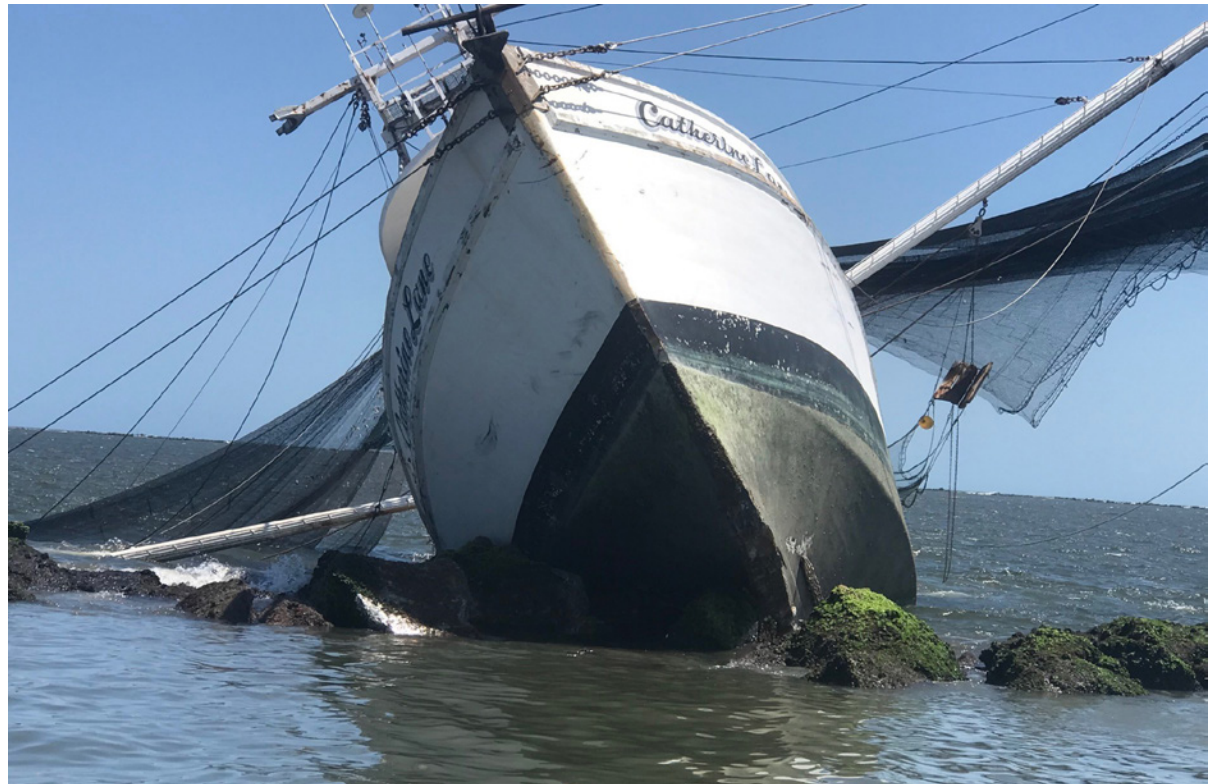
**Figure 127.** *Sage Catherine Lane* aground on the St. Marys Entrance north jetty. SOURCE: COAST GUARD

The vessel's reported sharp turn to port (about 90°) while on autopilot before grounding indicated that the autopilot system had failed. The sudden sharp turn likely resulted from the helm/autopilot receiving a signal that the vessel was far from its programmed heading and required significant rudder correction to return to the original heading. Based on the information provided to investigators (due to the sinking,

a postcasualty exam was not possible), this sudden change could have been caused by the loosening or detachment of the autopilot rudder angle sensor, which resulted in the transmission of incorrect rudder position data to the autopilot that subsequently commanded a large port rudder angle.

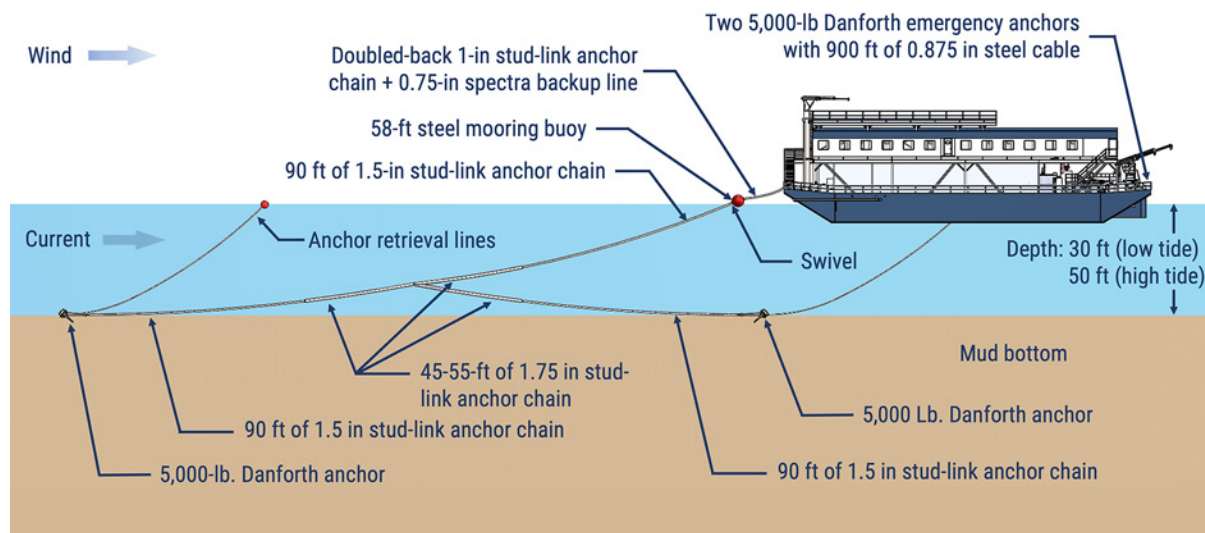
**Figure 132.** *SM-3* ground tackle system at the time of the casualty when the water depth was about 40 feet.

A postcasualty examination of the buoy showed that a 1.25-inch-wide fatigue crack had formed at the padeye's fillet weld, moving across nearly two-thirds of the weld before failing abruptly and tearing the cap plate it was welded to. Investigators were unable to determine whether the fatigue crack existed before the storm or developed because of it. If the crack was preexisting, it contributed to the failure of the buoy in the storm; if it was not preexisting, the forces on the buoy during the storm resulted in the fatigue crack and complete separation of the padeye and adjoining shell material from the buoy.

The lowest known general rating for a component in the ground tackle system was the breaking strength of the swivel, about 143,000 pounds. Requests to the supplier for exact design and manufacturing specifications for the mooring buoy went unanswered. Investigators were therefore unable to determine if the capability of the buoy was exceeded, or if there was a design flaw or manufacturing error.

**THE PROBABLE CAUSE** of the grounding of the fishing tender barge *SM-3* was a fatigue crack in one of the mooring buoy's padeye welds, which resulted in the padeye separating from the buoy's spherical steel plating, causing the barge to break free from its buoy and anchors and drift ashore during a storm.

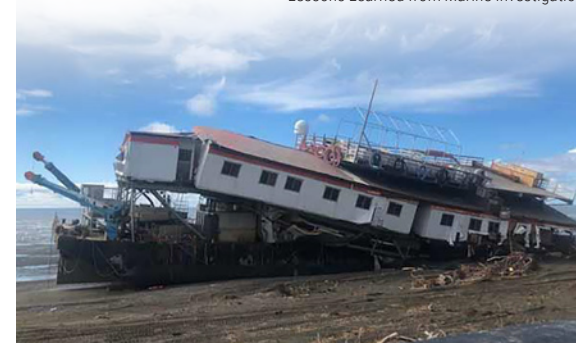
**Figure 133.** *SM-3* after the grounding.

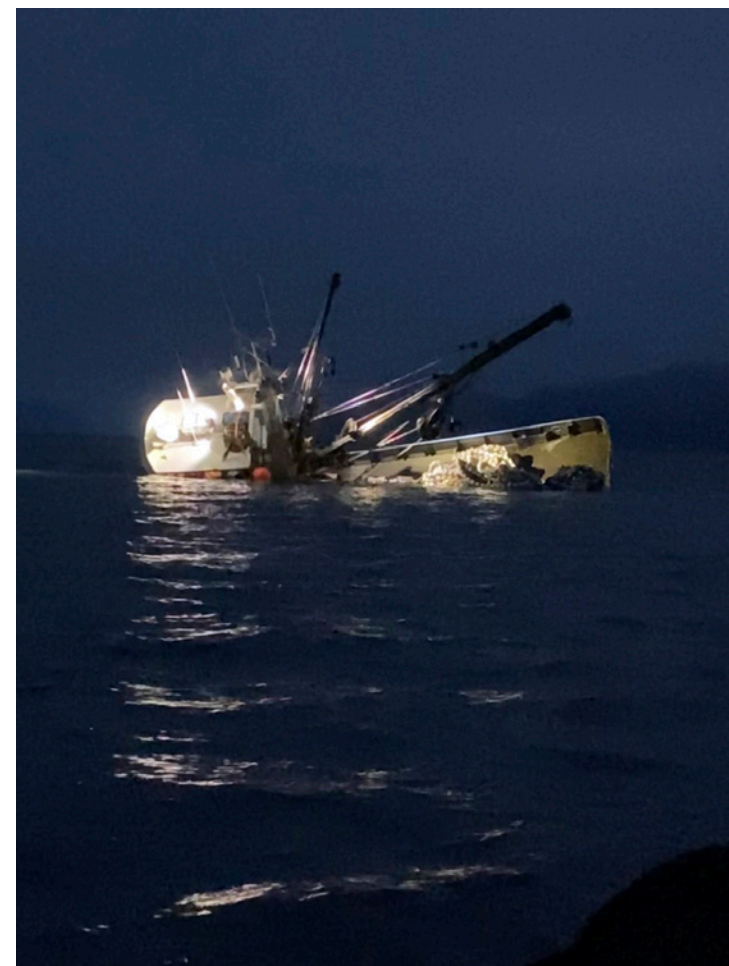
**Figure 137.** *Tenacious*, sinking by the bow, about 0345 on July 24. SOURCE: LUCAS BROCKMAN

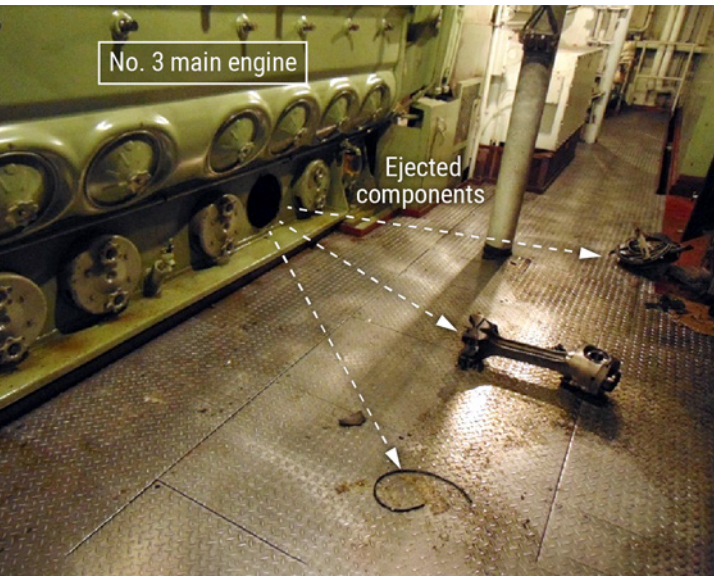
**Figure 138.** Ejected components from the no. 3 main engine. BACKGROUND SOURCE: COAST GUARD

An independent forensic analysis determined the root cause of the engine failure was an inadequately torqued bolt on the nos. 6 and 14 cylinder's fork and blade (connecting rods) lower basket assembly. The bolt unfastened while the engine was running, disrupted lubrication in this section of the crankshaft, and resulted in extremely high temperatures, which led to disassembly of the connecting rods and lower connecting basket assembly. After the broken engine parts were struck by rotating components in the engine, they were ejected from the crankcase through an inspection port.

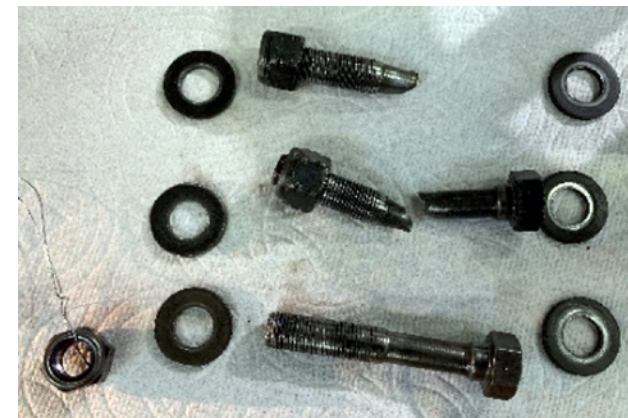
Based on the condition of the bolt, engineers determined that the nut had backed off (unfastened) while the engine was running. These nuts were required to be torqued to 75 foot-pounds during assembly using a torque wrench connected to a special extension tool that rotated the nut via a socket. Under magnification, engineers inspected the condition of the grooves on the lower basket nuts. Flattening was observed on properly torqued exemplar nuts but was not seen on the recovered nut that had unfastened from the no. 3 engine's lower basket assembly, indicating the nut had not been properly torqued.

**Figure 141.** Damaged lower basket bolts, washers, and nuts from no. 3 engine's nos. 6 and 14 connecting rod and piston pair. SOURCE: WASHINGTON STATE FERRIES

**THE PROBABLE CAUSE** of the mechanical failure of the no. 3 main engine aboard the passenger vessel *Wenatchee* was a connecting rod assembly that came loose and separated from the crankshaft due to insufficient tightening (torquing) of a lower basket bolt during the recent engine overhaul.

The NTSB has investigated several recent casualties that likely were caused by a failure to tighten fasteners on marine engines to the manufacturer's recommended torque settings. Undertorquing a fastener may cause excess vibration or allow the fastener to come loose, while overtightening may lead to failure of the fastener or the machinery component being secured. When installing fasteners, personnel should use a calibrated torque wrench, follow the manufacturer's recommended tightening guide and torque values, and verify that all required torque requirements have been completed.
