Report on the investigation of  
the grounding of the general cargo vessel

***BBC Marmara***

in the Little Minch, off the west coast of Scotland

REPORT NO 8/2023

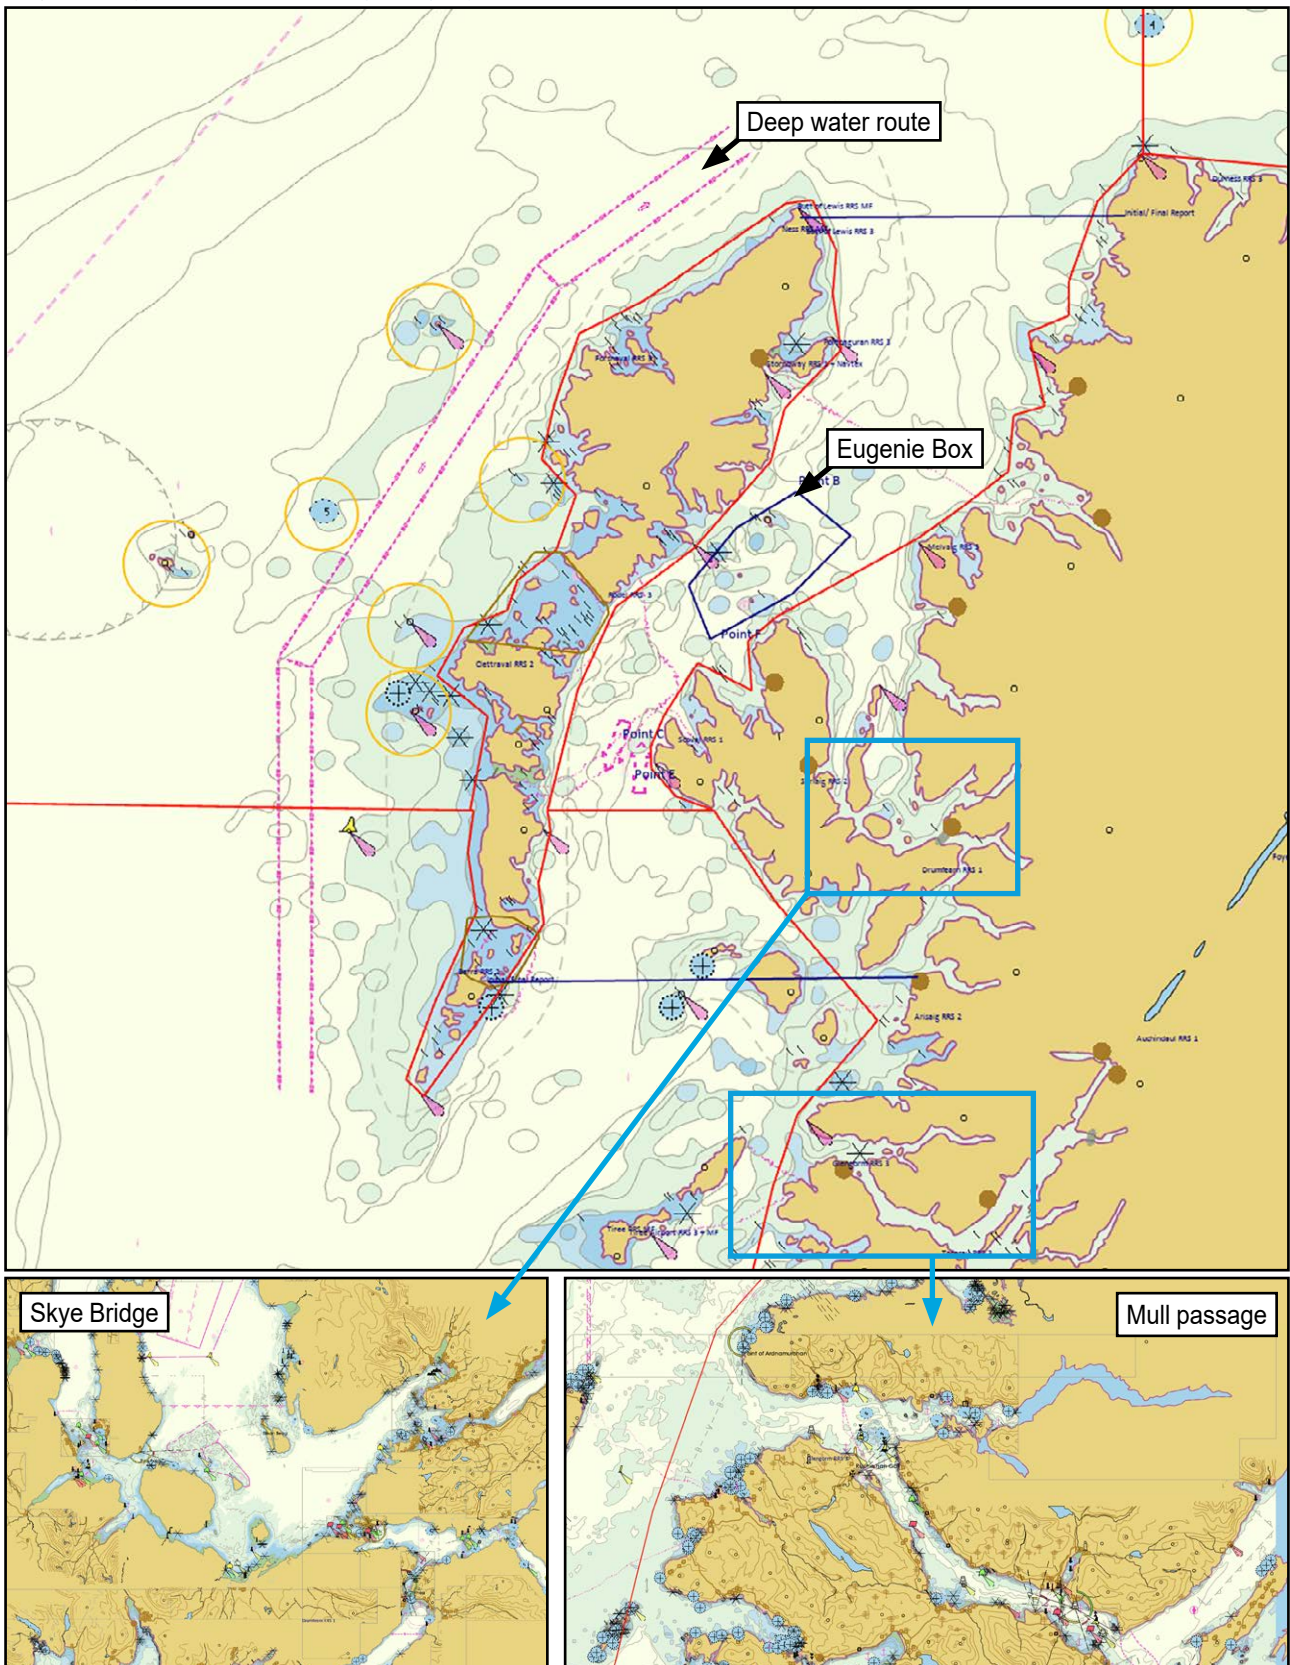
Figure 13: Stornoway MRCC VTM Area I

Stornoway MRCC was responsible for monitoring the deep-water route for laden tankers of over 10,000 gross tonnes to the west of the Hebrides, the Sound of Mull and the passage of vessels under the Skye bridge (**Figure 13**) in addition to the VTM Area I routeing schemes. Although it was the largest of the VTM areas to monitor, Stornoway MRCC had lower traffic and incident rates than other stations.
