Report on the investigation of the falling of  
a lifeboat into the sea during  
a launching exercise on board the  
polar research vessel

***RRS Sir David Attenborough***

on Loch Buie, Isle of Mull, Scotland

on 4 March 2021

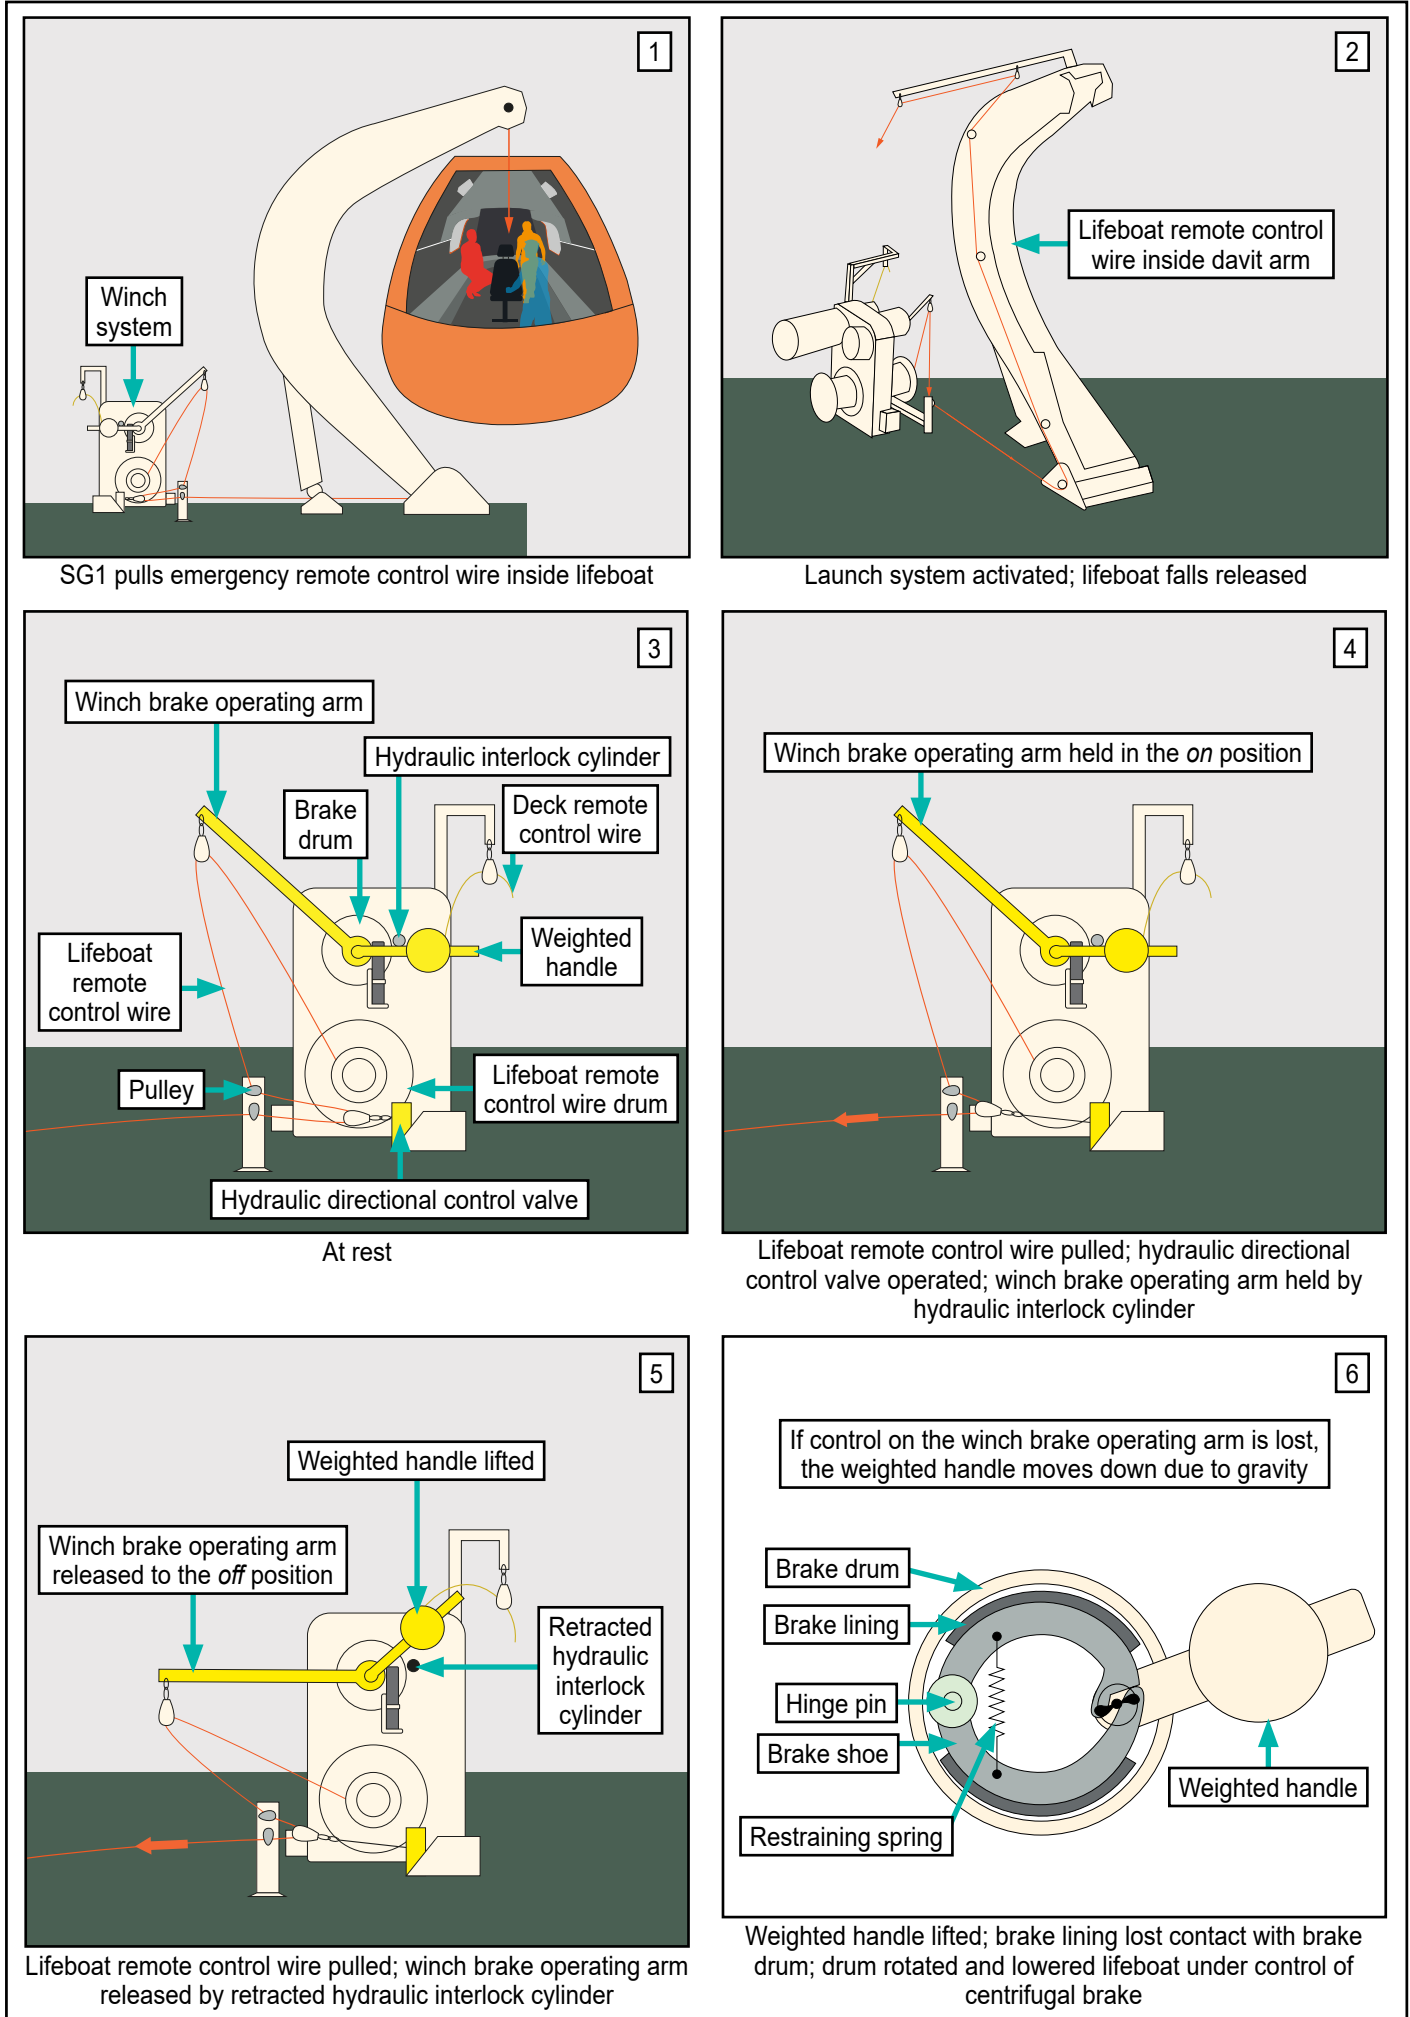
**Figure 4:** Davit system launch remote control method

The electric push button controller was fitted with an emergency stop button that cut all electric power to the davit system when pressed. This did not affect the launching of the lifeboat in either dead ship launch mode or training mode when the hydraulic directional control valve was operated by the attached wires.

In the event of total power failure and abandonment of the ship, the lifeboat was launched using the emergency remote control wire from inside the lifeboat following embarkation (**Figure 4**). The tension on the remote control wire operated the hydraulic directional control valve and stored hydraulic pressure moved the davit arms to the fully turned out position. The winch brake arm was prevented from lifting by the locking pin (**Figure 5**). When the davit arms were fully turned out the hydraulic proximity switches activated, retracting the winch brake arm locking pin. Tension on the remote control wire lifted the winch brake arm and the lifeboat was lowered to the water.

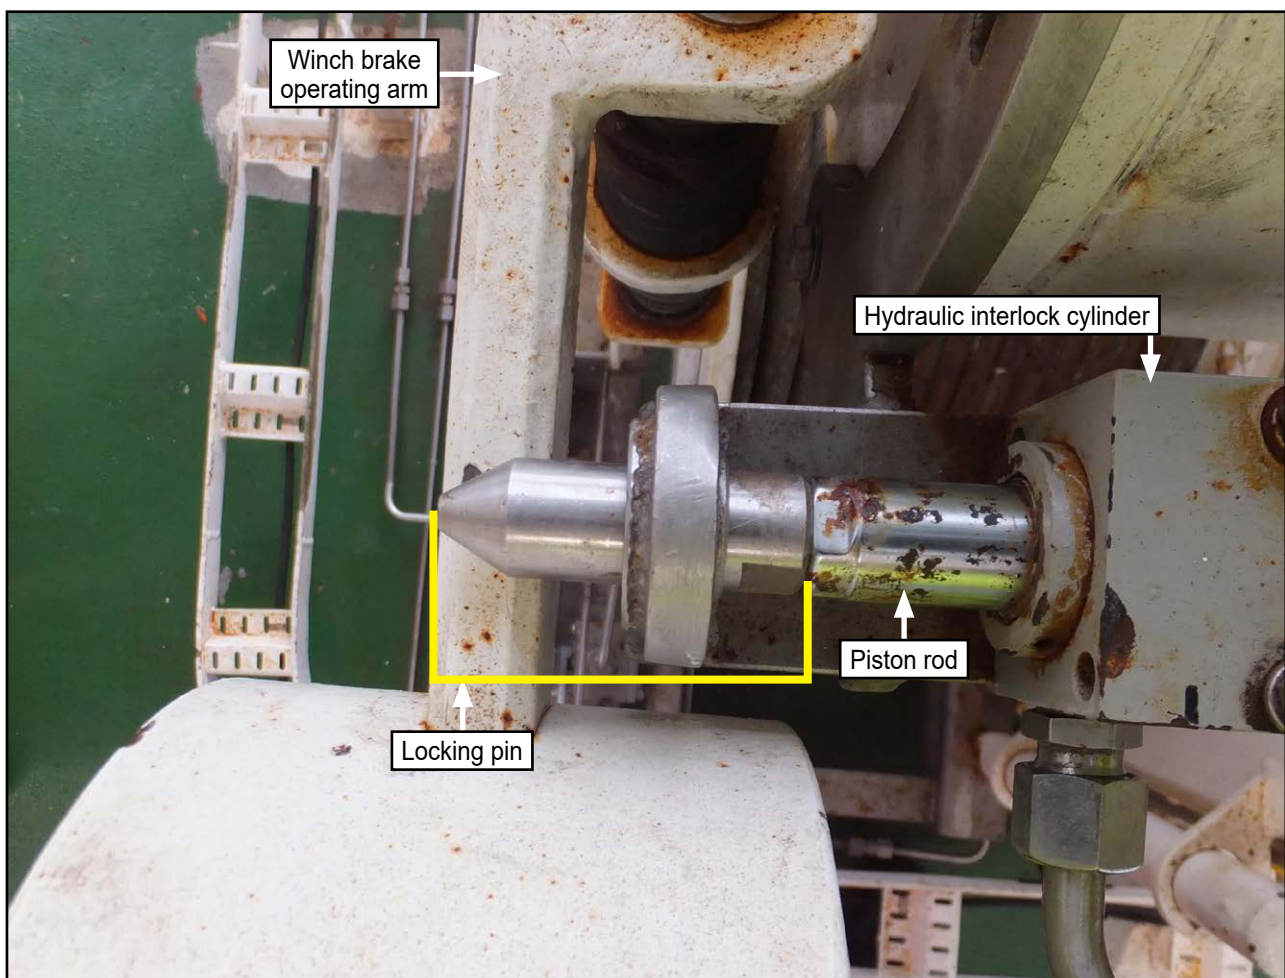
**Figure 5:** The hydraulic interlock cylinder as fitted to davit

The winch brake arm locking pin was attached to the end of the hydraulic interlock cylinder piston rod by a screwed connection. The free end of the locking pin had been machined to form a tapered cone shape (**Figure 5**).

The piston rod was manufactured from hardened chrome alloy steel designed to resist wear but not, specifically, to resist corrosion in a marine environment.

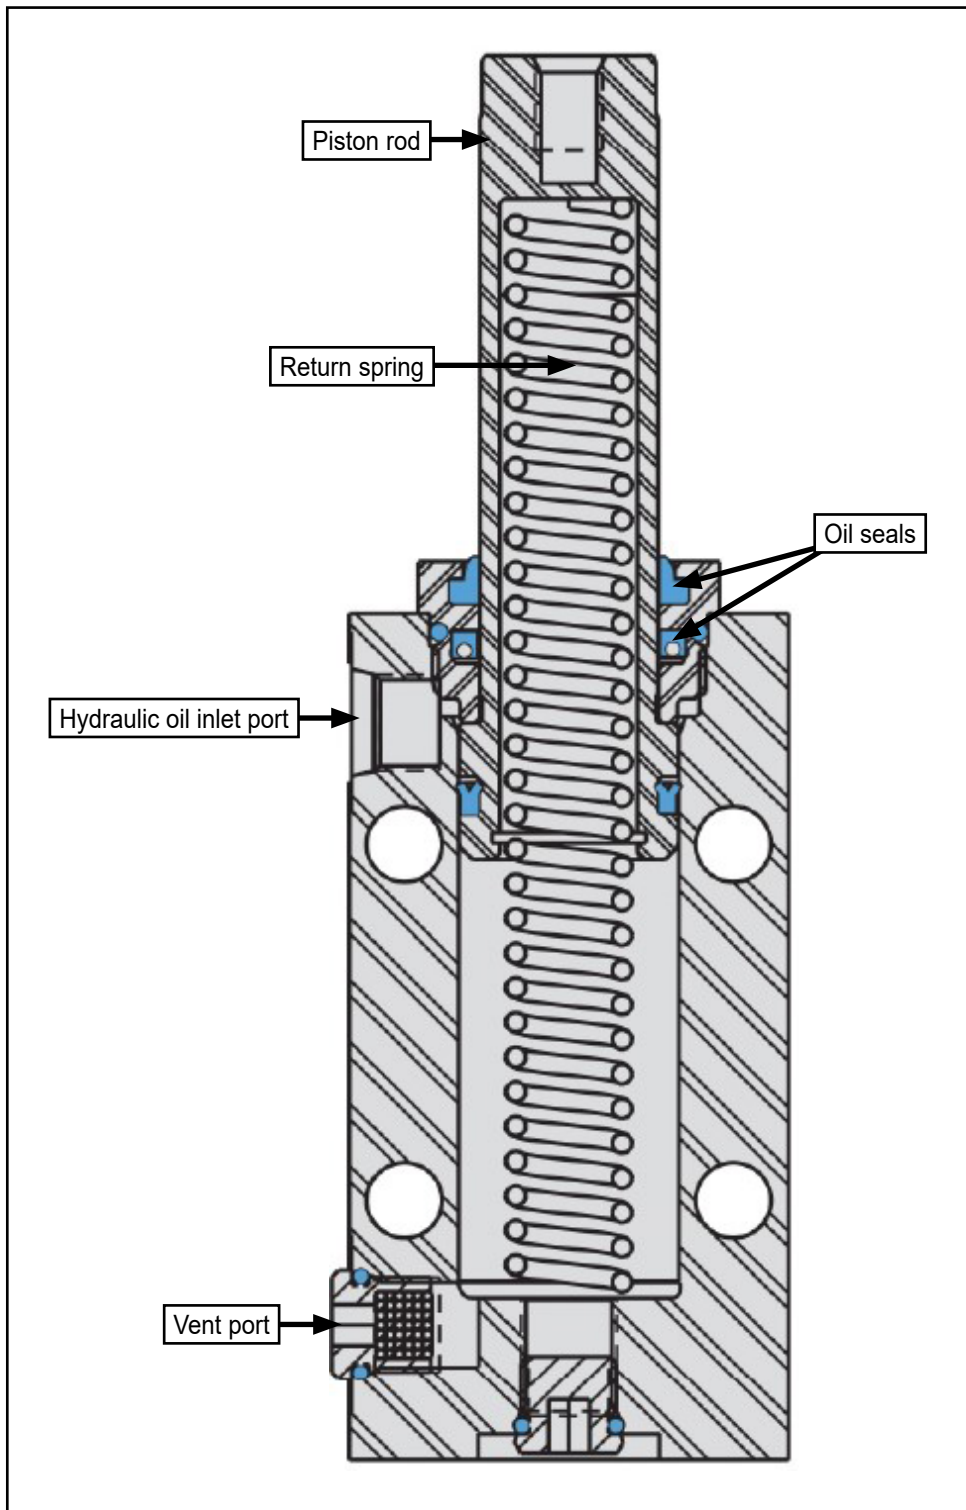
**Figure 6:** Cross-section of the hydraulic interlock cylinder

The interlock cylinder piston rod was retracted by applying hydraulic pressure through the hydraulic oil inlet port that acted against a piston, the other side of which was vented to atmosphere via a sintered bronze filter. When hydraulic pressure was removed the piston rod and its locking pin were extended outwards by means of a return spring (**Figure 6**).
