Ship Recycling in Turkey

Challenges and Future Direction

20 December 2023

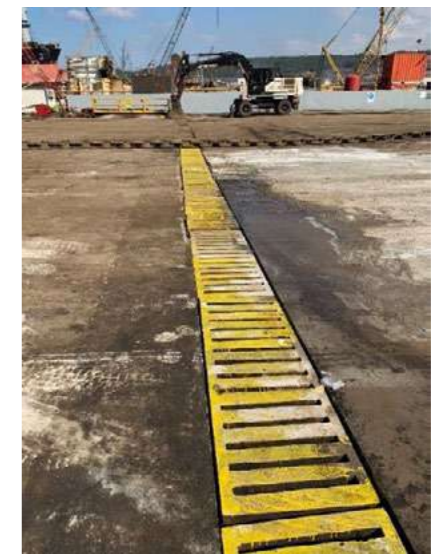
Drainage line, and drainage sump area
Source: Site Inspection Report of Dörtel (19.9.2022)

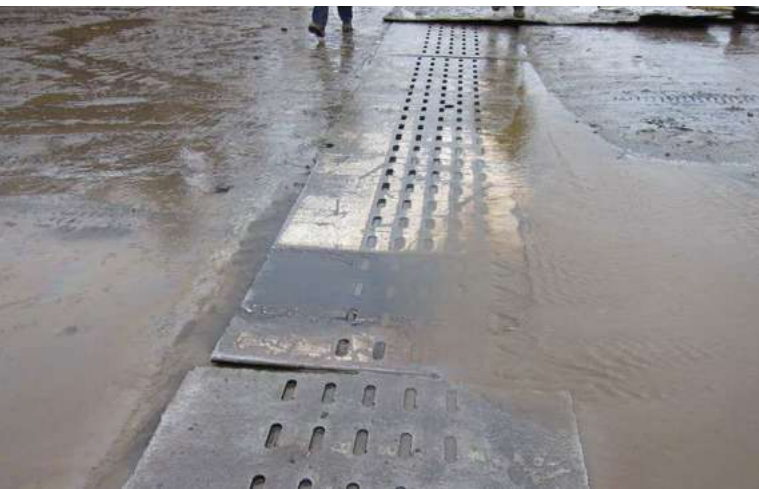
Overflowing primary drain line

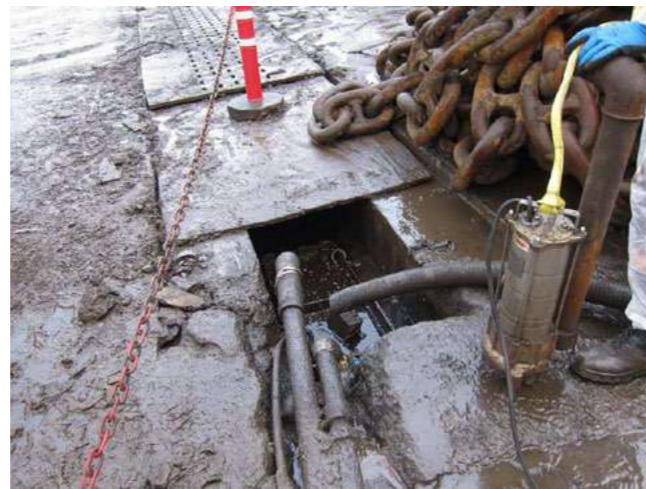
Drainage system pump was out of function

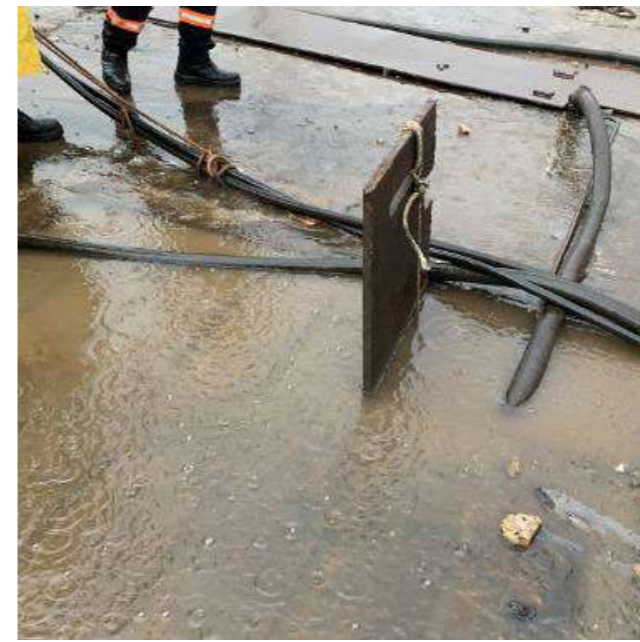
Drainage system unable to cope with the volume of rainwater at the time of the inspection.

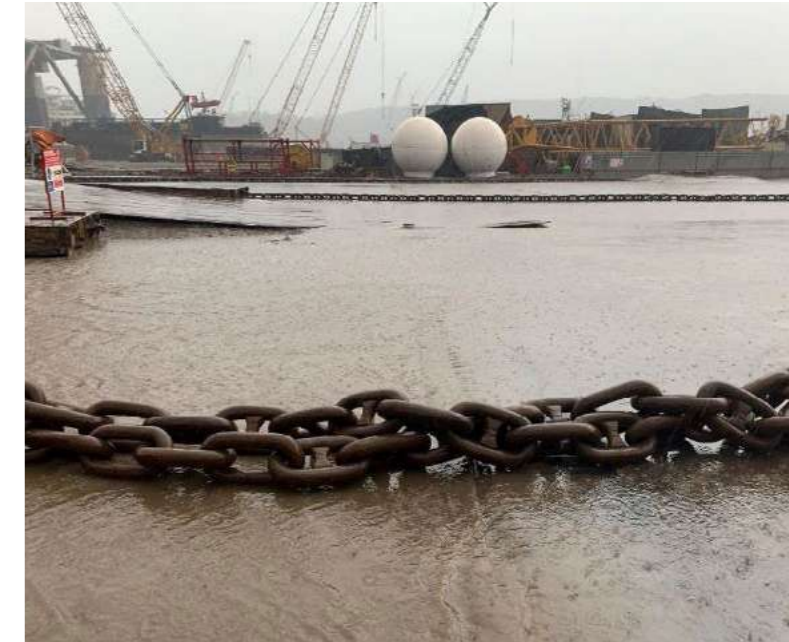
Flooded drainage system

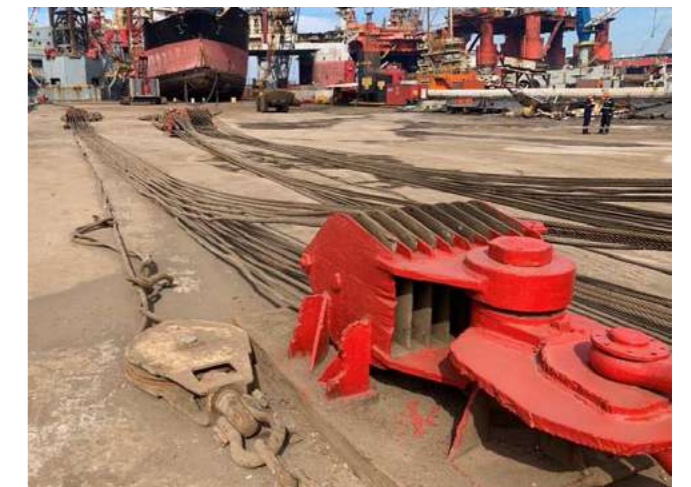
View of pulley systems

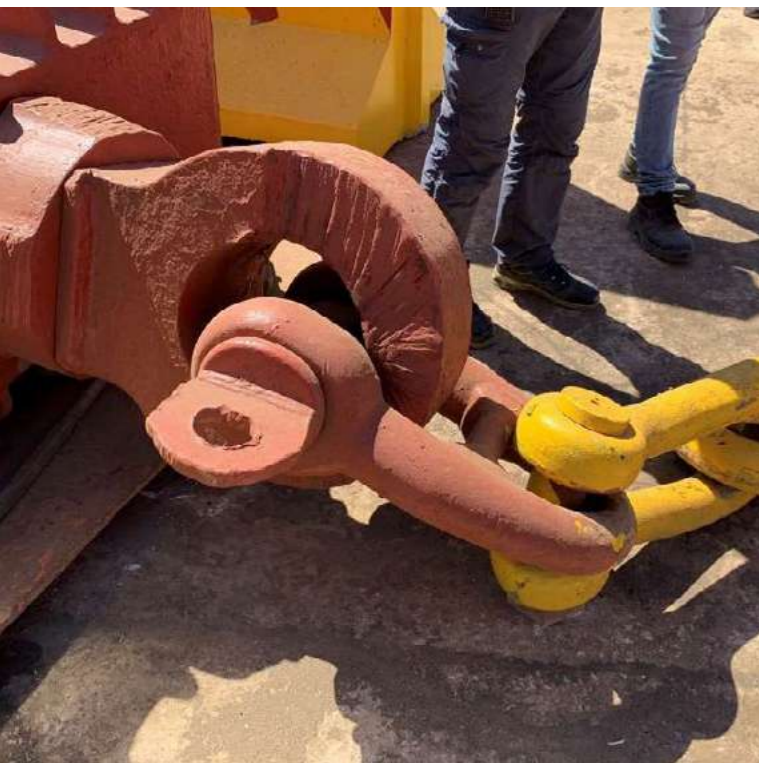
Crudely modified components in pulling system

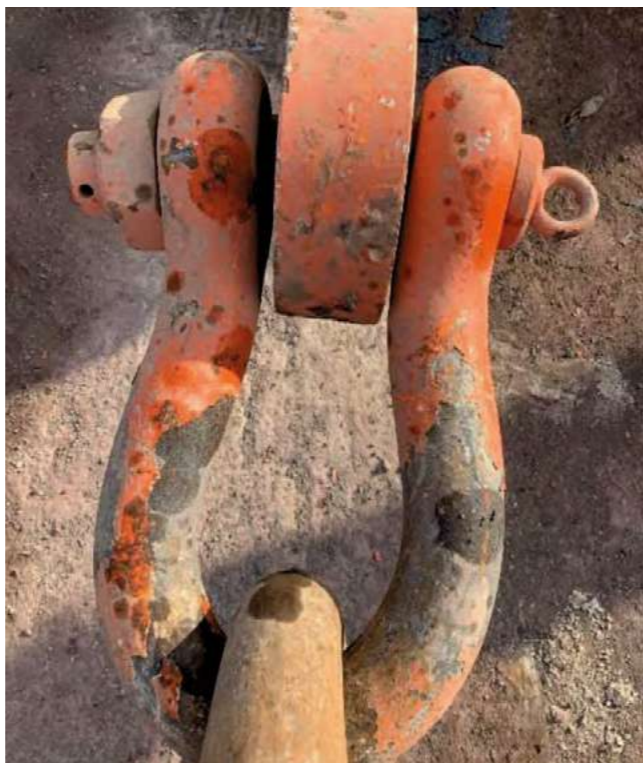
Deformed shackle pin in pulling arrangement

According to the first Report of Kılıçlar: "Parts of the wires were also found to be frayed and in poor condition. It was observed that there is no intrinsic redundancy in the system as is, and should a shackle fail completely, the results may be dramatic." During the second site inspection, it was observed that the equipment was being subject to repair and maintenance. The equipment was found in good condition. (EU Site Inspection Report of Kılıçlar (30.3.2023) p. 31).
