November 16, 2023

MIR-23-25

# Engine Room Fire aboard Tank Vessel *Endo Breeze*

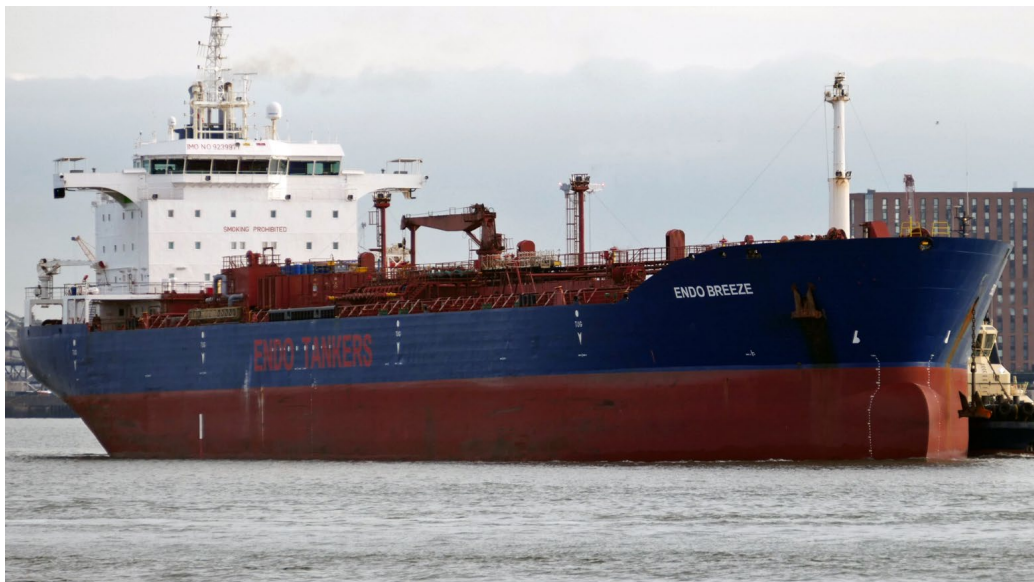
**Figure 1.** The *Endo Breeze* underway after the casualty. (Source: Martin Klingsick @ Shipspotting.com)

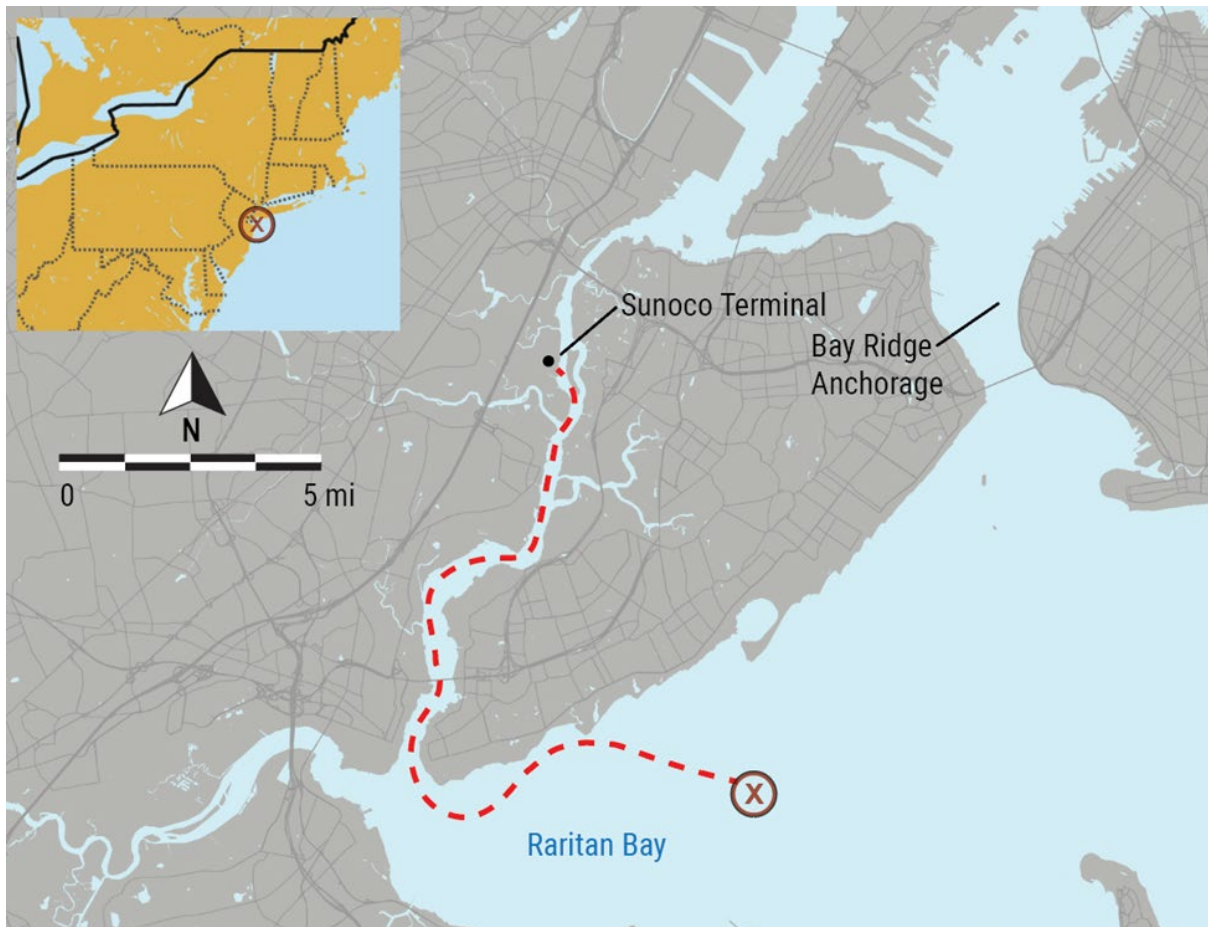
**Figure 2.** *Endo Breeze* outbound route and location where the fire occurred, as indicated by a red X. (Background source: Google Maps)

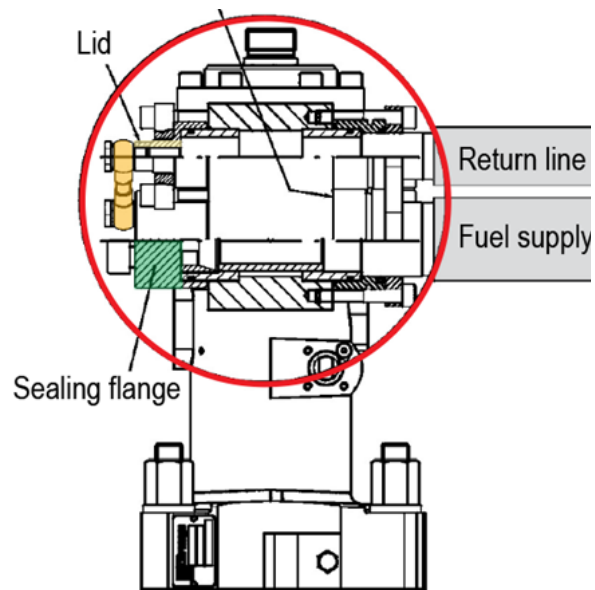
The banjo tube was only installed on the no. 1 cylinder fuel injector pump for each engine. The fuel supply line ended at the no. 1 cylinder fuel injector pump with a sealing flange; the corresponding return line was capped with a lid. The fuel lines were interconnected by a banjo tube secured by two banjo bolts, which provided a path for fuel oil not used in the supply line to circulate into the return line, which ultimately returned it to the diesel oil day tank.

**Figure 5.** Image from the MAK Maintenance and Repair Manual referencing the no. 1 fuel oil injector pump piping components. (Background source: MAK)
