## MARINE SAFETY INVESTIGATION REPORT

**Safety investigation into the engine-room fire on board the  
Maltese registered oil / chemical tanker**

***GRETA K***

MARINE SAFETY INVESTIGATION REPORT NO. 04/2024

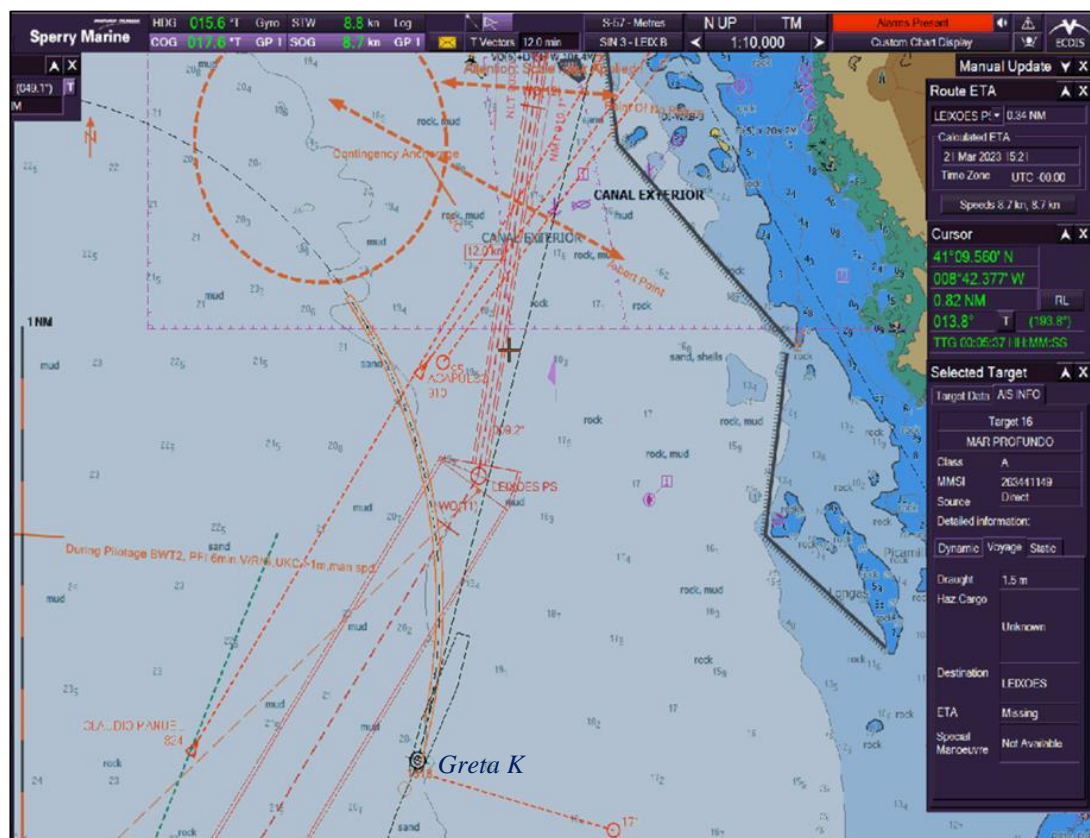
At about 1518<sup>3</sup>, the master heard the pre-warning alarm on the fire alarm panel and asked the chief mate to call the ECR to clarify the nature of the alarm. The chief engineer picked up the telephone and confirmed that there was a fire in the engine-room but did not give a location. The message was relayed to the master, who informed the pilot of the matter. At the same time, the fire alarm was activated, and an announcement was made on the public address (PA) system. The vessel's position was about two nautical miles from the breakwater (**Figure 8**) and the approach into port was aborted.

Figure 8: Screenshot from *Greta K*'s ECDIS showing its position when the fire broke out

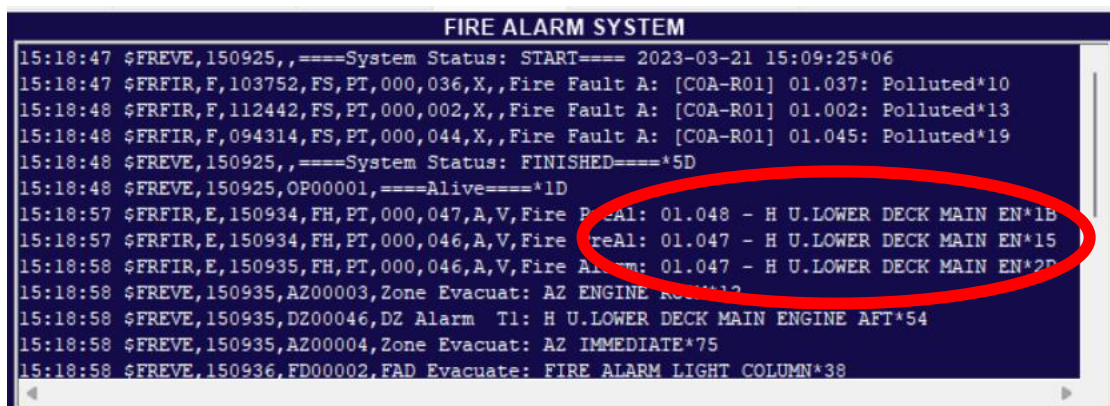
Since the vessel's fire detection system was not fitted with a printer, the exact time of the first fire detector's activation could not be ascertained. Moreover, the manufacturers could not extract data from the equipment due to the damage caused to the equipment during the fire. However, the VDR replay indicated that the fire alarm was activated at 15:18:57, in line with the pre-alarm heard in the bridge audio (**Figure 15**).

The VDR records of the fire detection system indicated the first two sections to pre-alarm were:

- Loop 01.048 – H U. Lower deck main; and
- Loop 01.047 – H U. Lower deck main (this section immediately alarmed within one second).
