SAFETY INVESTIGATION REPORT

REPORT NO.: 01/2024

MV CAPE KORTIA **Fire in the engine-room,** **leading to the loss of all power** **at the port of Rodman, Panama** **30 January 2023**

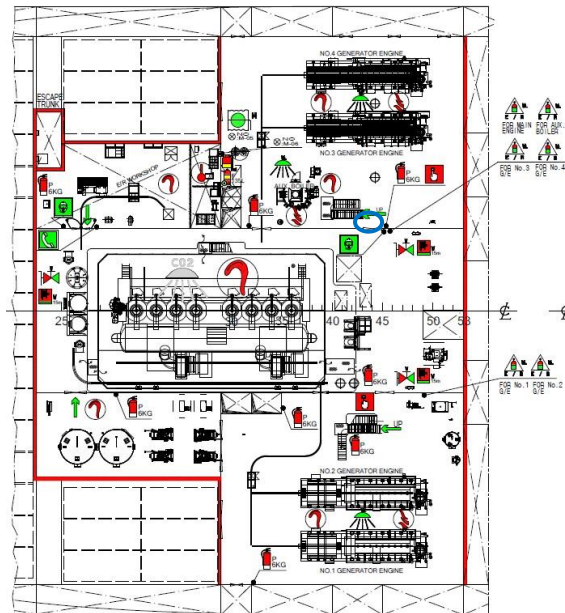
At about 0848, during a separate routine round in the engine-room, the wiper noticed oil on the second platform, in the vicinity of DG nos. 3 and 4. Approaching closer, he observed flames and smoke rising over DG no. 4. While rushing up from the second platform to inform the other crew members, the wiper activated the manual call point of the vessel's fire alarm system (**Figure 6**).

Figure 6: The location of the manual call point (blue circle)

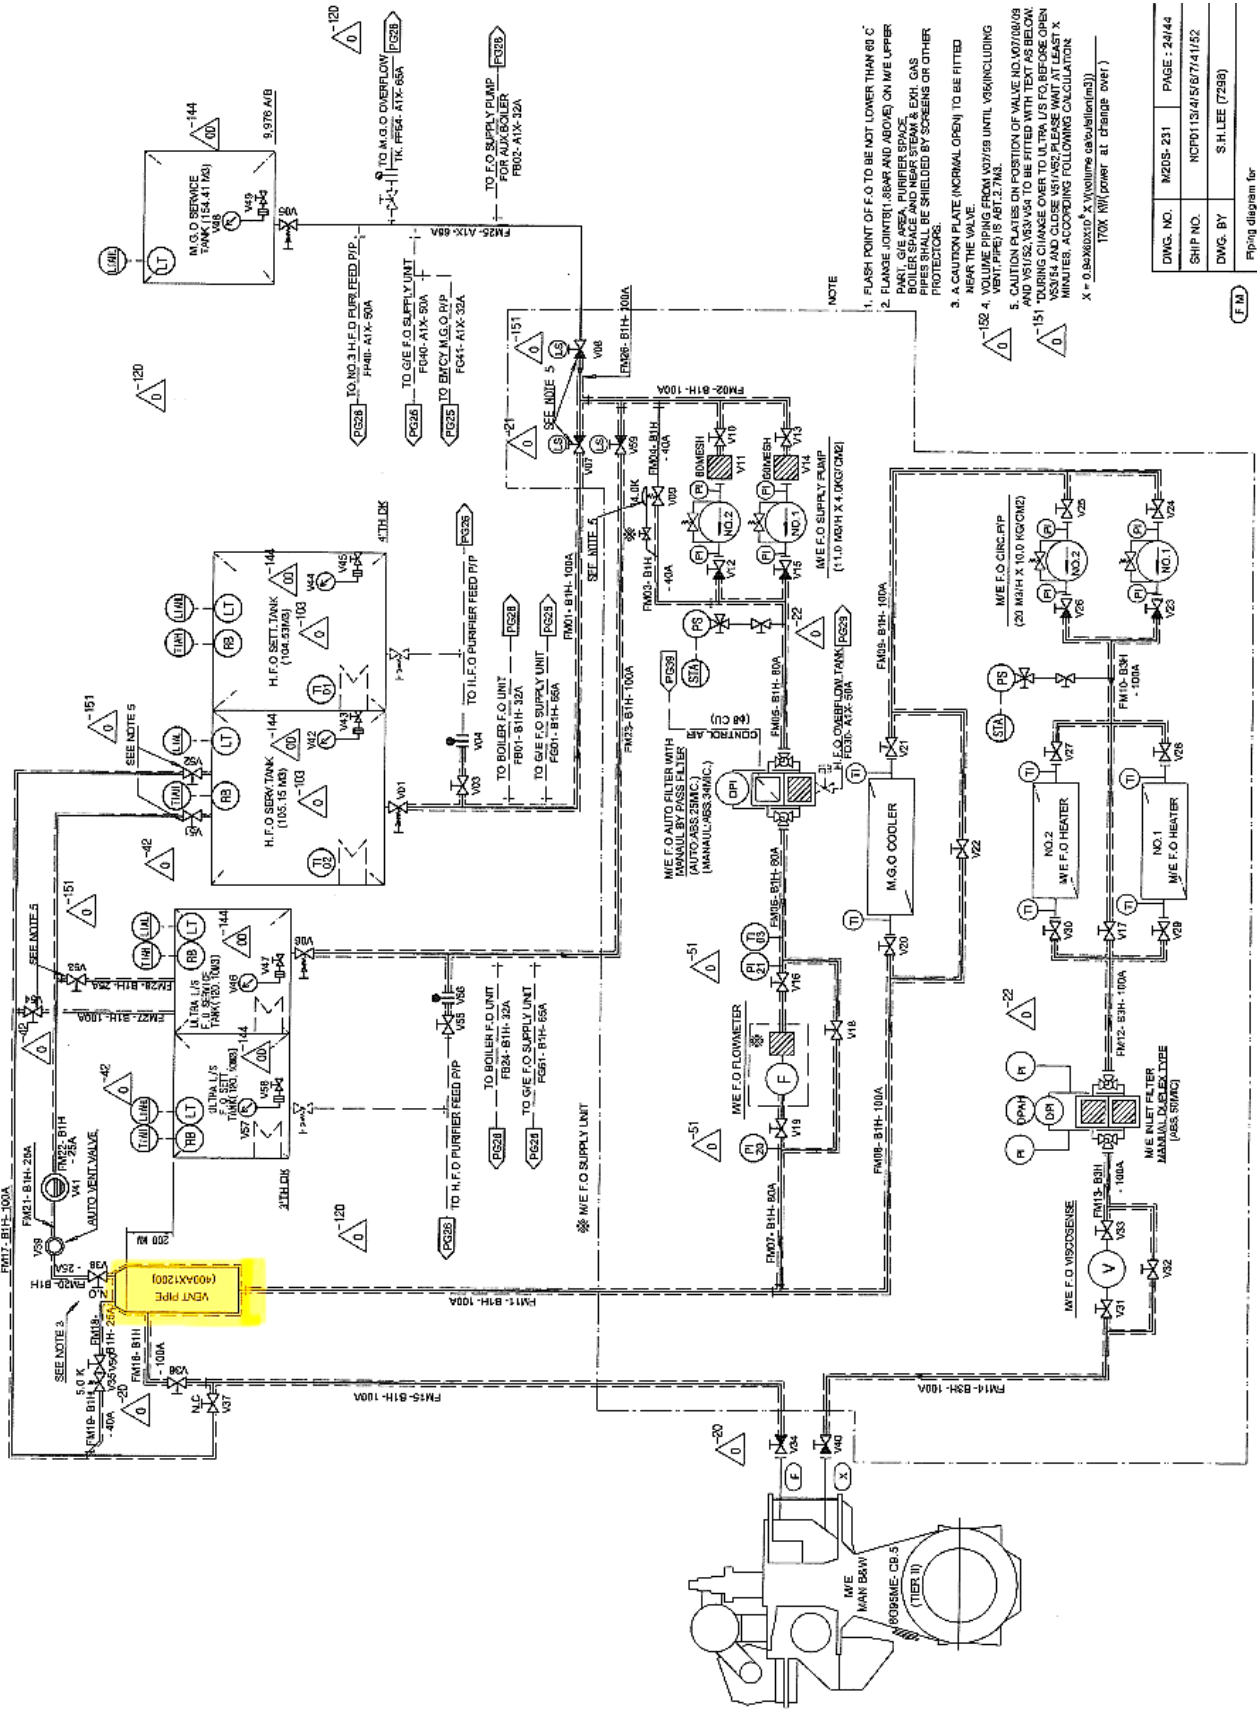
The vent pipe⁹ (highlighted in yellow in **Figure 11**) which is always full, has several functions, including:

Figure 11: Cape Kortia's fuel and diesel oil system
