## MARINE SAFETY INVESTIGATION REPORT

Safety investigation into the serious injury on board the  
Maltese registered ro-ro vehicle carrier

***TORTUGAS***

MARINE SAFETY INVESTIGATION REPORT NO. 02/2024

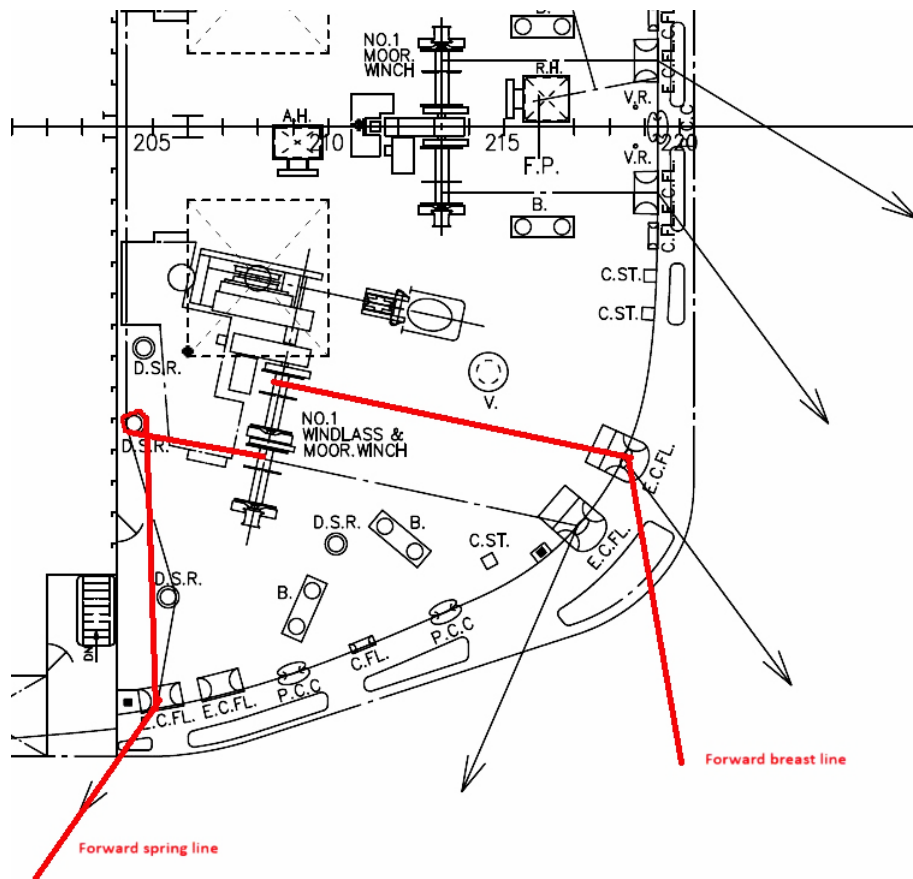
At 0735, due to a strong offshore wind, the forward tugboat was cast off and was requested to push *Tortugas* from the port side midship area, to help keep the vessel alongside the berth. Meanwhile the aft mooring station team passed the aft spring line ashore. One breast line each were then passed from the forward and aft mooring stations, with the forward breast line<sup>5</sup> being passed from the inner split-drum of the starboard side mooring winch (**Figure 3**).

**Figure 3: The forward mooring configuration after one spring line and one breast line were passed**

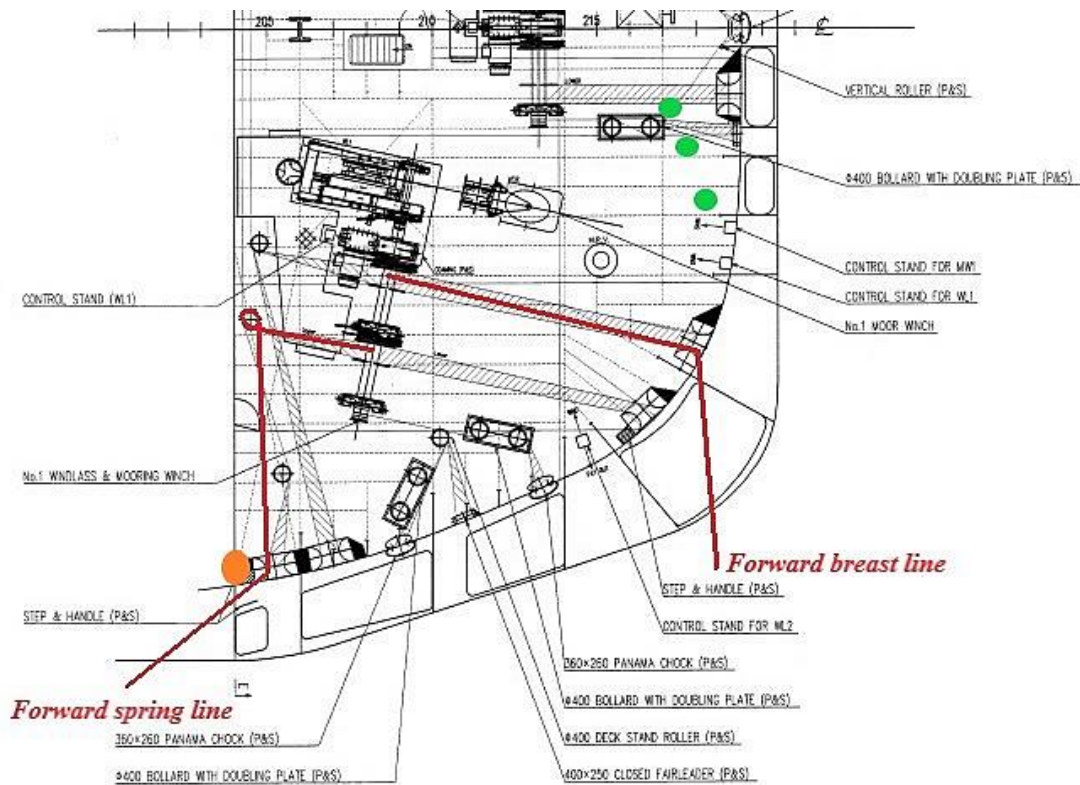
The bosun, OS and deck cadet were at the forward region of the mooring deck, preparing to pass an additional breast line (**Figure 5**). The forward spring and breast lines were held by the mooring winch brakes and their gears had been disengaged. None of the crew members were tending to these mooring winches<sup>8</sup>.

**Figure 5: Approximate reported locations of the crew members at the time of the occurrence (orange dot: the third officer; green dots: the bosun, OS and deck cadet)**

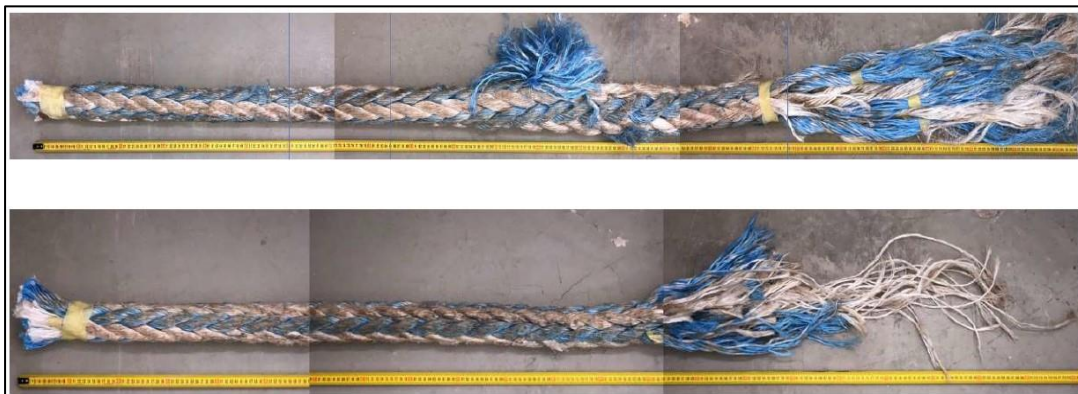
The MSIU requested the Company to ship two samples (A and B) of the parted mooring rope to Malta. Each sample was about 2.0 m long and were taken from either side of the point of failure (**Figure 10**).

**Figure 10: The rope samples (right: sample A; left: sample B)**

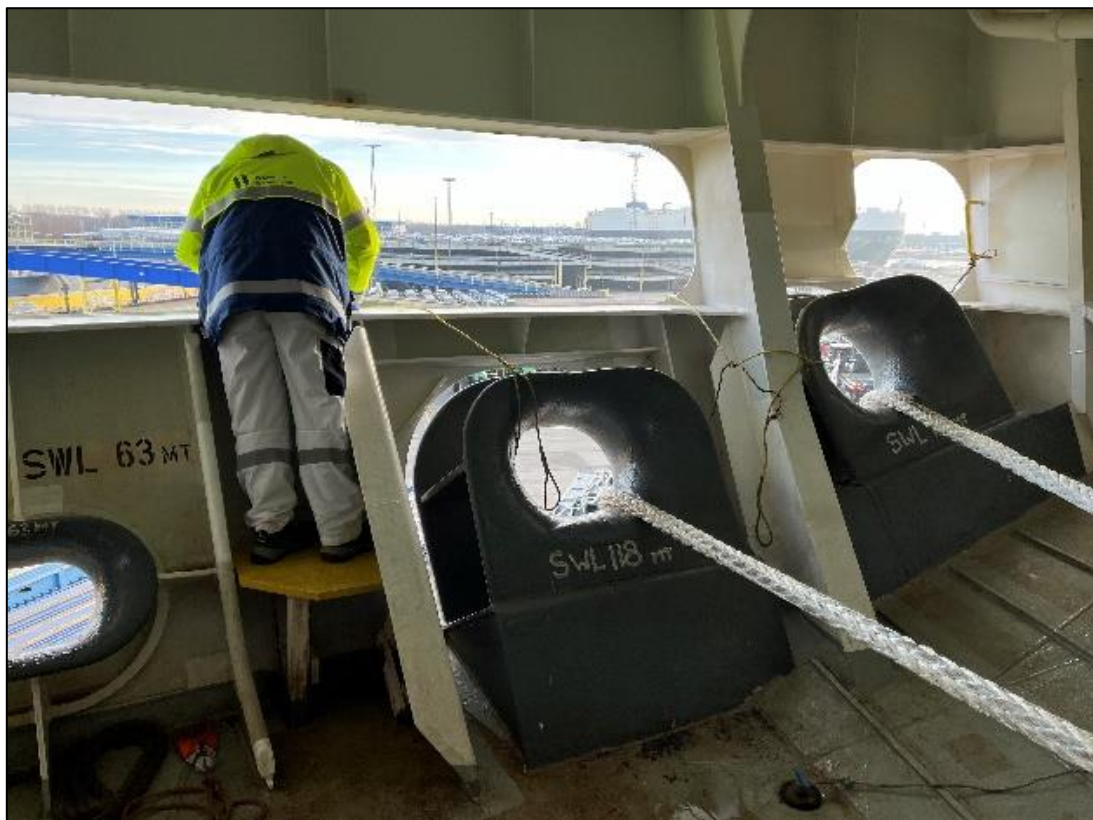
The safety investigation tool note that the vessel was fitted with pedestals to observe the mooring lines overside. One pedestal was located close to the site of the occurrence (**Figure 19**).

Figure 19: The starboard side pedestal

The seriously injured third officer, however, informed the safety investigation that he was not comfortable using this pedestal, fearing that he could fall overboard, since he felt that using it would require him to lean over the side too much to get a proper view of the spring line.
