MARINE SAFETY INVESTIGATION REPORT

**Failure of an overhead monorail crane wire rope,
resulting in fatal injuries to a crew member on the deck
of the Maltese-registered container vessel,**

CMA CGM MANTA RAY,

**in the port of Laem Chabang, Thailand,
on 07 November 2022**

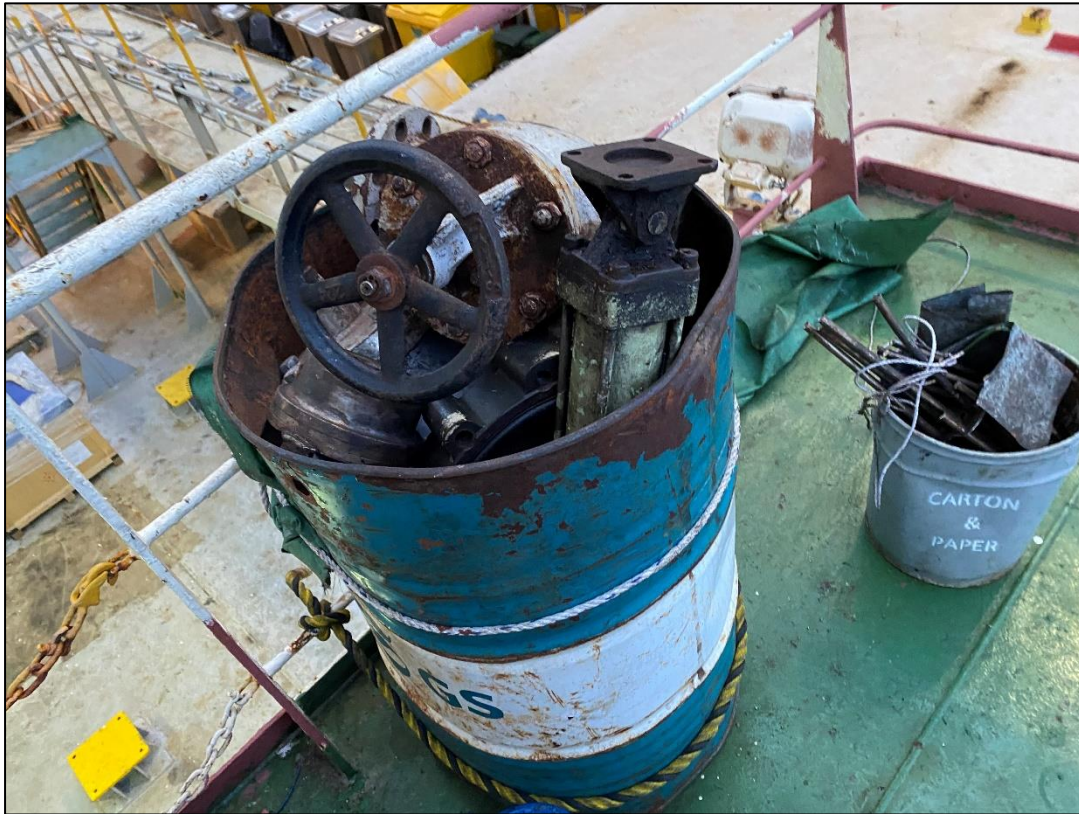
Figure 2: The drum with the scrap, metal items

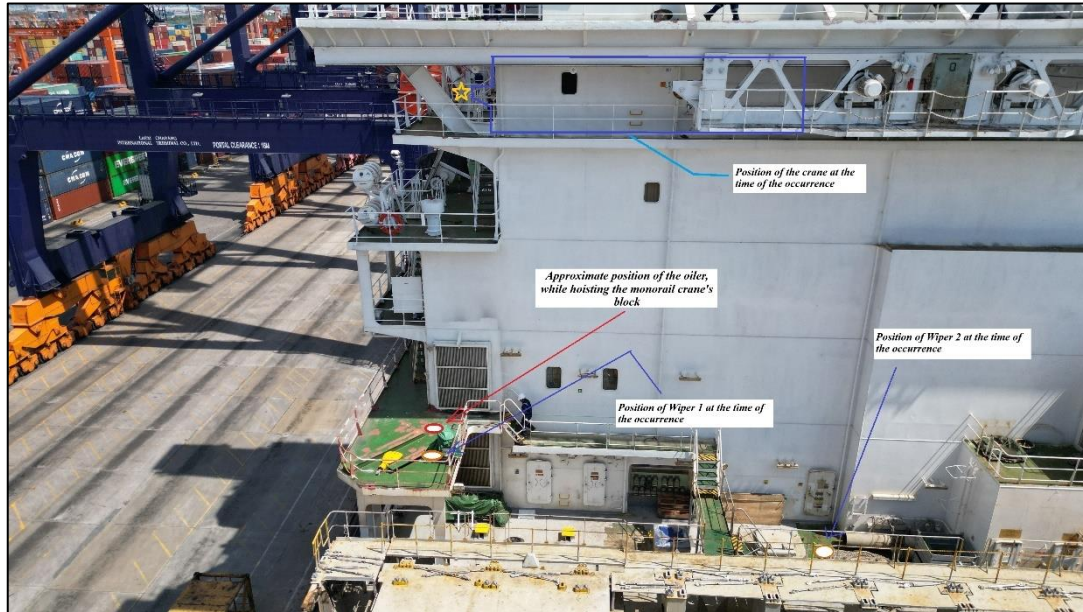
Figure 3 shows the accident site and the positions of the crew members at that time.

Figure 3: The positions of the crew members at the time of the occurrence

As seen in **Figure 3**, the oiler was standing directly below the monorail crane's port side arm when the accident occurred. Considering the height from which the block fell, the safety investigation is of the opinion that any location on the port side of the external 'A' deck would have been a hazardous location to stay in. The safest location may have been the external 'D' deck, at around the same level as the monorail crane. In fact, this was the location that the bosun stated that he would always be at, when he operated the monorail crane¹⁴.

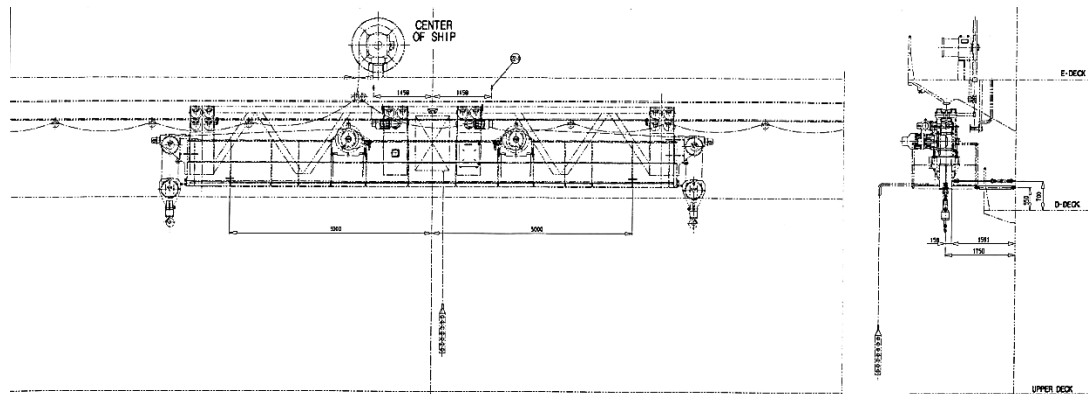
The monorail crane on deck (*i.e.*, the one involved in the accident) had been in service between 15 and 20 years. It was an electric, sliding, two-hook type crane (**Figure 9**),

with a total travelling length of 42.2 m and hoisting height of 34.0 m. It had a traversing speed and hoisting speed of 10 mmin^{-1} .

Figure 9: Extract of the monorail crane's general arrangement plan
