**Bundesstelle für Seeunfalluntersuchung**  
Federal Bureau of Maritime Casualty Investigation

## **Summary Investigation Report 286/20**

**Risk to the health of a dock worker due to electric shock while connecting a refrigerated container to a socket on board the fully-containerised vessel  
MONTREAL EXPRESS  
on 29 August 2020**

15 May 2024

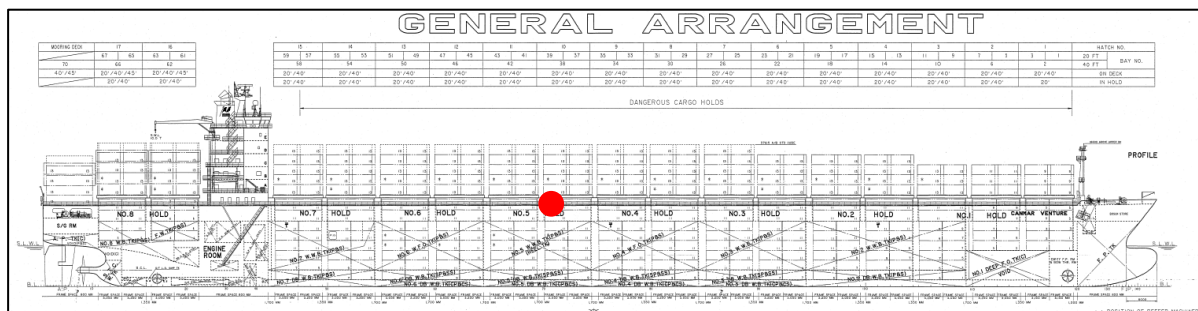
Figure 5: Extract from the general arrangement plan of the MONTREAL EXPRESS (side view)<sup>4</sup>

A dock worker had intended to connect a refrigerated container stowed on deck in the area of bay 38/39 to the ship's power supply system. To this end, he went to the nearest terminal/switch box with the plug of the power cable, which was fitted to the container in the usual manner (see **Figures 3 f.**). This was located on the port side of the ship below the hatch coaming in the area of bay 39 (see red marking in the extract from the general arrangement plan in **Figures 5 f.**).

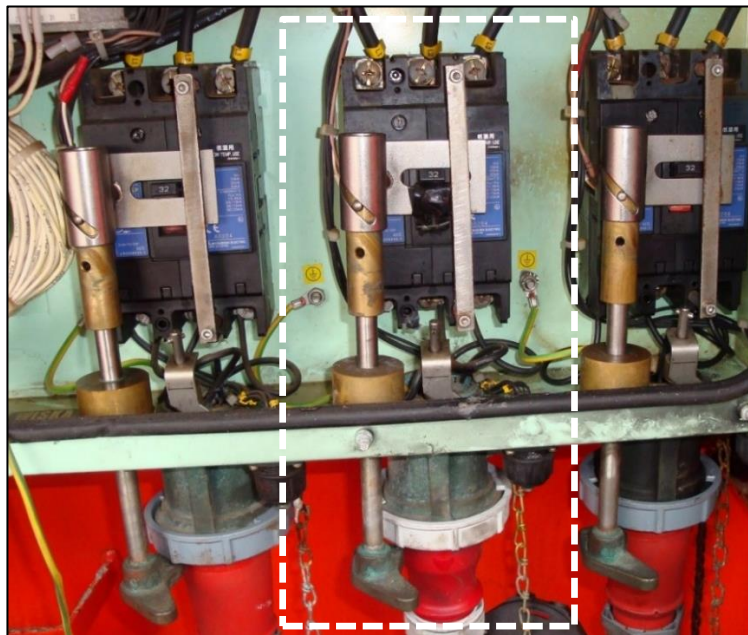
*There are two versions on board. One version of the box has four sockets, the other version has five sockets.<sup>20</sup> The sockets are basically the 4-pin circular type. The operating principle is the same for both versions. After inserting a plug, e.g. a refrigerated container cable, into the socket, the circuit breaker assigned to the socket and acting as a safety element can be switched on and off mechanically by means of a switching rod via a push and pull lever (see **Figure 17**).*

Figure 17: Circuit breaker with push/pull lever and occupied socket
