**Bundesstelle für Seeunfalluntersuchung**  
Federal Bureau of Maritime Casualty Investigation

## **Investigation Report 582/22**

### **Serious Marine Casualty**

**Bridge allisions on the Kiel Canal  
with a mobile harbour crane carried on the  
heavy-lift vessel MERI on  
30 November 2022**

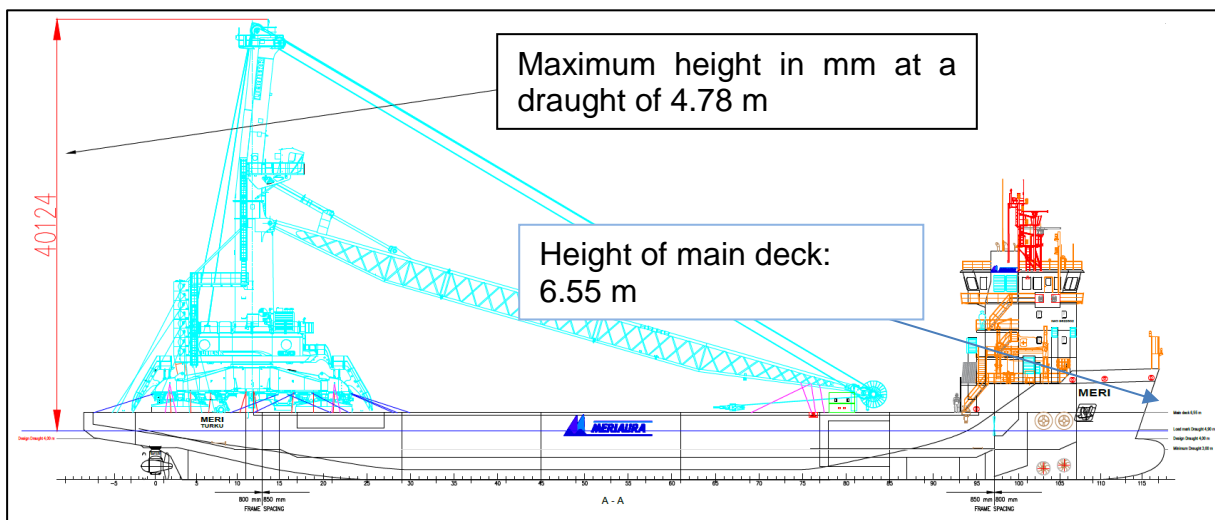
Figure 3: Stowage plan (extract)<sup>12</sup>

The MERI, a heavy-lift vessel flying the flag of Finland, had loaded an LHM 600 mobile harbour crane to transport it from the crane's manufacturer in Rostock to the customer in Esbjerg on the Danish North Sea coast. As is usual with such ships, the superstructure with the ship's bridge is positioned at the bow. The open cargo deck extended from the superstructure to the stern. The crane was lashed aft on this deck. Accordingly, the highest point of the ship, the crane tower, was located in the aft section. The crane jib was positioned and secured on the cargo deck in the direction of the fore section. For the passage through the Kiel Canal, the ship had received admission for passage from WSA<sup>10</sup> Kiel Canal to pass through the canal once with a maximum height of 40.20 m at a gauge datum<sup>11</sup> of up to +5.20 m following a corresponding request. The admission for passage was based on a stowage plan which indicated the exact details of the crane's maximum height of 40.124 m above the waterline at a draught of 4.78 m (see Annex 9.1 to the report).

Basis for WSA Kiel Canal's decision to authorise the MERI to pass through the NOK once with a maximum height of 40.2 m.

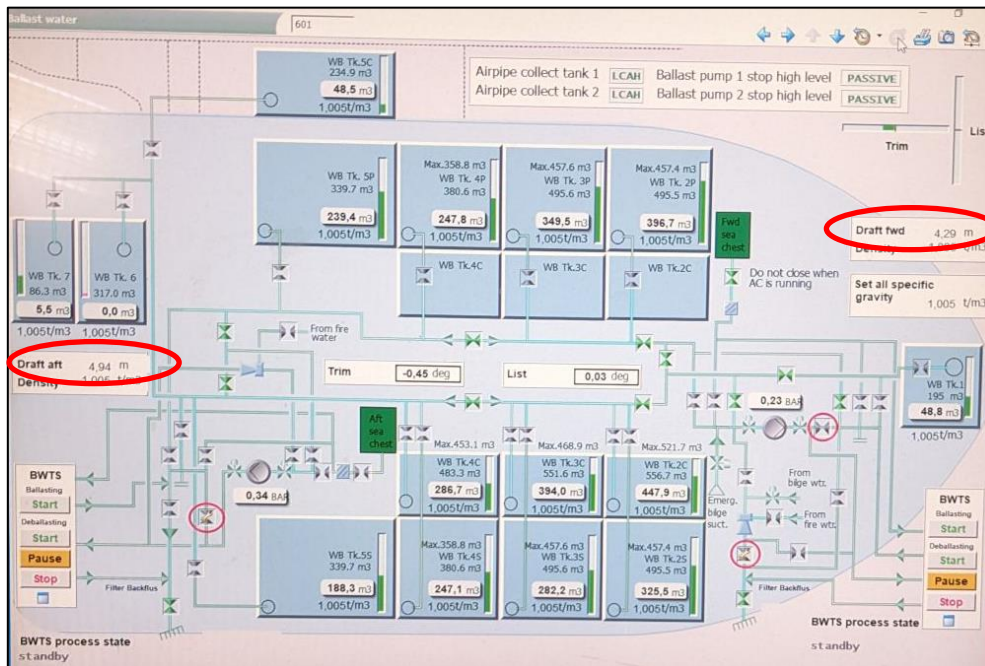
Figure 4: Draught (fore/aft) of the MERI<sup>13</sup>

The MERI called Kiel Canal 4 at 0345, reporting that the draught at the stern had now increased by 10 cm. Kiel Canal 4 acknowledged receipt of this message and informed the MERI that they would continue to take height measurements and that they could read a draught of about 5.05 m at the stern. Kiel Canal 4 asked if the draught could be determined on the basis of technical equipment. The master confirmed via the pilot a draught of 5.05 m. Kiel Canal 4 informed the MERI about further measurement attempts and stated that the mathematical results looked quite good.

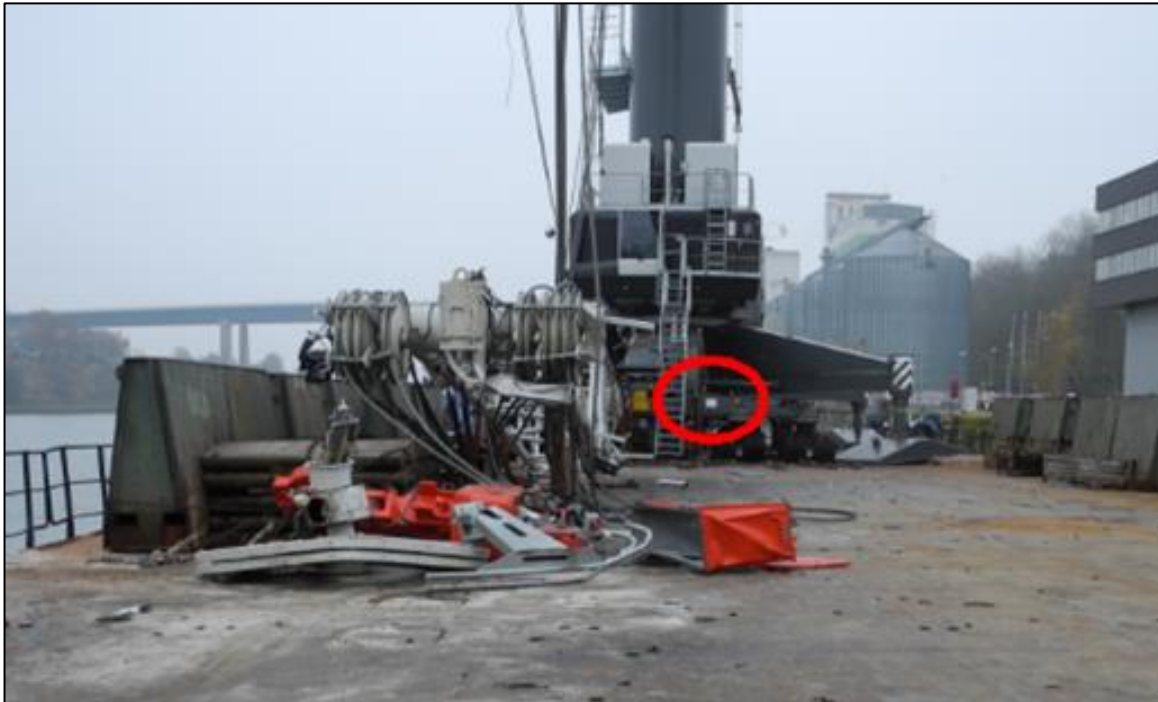
Figure 24: Shipping label<sup>32</sup>

APPLICANT:	ESBIERG HAVN HULVEJEN 1 6701 ESBIERG DENMARK
PORT OF DISCHARGE: PORT OF ESBIERG DENMARK	
SHIPPER:	Liebherr-MCCtec Rostock GmbH Liebherrstraße 1, 18147 Rostock, GERMANY
CRANE TYPE:	LHM 600
COLLI NO.:	<b>1</b>
GROSS WT:	<b>643000 kg</b>
MEASUREMENT:	<b>7335 x 1580 x 3825 cm</b>

According to the cargo documents and the crane inscription, the crane was intended for the Port of Esbjerg. A few days after the accident, the BSU received the ordered crane's (LHM 600 Litronic®) technical data from its recipient following a corresponding request. These data indicated that the ordered crane's tower height should be 43.2 m, i.e. 4.95 m higher than indicated on the shipping label.

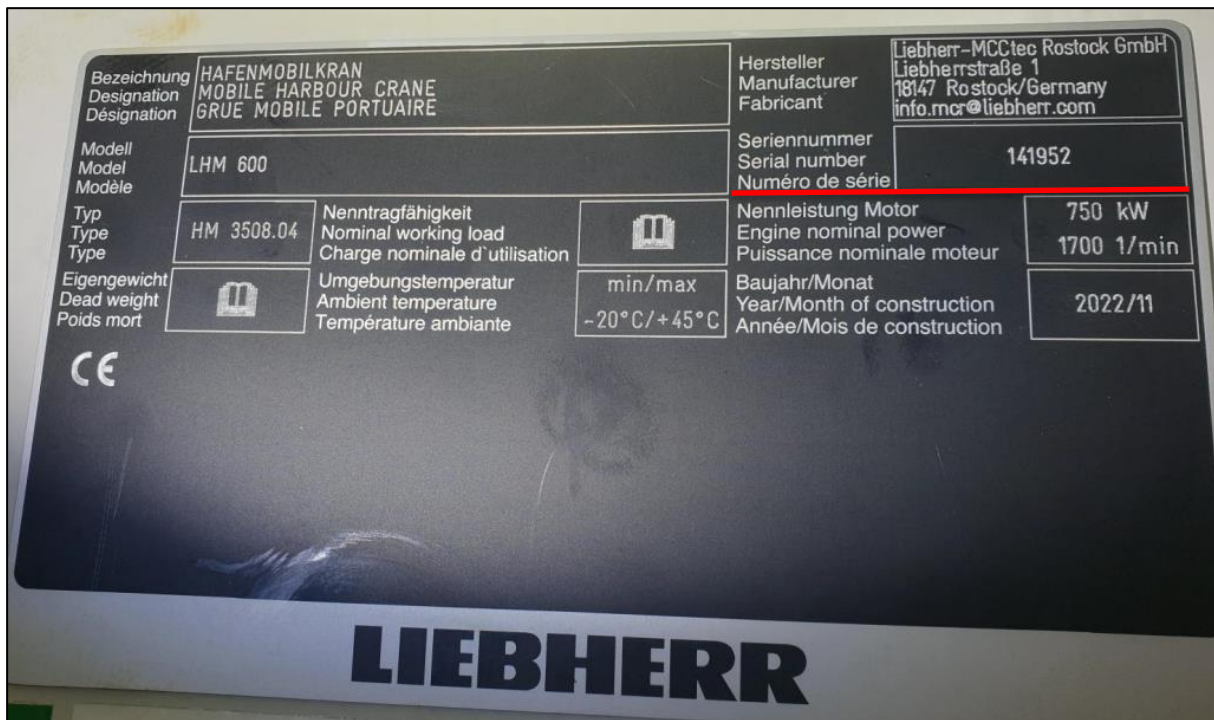
Figure 28: Nameplate of loaded crane<sup>35</sup>

The serial number (S/N) of the crane being delivered should be 141952. This number corresponded to the S/N on the loaded crane's nameplate.

According to the crane's manufacturer, the crane carried on the MERI was one of the first cranes from the sixth evolutionary stage (Evo6), introduced in 2022, to be delivered. In addition to changes in the design and build, the tower had been raised by almost five metres. The design drawing of this new LHM 600 Evo6 was released on 23 September 2022. The manufacturer believed that in this particular case there was evidently a problem in connection with the transport drawing sent to the owner, which did not show the current evolutionary stage. On being questioned, the manufacturer stated that numerous people from several departments were reportedly involved in preparing for shipping and loading and that internal company processes were being reviewed and improved as required following this accident.

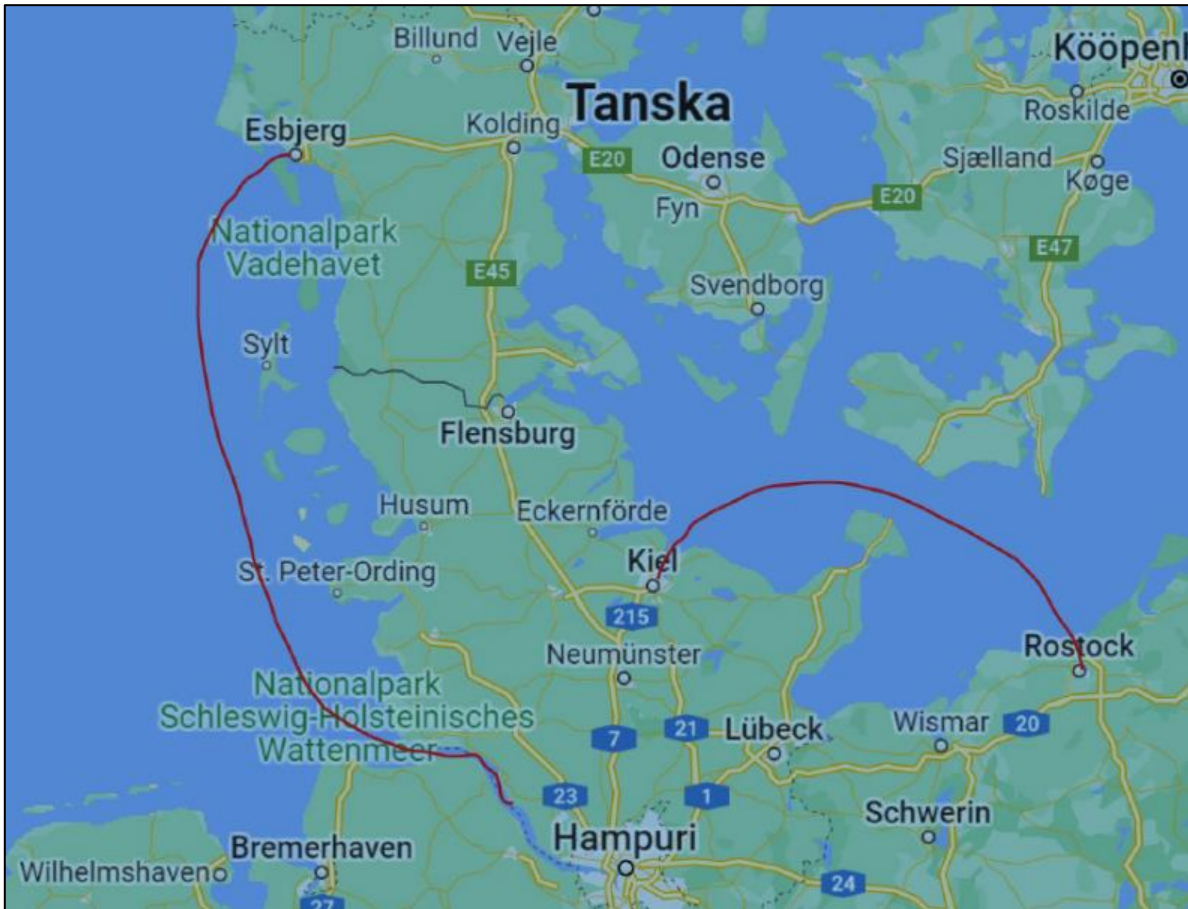
Figure 35: Voyage plan according to the transport manual<sup>38</sup>

- Chapter 8 (navigation)/Annex 9: This chapter refers to a list of waypoints in Annex 9. According to the heading, Annex 9 should include a voyage plan with ports of refuge. However, this Annex merely contains a road map in which a route through the NOK is drawn.

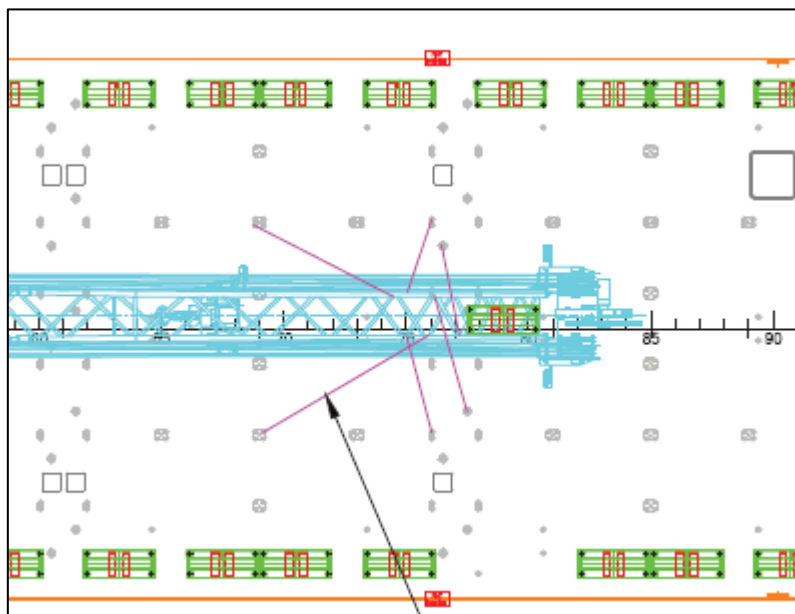
Figure 38: Stowage plan (detail) showing the position of the jib

According to the plan, the jib was to be set down with the ship's frame no. 85.

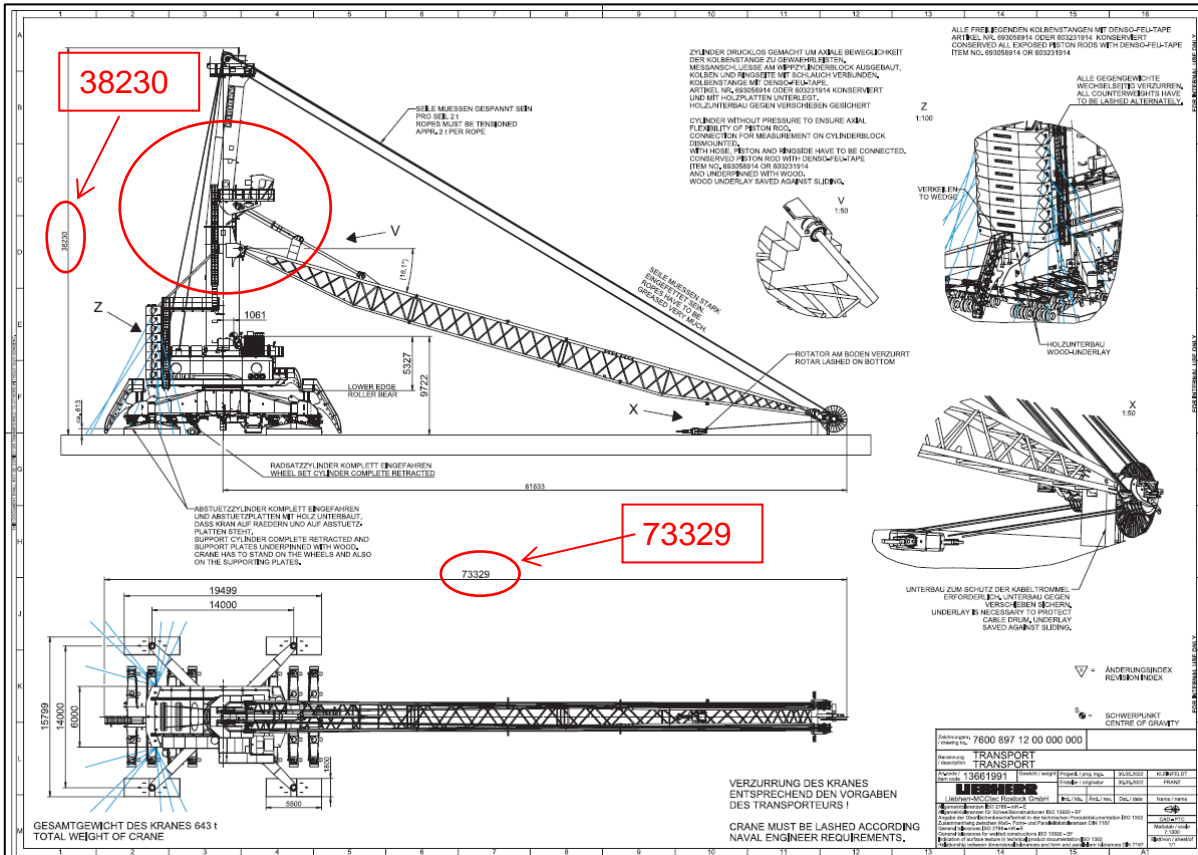
Figure 39: Transport drawing of the LHM 600 from the transport manual

manufacturer provided for the investigation, indicates a length of 71.712 m due to the modified design. According to the plan, the jib of the crane loaded on board was 1.617 m shorter.
