NATIONAL TRANSPORTATION SAFETY BOARD 2023

SAFER SEAS Digest

Lessons Learned from
Marine Investigations

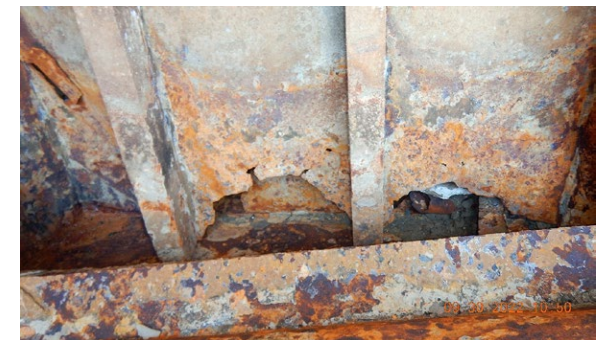
The bottom of the centerline longitudinal bulkhead between the no. 1S and no. 1P compartments of the port barge showing metal loss and corrosion holes.

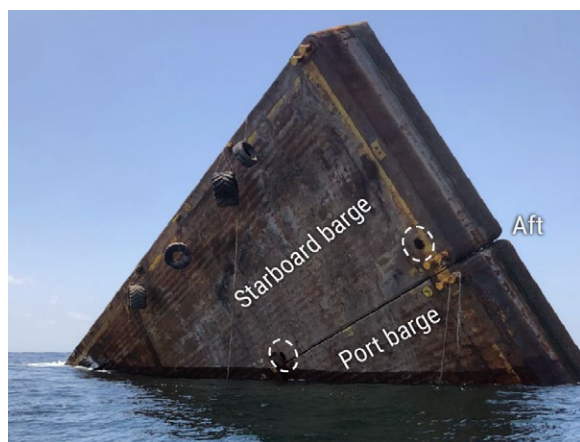
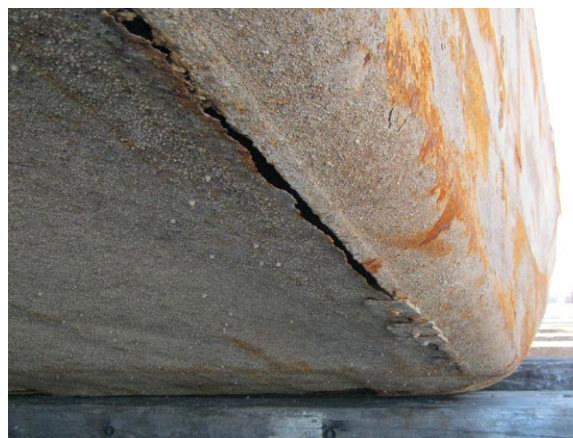
The port barge's separation at the weld seam, between the bottom plate and bilge knuckle plate.

At some point, a temporary repair, which consisted of steel plates welded to the floor and knuckle plating, forming a box inside compartment no. 1S, had been made to the area around the separation, to contain water ingress. However, the separation had grown aft, beyond the steel box, likely due to it being in an area known to be subject to longitudinal stress. The corrosive deterioration of the bottom and bilge knuckle plating and their separation along their weld seam would have allowed water to enter compartment no. 1S of the port barge, which was the likely origin of initial water ingress.

Rigid Constructors did not have an inspection or maintenance plan for the *Ambition's* hull. As such, they failed to conduct permanent repairs in an area critical to hull strength, and the separation between the bottom plating and the bilge knuckle plating progressed beyond the temporary repair. Rigid Constructors' lack of hull inspection, maintenance, and permanent repairs resulted in the poor hull condition that caused the failure of the hull. Additionally, there was evidence of past dewatering of two compartments on the starboard barge of the *Ambition*, implying that water accumulation was a known issue with those compartments. However, none of the Rigid crewmembers were tasked with checking compartments and voids on the barge for water. Thus, Rigid Constructors allowed for the *Ambition* to be taken under offshore tow without verifying the watertight integrity of the hull.

To protect vessels and the environment, it is good marine practice for vessel owners to conduct regular oversight and maintenance of hulls, including between drydock periods. An effective maintenance and hull inspection program should proactively address potential steel wastage, identify hull and watertight integrity deficiencies, and ensure corrosion issues are repaired in a timely manner by permanent means.

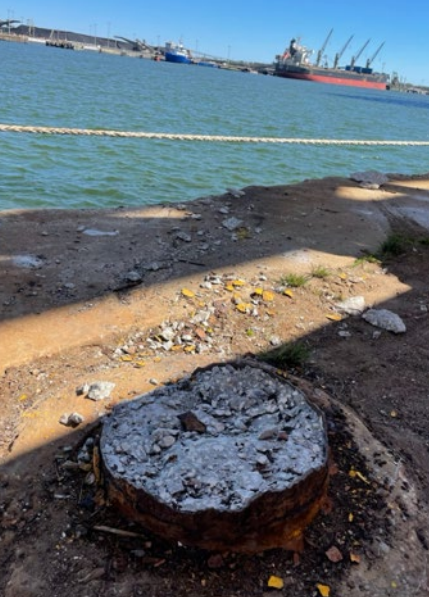
Remaining base of bollard 6 after breakaway.

Postcasualty ultrasonic thickness tests performed on the remaining bollards in the area where the VALARIS DS-16 was moored indicated that there was deteriorated steel at the lower portion of several bollards. The broken top of bollard 6 was not recovered from the channel, but a postcasualty measurement of the remaining 18-inch-diameter base of the bollard showed that the steel wall thickness was less than 0.25 inches on the side farthest from the edge of the pier—an apparent reduction in thickness of about 0.5 inches (original bollard design drawings showed a wall thickness of 0.75 inches). Additionally, several bollards showed signs of external corrosion and wastage.

There were no records of any pull tests that could confirm the safe working load of the bollards used by the VALARIS DS-16. All the bollards had been modified from the original 1997 design (for which there were no engineering records). The modifications increased the bollard pipes' overall height from just over 2 feet to about 4 to 7 feet—about 2 to 5 feet higher than

originally designed—with additional horns, which allowed for additional mooring lines to be placed higher on the bollards. As the height of a bollard (or its horns) increases, the horizontal or up-leading pull on the upper portion of the bollard significantly increases the moment of force applied to the base of the bollard. Therefore, bollard 6 and many of the other bollards used to secure the vessel's mooring lines were likely incapable of sustaining the working loads of their original design.

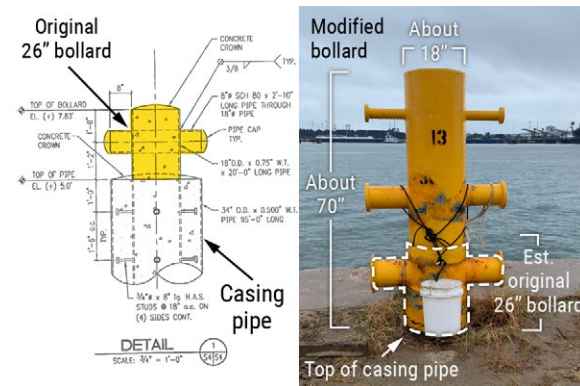
Left to right: 1997 construction plans for bollards and a modified bollard in October 2022, seven months after the casualty.

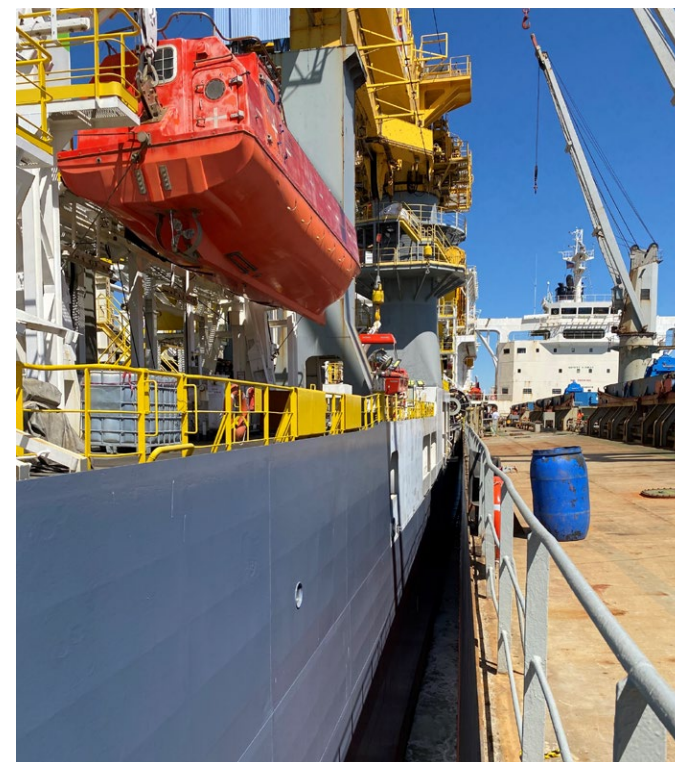
VALARIS DS-16 (left) alongside the Akti after colliding.

THE PROBABLE CAUSE of the breakaway of the VALARIS DS-16 from the STEHMO Shipyard dock and the subsequent collision with the cargo vessel Akti was the failure of one of the shipyard's mooring bollards—which had been modified to increase its height to accommodate more lines—used to secure the VALARIS DS-16's bow mooring lines to a pier, during a cold front with strong winds.

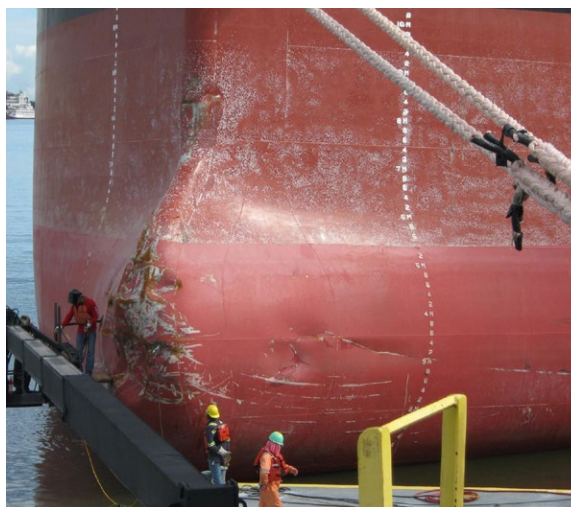
Damage to the bulbous bow of the *Bunun Queen* after the casualty. SOURCE: COAST GUARD

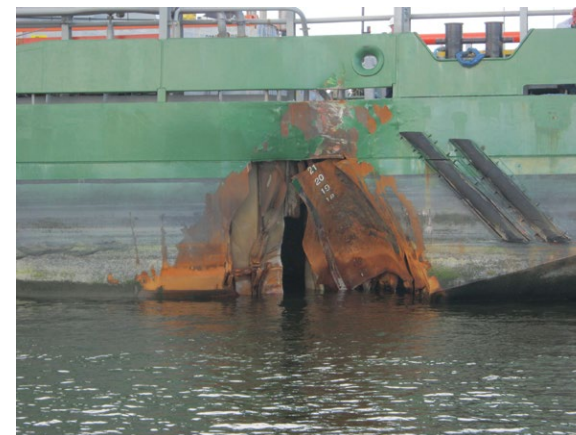
Damage to the aft port side of the *Thunder*. SOURCE: COAST GUARD

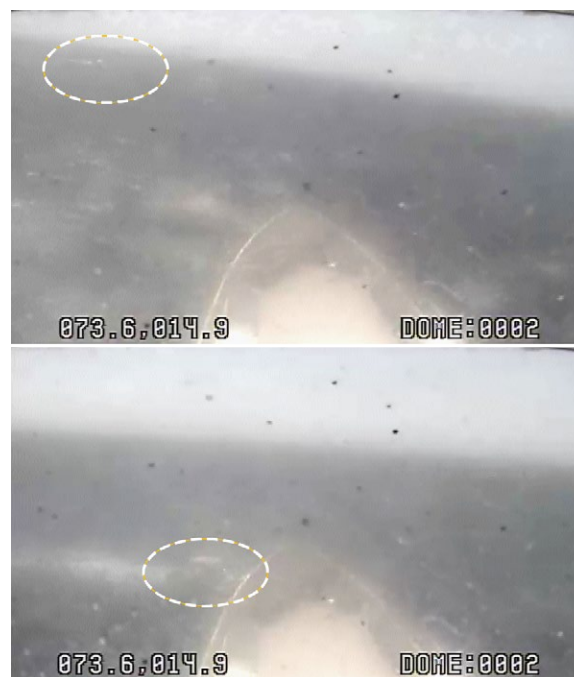
A forward-looking camera high on the *Winslow Griesser's* mast above the bridge first captured the *Desakata* about 19 seconds before the collision, crossing from port to starboard at a near right angle roughly 10° off the bow. The camera footage, which was not clear because of a salt-crusted lens, appeared to show the *Desakata* disappearing and reappearing in the waves a few times. Camera footage also showed the *Winslow Griesser* yawing to port and starboard in following seas.

Left: The *Desakata* (circled) as recorded from the *Winslow Griesser's* salt-encrusted mast camera at 1416:53, 19 seconds before the collision, and at 1417:12, immediately before the collision.

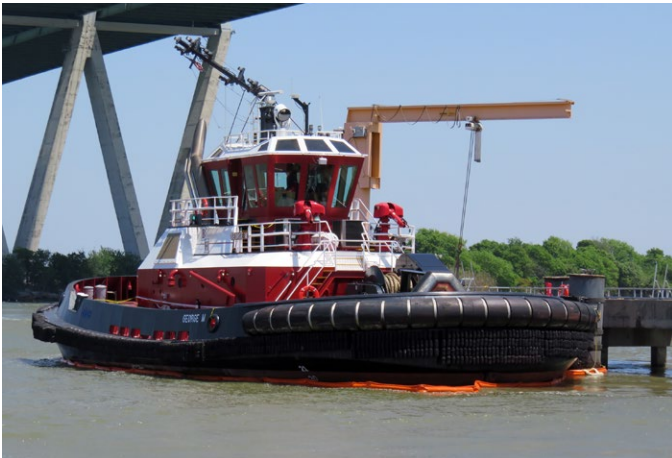
The George M after the casualty.

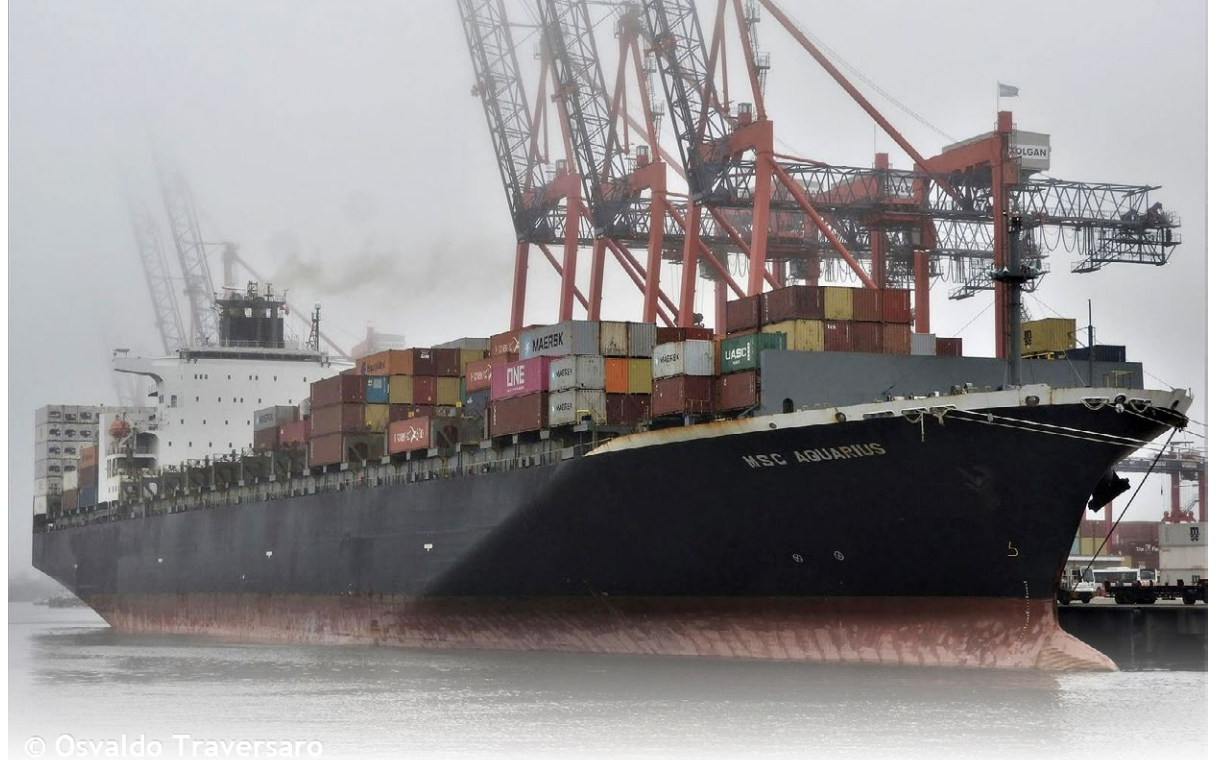
The MSC Aquarius after the casualty. SOURCE: OSVALDO TRAVERSARO, MARINETRAFFIC.COM

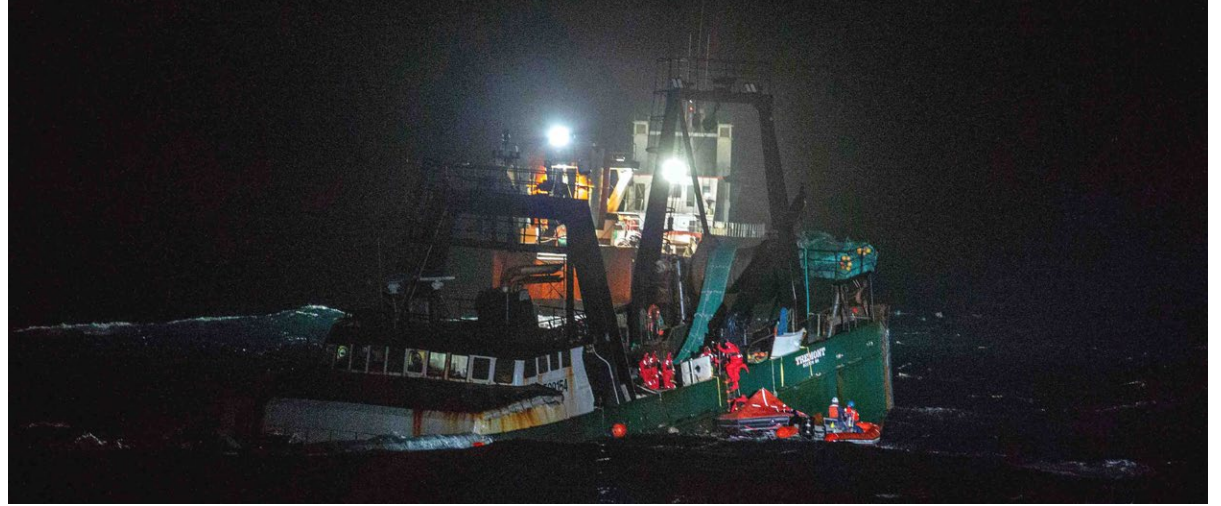
Tremont bow awash during the abandonment. SOURCE: LANCE WILLIS

Within 10 minutes of the collision, flooding reached the *Tremont*'s main deck above the fish hold. The crew did not determine the source of the rapid flooding and subsequently abandoned the vessel. The flooding was likely caused by portside shell damage at the engine room and/or the vessel's forepeak.

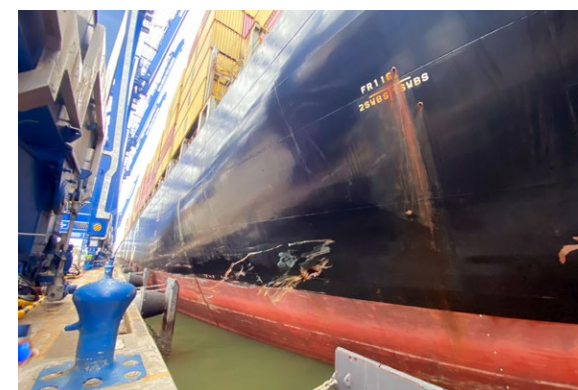
Damage to the MSC Rita's starboard hull.

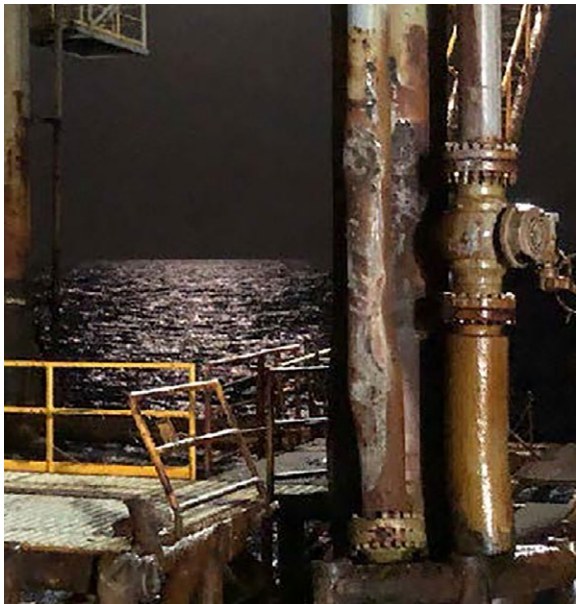
Damage to platform EI-259A. SOURCE: COX OPERATING

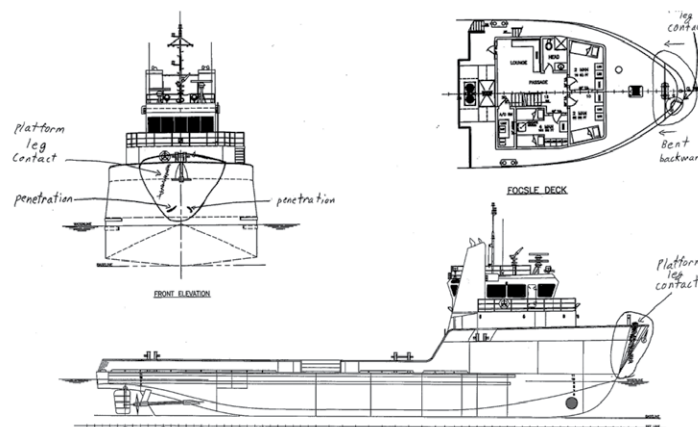
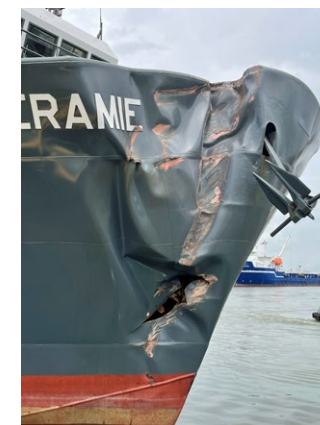
Left to right: Diagram of vessel damages as provided to the NTSB and damaged bow of the *Elliot Cheramie*.

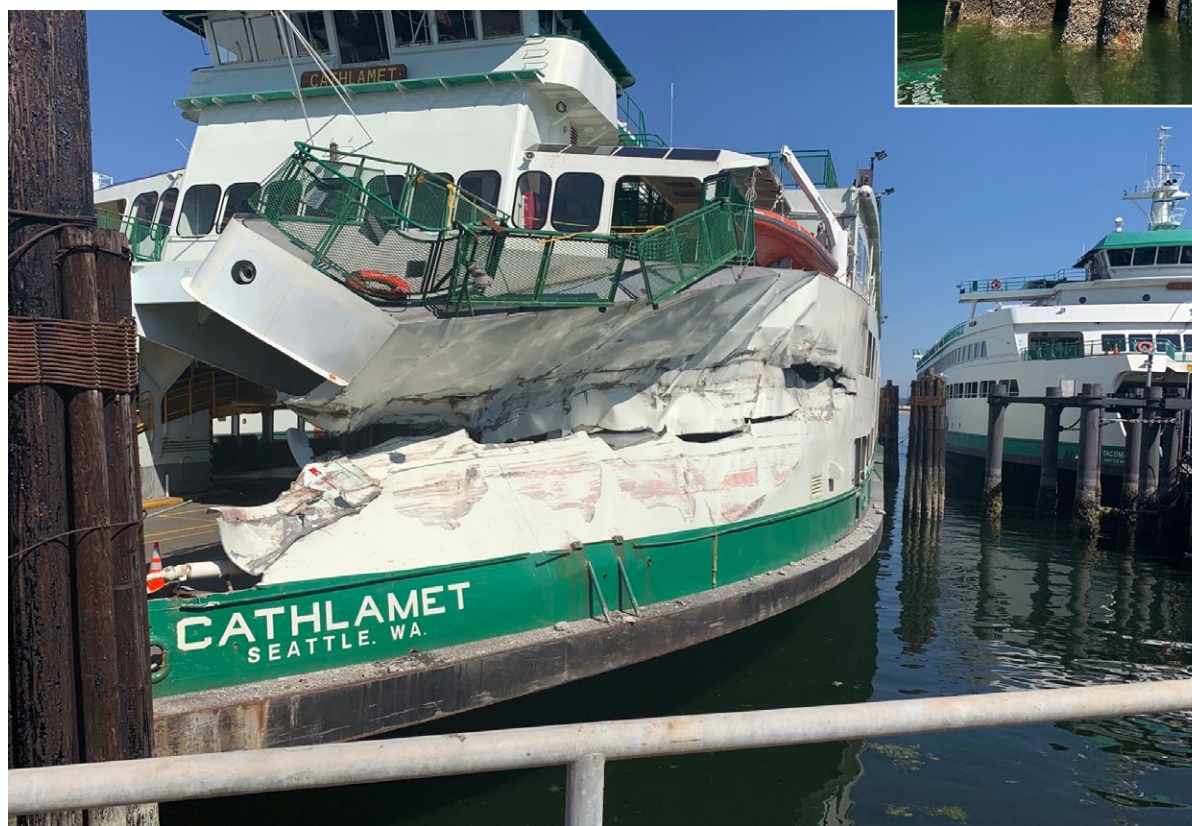
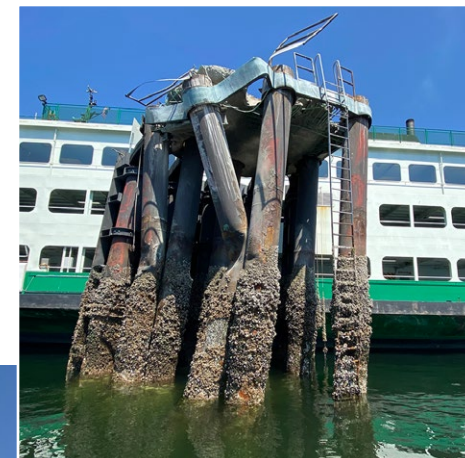
Below: The damaged *Cathlamet* after the contact with the dolphin.
Right: The damaged dolphin. SOURCE: WSF

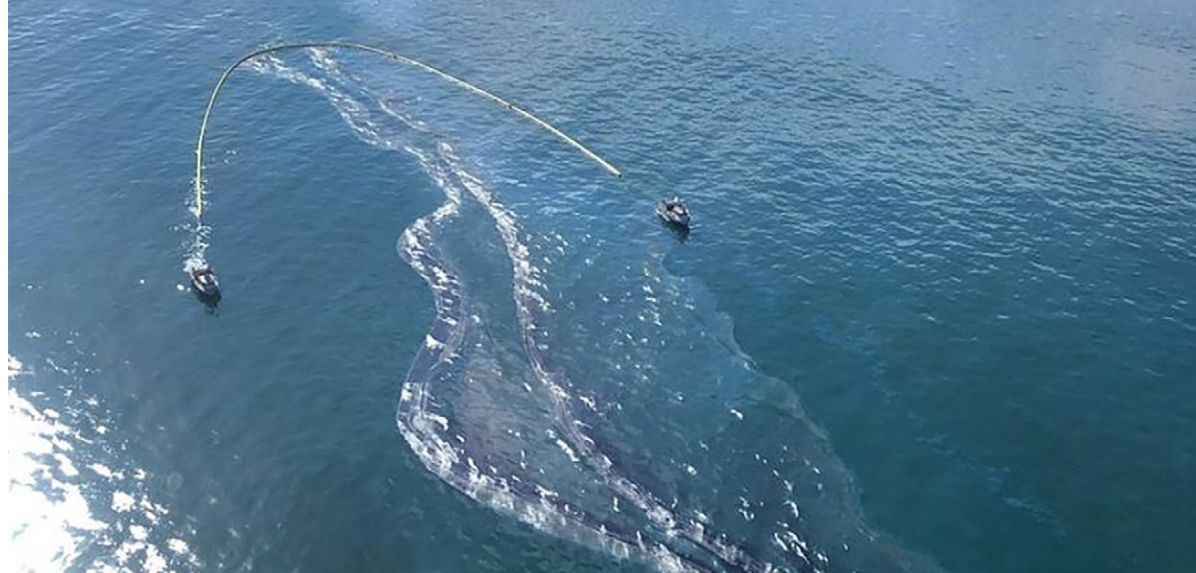
Crude oil in the Pacific Ocean off the California coast on October 3, 2021. Oil spill removal organization vessels are towing a skirted oil boom to contain the oil spill. SOURCE: COAST GUARD

leaked from the pipeline. Damage, including clean-up costs, was estimated at \$160 million. There were no injuries. A postaccident underwater examination of the pipeline found a crack along the top of the pipeline within a section of the pipeline that had been displaced from its originally installed location. Additionally, scarring consistent with anchor dragging was identified on the seafloor near the crack location, which was 4.75 miles from shore. Postaccident investigation determined that the containerships *MSC Danit* and *Beijing* had dragged anchor near the pipeline months before the oil release, on January 25, 2021.

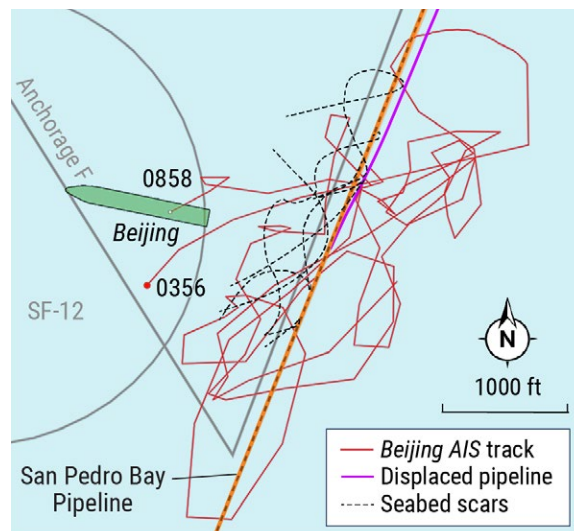
Location data from anchor dragging scars on the seabed, when overlaid with the Beijing's AIS data, indicate that the Beijing anchor likely struck the pipeline multiple times. SOURCE: NTSB

The NTSB determined that the *Beijing* and *MSC Danit*'s dragging anchors struck, displaced, and damaged the San Pedro Bay Pipeline. Over the next 9 months, the deformation to the pipeline caused by the *MSC Danit*'s anchor strike resulted in progressive cracks initiating and growing through the pipe wall until the pipe wall ruptured on October 1.

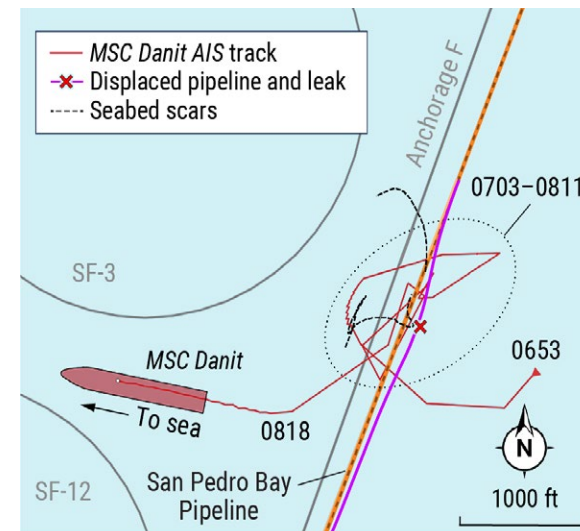
The MSC Danit's AIS data indicated that the vessel maneuvered directly over the pipeline and remained there for over an hour. SOURCE: NTSB

At 0655, the *MSC Danit* began moving forward again, toward the pipeline. However, 8 minutes later, the containership's forward progress halted, with the ship directly over the pipeline. For the next 1 hour and 8 minutes, the vessel's AIS position remained within an area about 600 feet in radius, centered on the eventual leak location on the pipeline. After 0811, the *MSC Danit* began moving to the west again. The ship's crew reported "anchor aweigh" to VTS LA-LB at 0816 and logged "anchor up" in the bell book at 0820. The *MSC Danit* then departed San Pedro Bay.

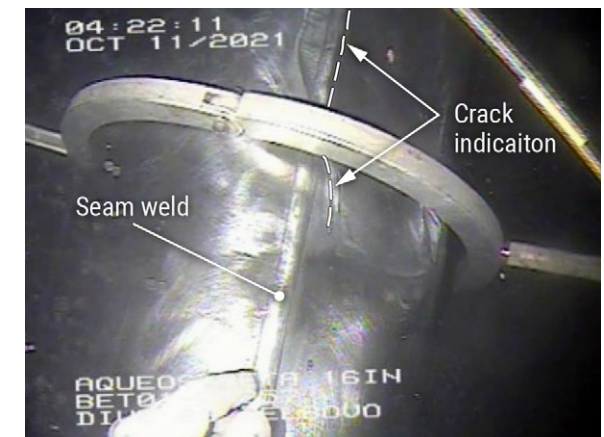
San Pedro Bay Pipeline underwater nondestructive testing showing a portion of the crack indication (dashed line) on the pipe on October 11, 2021.

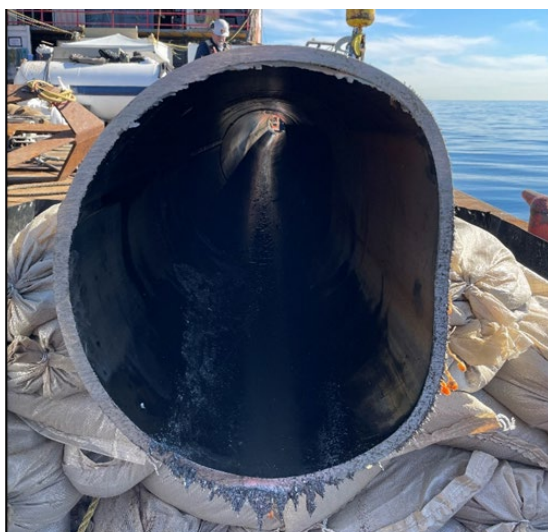
Opposite ends of the pipe segment that contained the leak site, which had been temporarily repaired with a welded repair patch, visible in the right image. Damage signatures observed included lateral deformation, out-of-roundness deformation (a typical example indicated at the end of the segment in the right image), and missing concrete coating, especially north of the leak site.

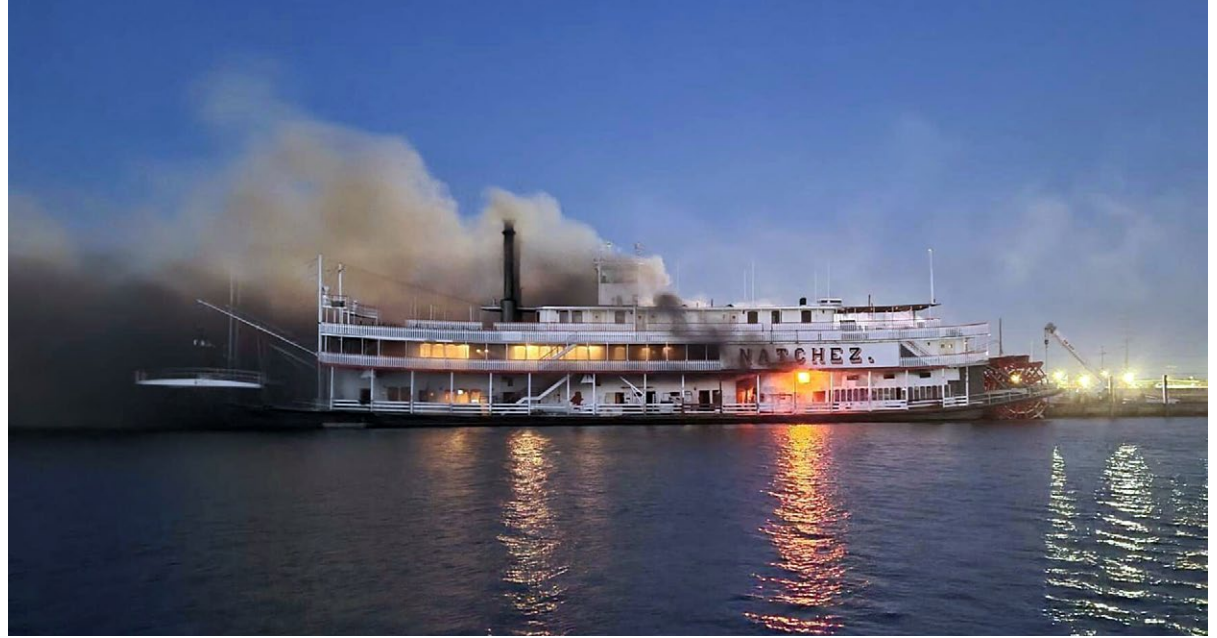
The *Natchez* on fire. SOURCE: UNIDENTIFIED WITNESS VIA COAST GUARD

On May 3, 2022, about 1945 local time, the inspected passenger vessel *Natchez*, with one crewmember on board standing a security watch, was moored in the Industrial Canal in New Orleans, Louisiana, undergoing renovations, when a fire broke out. Local firefighters extinguished the fire at 2139. No pollution or injuries were reported. Damage to the vessel was estimated at \$1.5 million.

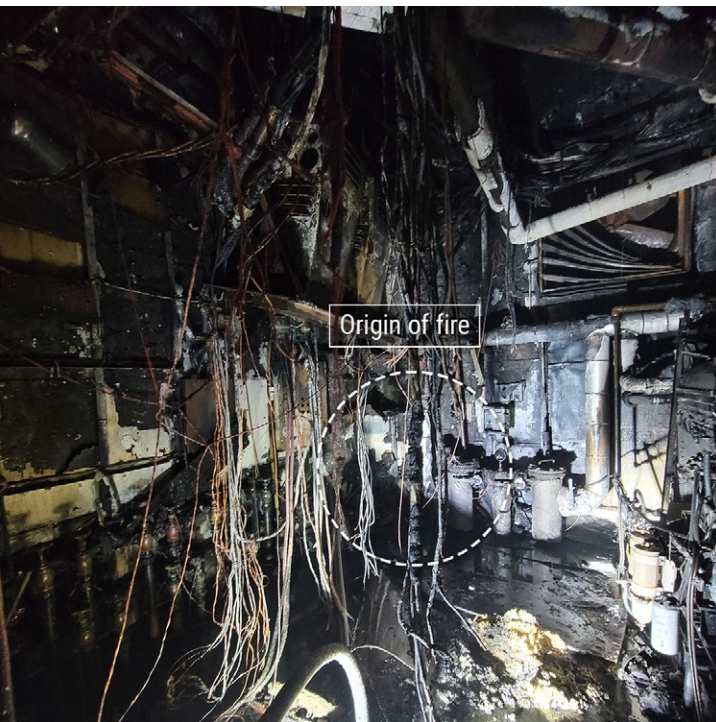
During the examination of the generator space following the fire, ATF fire investigators noted a distinctive V-shaped fire pattern on the forward bulkhead of the generator space, which indicated that this was most likely where the fire started. Combustible materials (cardboard boxes) were stored in the ignition area (forward storage area), which was located about 2 feet from where the hot work occurred. Although the electrical panel removal work had stopped about 1545, a smoldering hot spot had most likely formed within the boxes from the sparks generated from the acetylene torch cutting the metal panel. Between 1545 and when the fire was discovered at 1945, the hot spot expanded and eventually ignited. The combustible materials provided ample fuel for the fire as it expanded within the generator space.

Above, left to right: The *Natchez* generator space before the fire. Left photo, looking aft, shows exposed boxes and plastics (circled) stored aft of the metal foundation for the electrical panel that was removed during the hot work. Right photo, looking forward, shows exposed boxes (circled) forward of the foundation. **Below:** The generator space postfire, looking forward, showing the location on the forward bulkhead (circled) identified by the ATF as the fire's origin.

Mandated by OSHA regulations, fire safety plans are required to identify significant fire hazards. Having a fire safety plan in place and following the plan as instructed reduces risk of fire from hot work—protecting both the space and the people conducting the work. Although the contract workers had conducted a safety evaluation of the generator space before initiating the hot work and had a dedicated fire watch, and the vessel's chief engineer directed that sheet metal be placed between the port generator and the hot work area, neither the contractors nor the *Natchez* crewmembers identified the fire risk from combustible material within the generator space about the same distance from the hot work as the generator. According to OSHA regulations, all combustible material closer than 35 feet to the hot work in either the horizontal or vertical direction that cannot be removed had to be protected with flameproofed covers or otherwise shielded with metal or asbestos guards or curtains. This was not performed over known areas of combustibles.

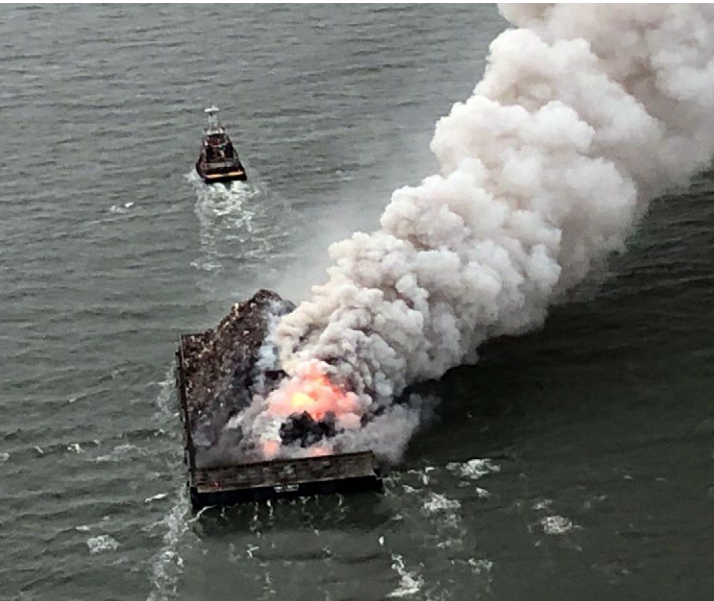
Towing vessel *Daisy Mae* pulling the *CMT Y Not 6* barge with scrap metal cargo on fire.

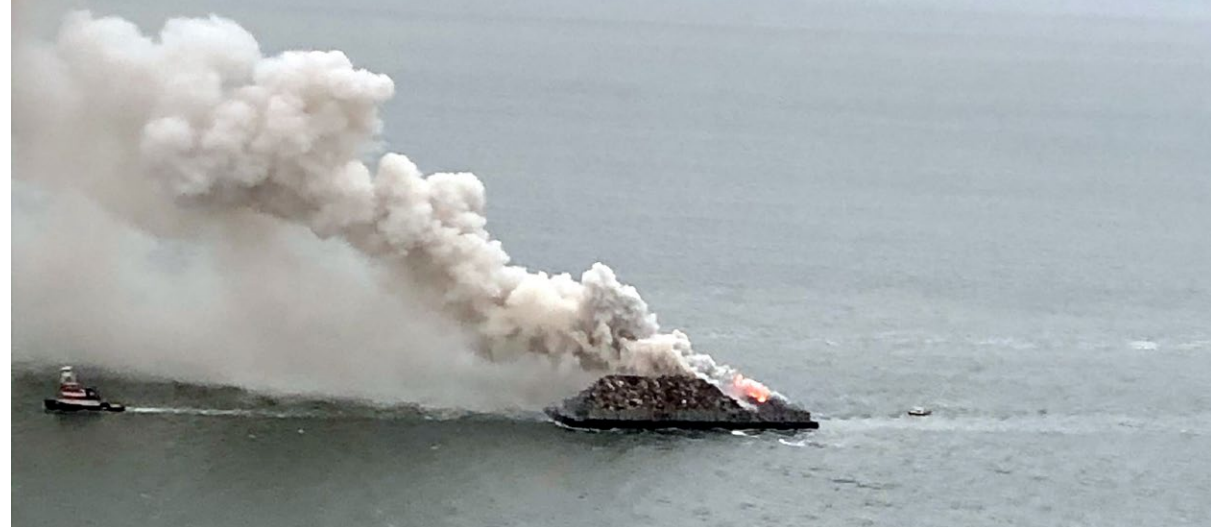
Portside view of *CMT Y Not 6* barge with cargo on fire. SOURCE: COAST GUARD

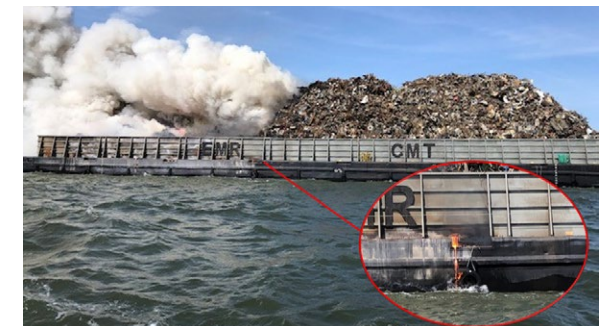
The scrap metal fire aboard the *CMT Y Not 6* on the morning of May 23. Inset shows molten metal leaking out of a starboard-side freeing port.

The postcasualty inspection of *CMT Y Not 6* revealed structural damage consistent with a high-temperature fire concentrated in the aft section of the barge. The scrap metal cargo in that area also exhibited signs of a high-temperature fire. Much of the scrap metal had melted from the heat and then solidified when the fire was extinguished, creating large metal pieces. The magnitude of the fire and the destruction of the cargo in the area where the fire was first identified prevented investigators from determining a conclusive origin of the fire. However, investigators found flammable nonmetallic materials, such as plastic, rubber, insulation, and electrical components, within the nondamaged cargo. It is likely that these materials were present throughout the cargo and, once exposed to an ignition source, caught fire and then fueled and sustained the fire.

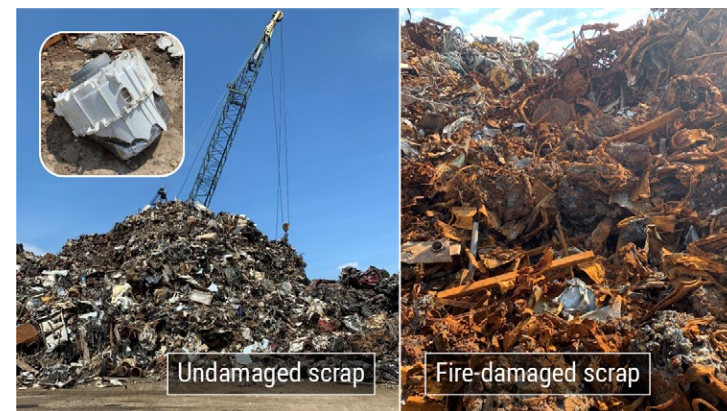
Cargo removed from *CMT Y Not 6* postfire. Left: Scrap metal unaffected by the fire; rubber tires and other nonmetallic materials are visible. Inset: A washing machine drum shrouded in plastic. Right: Scrap metal exposed to the fire, with large metal pieces of solidified molten metal. SOURCE: NTSB

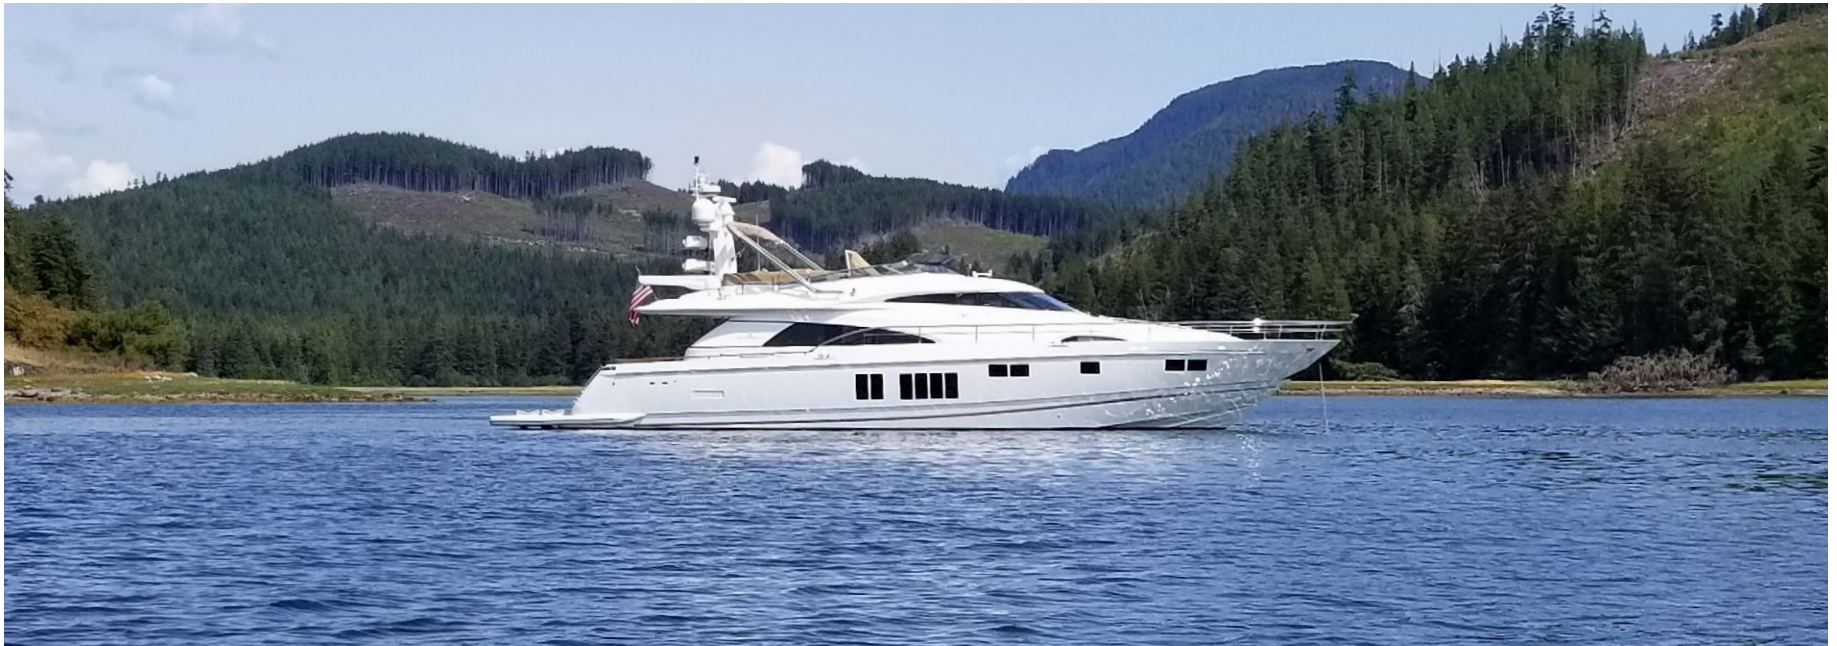
The Pierce County Fire Prevention Bureau fire marshal found extensive damage on the aft deck, including “mass loss of fiberglass” in that area and a wood table and bench that had been consumed by the fire. There was no evidence to suggest the fire was caused by an electrical system failure, and damage to engine room components indicated that the fire originated above the space and was not the result of a mechanical issue.

The day before the fire, the owner’s employee had placed a bag with rags soaked with a raw-linseed-oil product under the table on the aft deck—the area where the fire originated. Rags soaked in oil-based finish are a risk for spontaneous combustion, and the product container included a warning of this hazard. The Pierce County fire marshal determined that, on a probable basis, the fire aboard the yacht *Pegasus* was caused by the spontaneous combustion of the oil-soaked rags that had not been properly discarded.

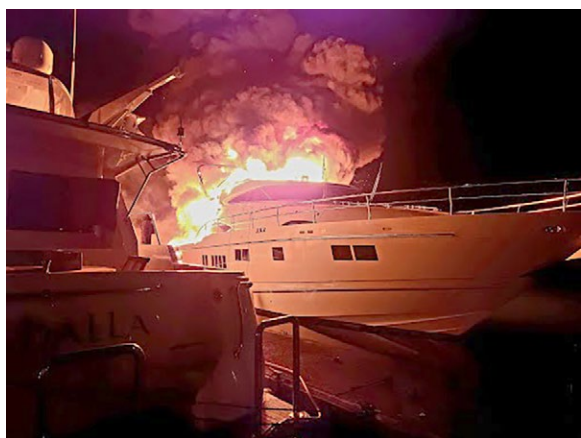
Yacht *Pegasus* fire at 0322 local time, just before the arrival of firefighters at the vessel’s berth.

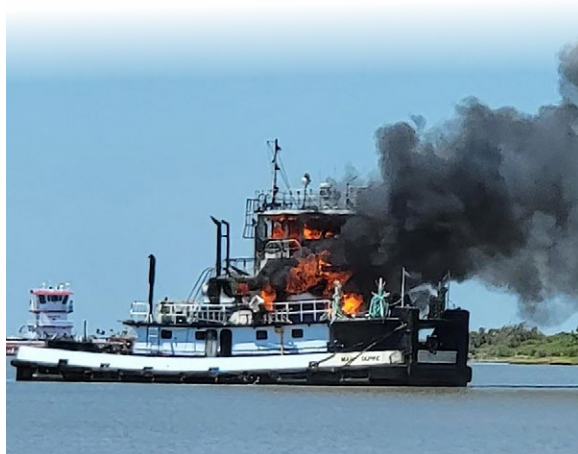
Fire aboard *Mary Dupre* minutes after crewmembers abandoned the vessel.

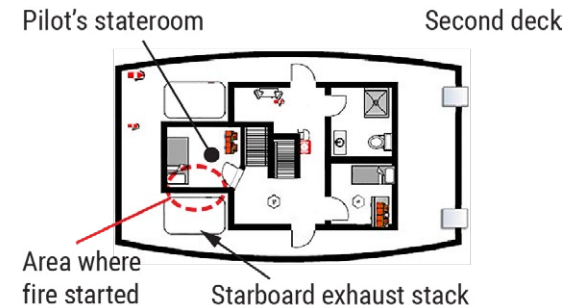
A fire had started behind the wood-paneled bulkheads in the pilot's stateroom, which was located between the vessel's two stacks, each containing engine exhaust mufflers and piping. Cracks in the welds on the upper section of the starboard muffler located inside the starboard stack—which may have been caused by a latent issue, such as a defect in the muffler during construction or the exhaust system design's allowance for thermal expansion and contraction of exhaust piping above the muffler outlet—allowed the hot exhaust gases from the operating starboard engine to escape into the stack area and increase the temperature of the space and its bulkheads.

**Layout of the *Mary Dupre* second deck. The dashed oval identifies the area where fire started.**

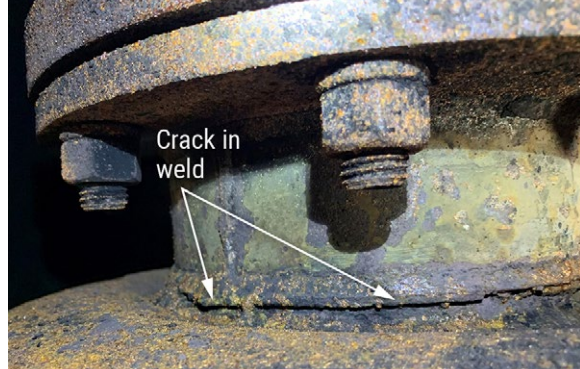
Crack in weld below the upper (outlet) flange of the starboard muffler aboard the *Mary Dupre*. SOURCE: NTSB

Additionally, the muffler's exhaust blanket was disconnected and not fully wrapped around its entire circumference, leaving a section of the muffler uninsulated—thereby allowing heat to radiate into the stack area. The inboard steel bulkhead of the starboard stack was common with the wood-paneled outboard bulkhead of the pilot's stateroom and was just 10 inches from the uninsulated part of the muffler radiating heat. Therefore, the elevated temperature of the stack's steel bulkhead increased the temperature of the wooden studs bolted directly to the shared bulkhead above that required to ignite wood by short term heating (about 480°F), causing the studs to smolder and ignite. In fact, the temperatures within the stack were likely much greater. The paint on the exterior bulkhead of the starboard stack began to blister, indicating that the temperature in the stack had risen above the maximum temperature resistance of the exterior paint (750°F).

THE PROBABLE CAUSE of the fire aboard the towing vessel *Mary Dupre* was undetected cracks in the starboard muffler that allowed exhaust gases from an operating engine to escape and ignite wooden structures affixed to the common bulkhead of an accommodation space. Contributing to the extent of the fire damage was the substantial use of combustible materials in the joinery, outfitting, and furnishings in the accommodation spaces.

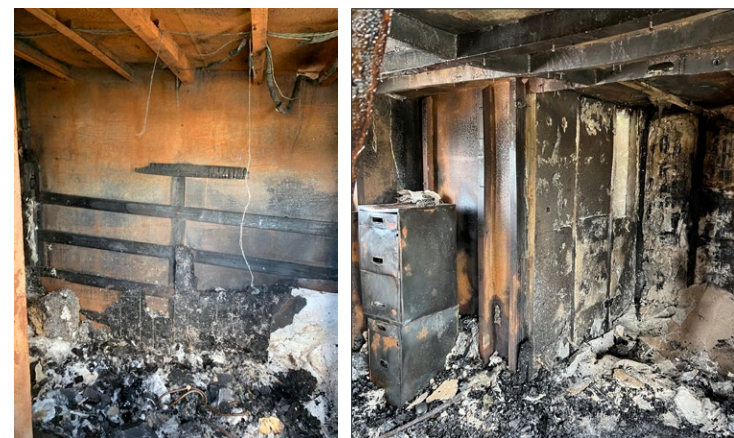
Left to right: Charred wooden framing attached to steel bulkhead and pilot's stateroom adjacent to the starboard stack where the fire started. SOURCE: NTSB

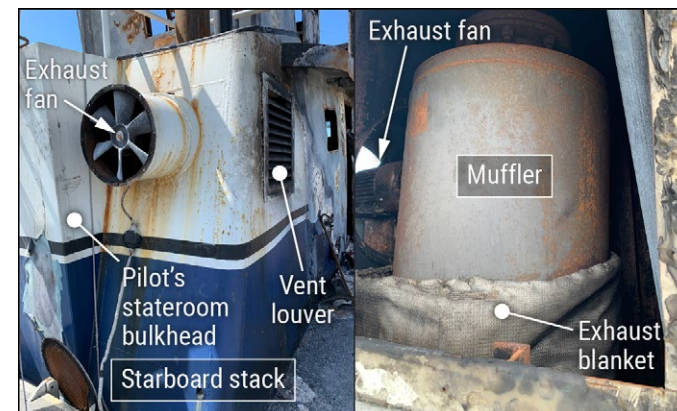
Left to right: Exterior view of the starboard stack after the fire; the starboard muffler's outboard side, as seen through the removed vent louver, and upper exhaust blanket removed after the fire. SOURCE: NTSB

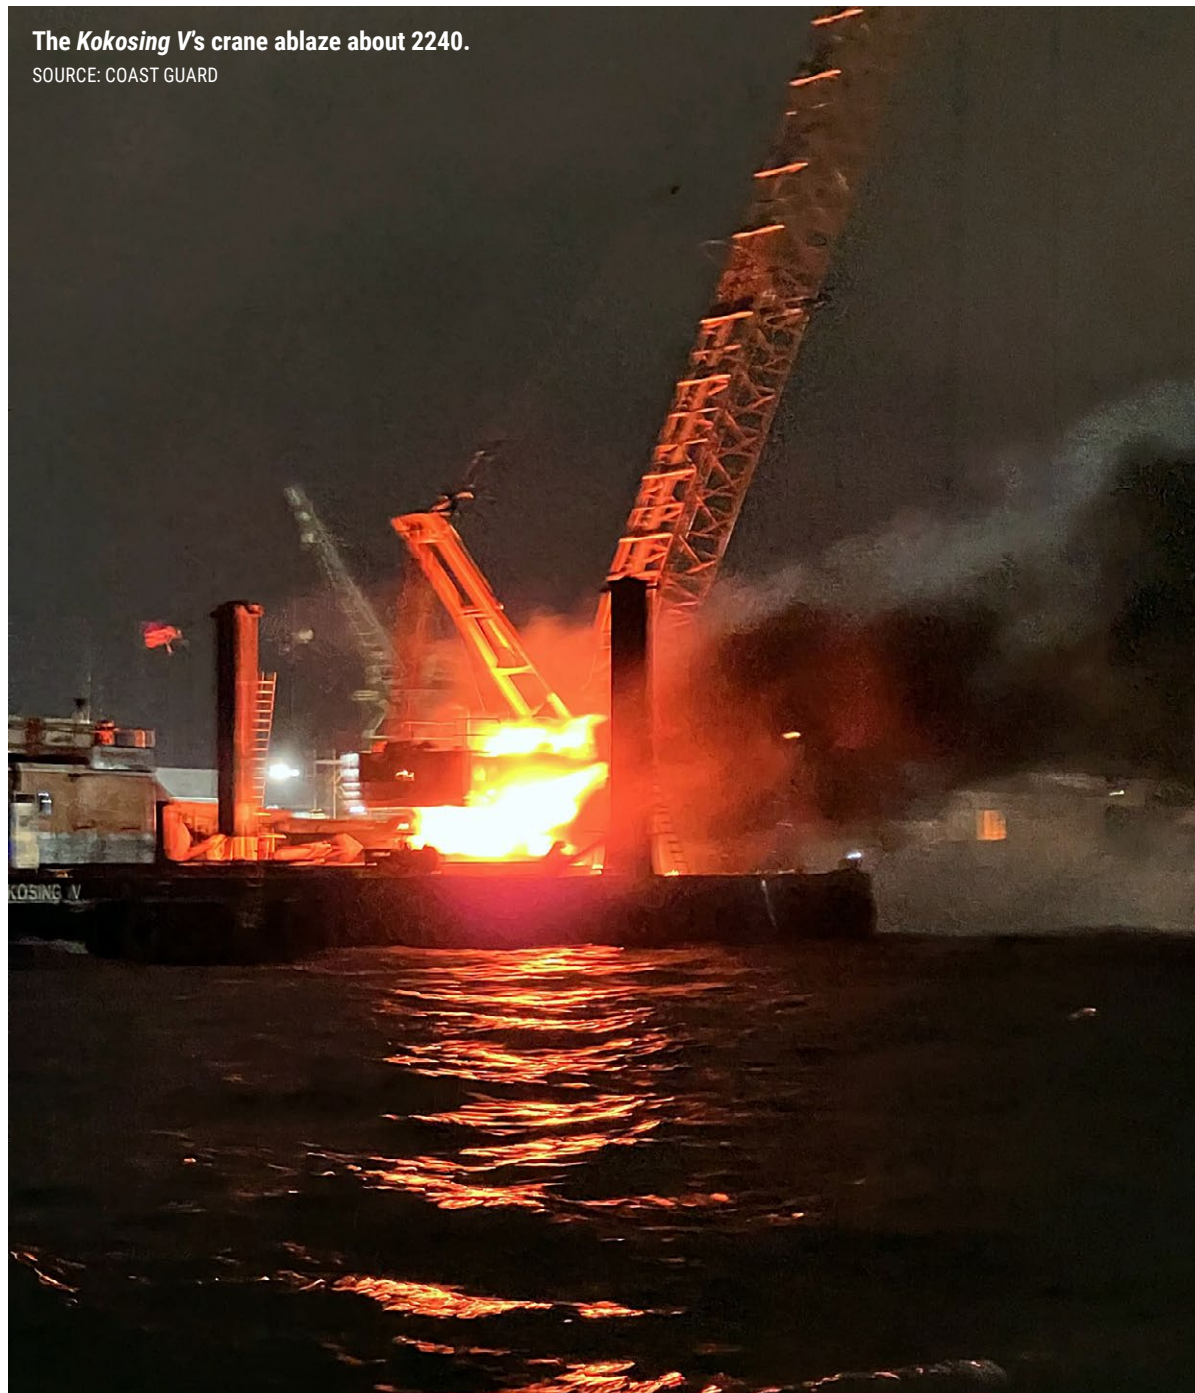
The damaged crane postfire. SOURCE: COAST GUARD

About 8,900 gallons of diesel fuel were on board the *Kokosing V*. The crane held another 85 gallons of diesel fuel and 50 gallons of hydraulic oil, which were all reported to be burned or lost overboard. Investigators could not rule out a hydraulic or fuel leak as a cause of the fire. However, the crane's battery compartment, located behind the driver compartment on the left side of the crane, was destroyed, and fire patterns indicated that the fire spread from the left side under the crane.

There were no signs of fire around the crane's engine. Further, fire marshals also documented electrical "beading and fusing," indicating arc damage on the electrical cables under the crane. Therefore, it is likely that the fire originated in the crane's battery compartment and was electrical in nature. Potential ignition sources within the battery compartment include loose electrical connections and chafed or damaged wiring. The extensive damage to the compartment precluded examination of components, and therefore the ignition source could not be determined.

THE PROBABLE CAUSE of the crane fire on board the spud barge *Kokosing V* was an undetermined electrical ignition source in the crane's battery compartment.

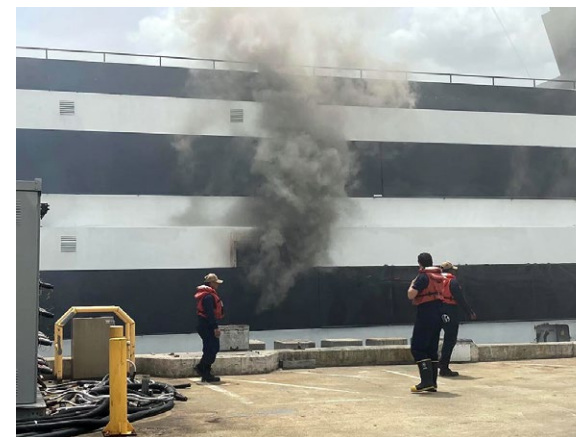
Smoke from the engine room starboard exhaust ventilation opening. SOURCE: COAST GUARD

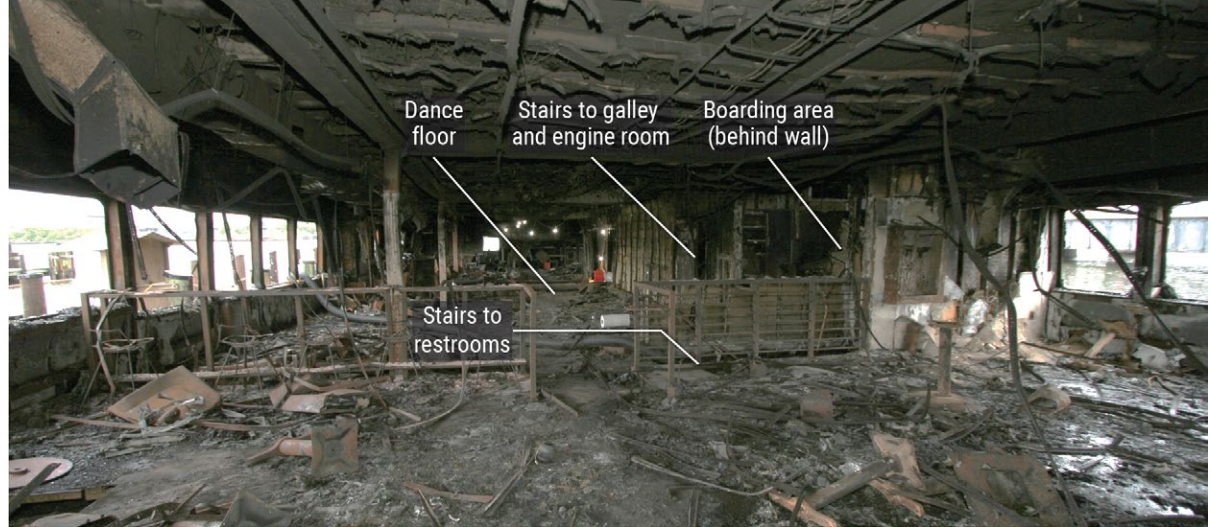
Main deck interior looking aft. SOURCE: NTSB

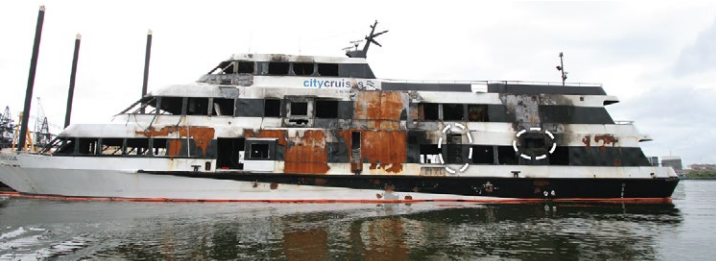
Exterior damage to the *Spirit of Norfolk* port side after the fire. The engine room ventilation openings are circled. SOURCE: NTSB
