NATIONAL TRANSPORTATION SAFETY BOARD 2023

SAFER SEAS Digest

Lessons Learned from
Marine Investigations

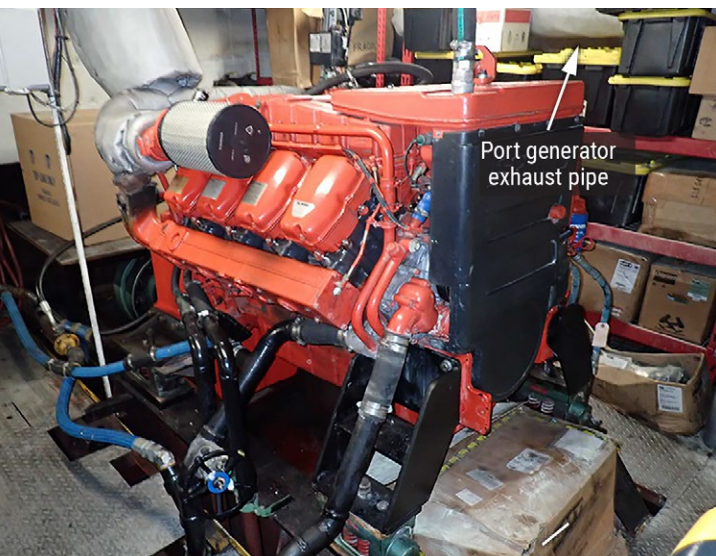
The crew found the engine room full of thick black smoke and flames and determined that the room would be unsafe to enter. Based on crewmember observations and a postcasualty damage assessment, the NTSB concluded that although a definitive ignition source of the fire could not be determined, the most likely cause of the fire was the ignition of combustible materials stored near the exhaust pipe of the operating port generator in the engine room.

Photo from survey on June 2, 2022, showing port main engine (foreground) and storage shelf. The white port generator exhaust pipe is visible behind some of the boxes on the shelves.

THE PROBABLE CAUSE of the fire on the *Spirit of Norfolk* was likely the ignition of combustible material stored near the exhaust piping from the operating port generator. Contributing to the severity of the fire was a lack of a fire detection system and a fixed fire extinguishing system in the engine room. Also contributing to the severity were ineffective communications between the unified command and firefighting teams that led to the fire attack team opening the engine room door, allowing the fire to spread.

As a result of our investigation, the NTSB issued new safety recommendations to the Coast Guard. We found that, because the *Spirit of Norfolk* was exempt from small passenger vessel requirements for engine room fire detection and fixed fire extinguishing systems, the fire was able to spread undetected. Additionally, had the vessel been equipped with an engine room fixed fire extinguishing system, the fire could have been extinguished. As a result, we **recommended** that the Coast Guard require that existing exempted Subchapter K small passenger vessels that were in operation as of March 10, 1996, be fitted with a fire detection system and a fixed gas fire extinguishing system in their engine rooms.

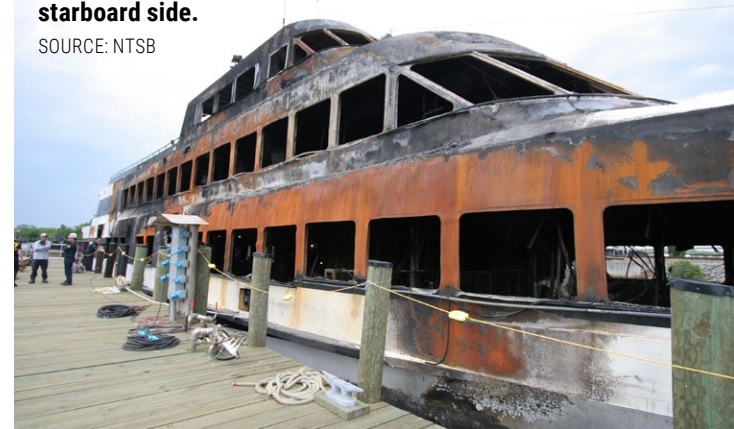
Exterior damage to the *Spirit of Norfolk*, starboard side.

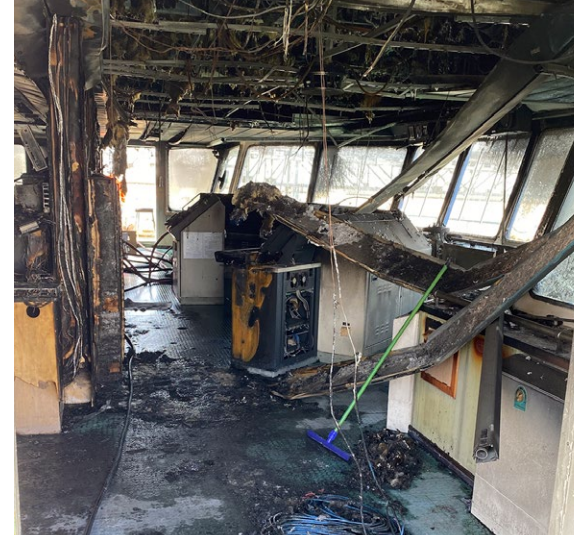
**The damage to the bridge.** SOURCE: COAST GUARD

Investigators from the Coast Guard and the ATF discovered extensive fire damage throughout the bridge. When investigators examined the area around the communications table on the bridge where the video showed the orange flash, smoke, and fire, they found the remains of a lithium-ion battery charger and a nickel-metal hydride battery charger.

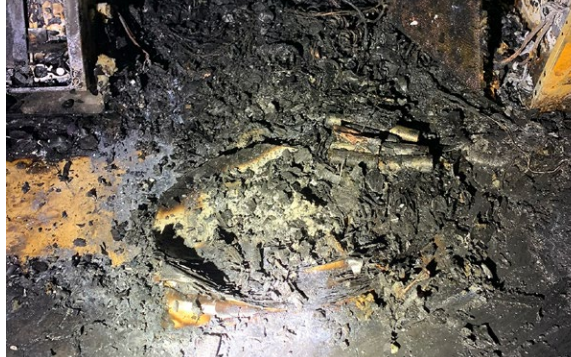
A closer examination found the remains of three batteries among the charger remains—one nickel-metal hydride battery (which contained six cells) and two lithium-ion batteries (each containing two cells). The single nickel-metal hydride battery (all six cells) was intact; one of the lithium-ion batteries (both cells) was found intact in the remains of the chargers. Investigators only found components of the second lithium-ion battery (a two-cell battery).

Remains of the lithium-ion and nickel-metal hydride battery chargers on the communications table.

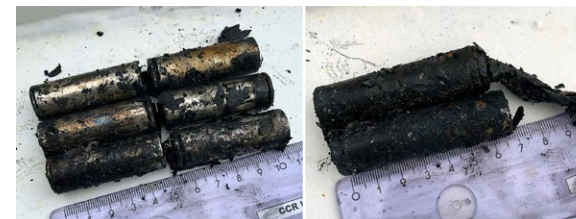
The ATF concluded that the fire was caused by one of the lithium-ion battery cells on the communications table exploding. Lithium-ion battery cell explosions are typically caused by a thermal runaway, as such, the initial orange flash and puff of smoke on the video feed was likely the result of one of the missing lithium-ion cells exploding due to a thermal runaway.

THE PROBABLE CAUSE of the fire on the bridge of the S-Trust was the thermal runaway of one of the cells in a lithium-ion battery for a UHF handheld radio.

Left to right: Remains of the nickel-metal hydride and the lithium-ion battery cells and components found on the communications table. SOURCE: ATF

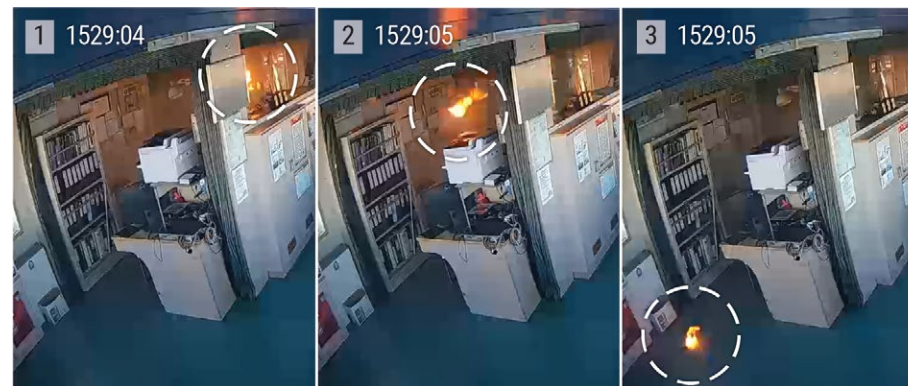
The heat produced from a thermal runaway of a lithium-ion battery cell can exceed 1,100° F, which can easily cause any nearby combustible material to ignite, including adjoining cells of the same battery. As the fire expanded, the closed-circuit video captured a second flash, followed by a flaming object being propelled from the fire and landing on the deck of the bridge, where it continued to burn. This was most likely the other missing lithium-ion cell from the same battery. Based on the video, investigators determined that the second missing lithium-ion cell also experienced a thermal runaway, most likely initiated from the heat of the fire started by the initial battery cell thermal runaway.

Left to right: The bridge closed-circuit camera footage showing (1) a second explosion, (2) an object on fire propelled into the air, and (3) the object, still on fire, landing on the floor (circled).

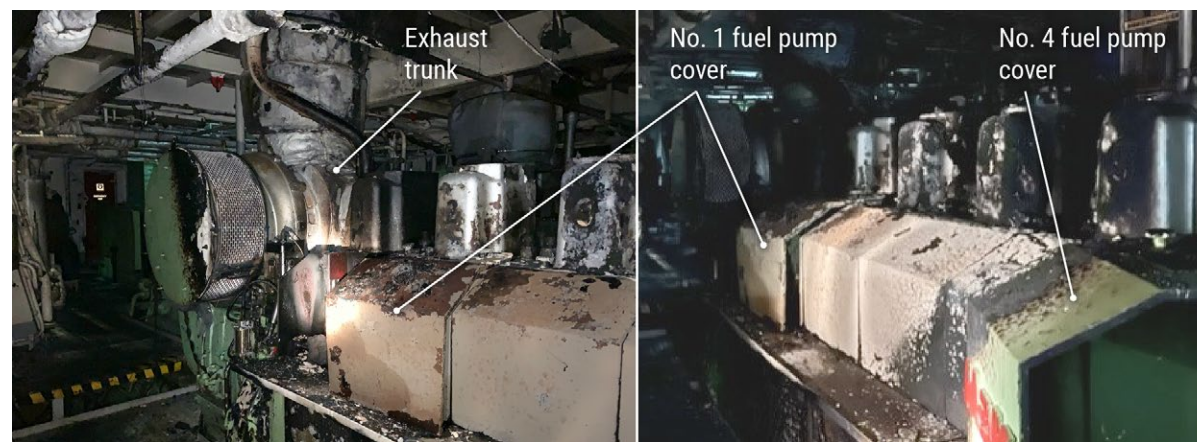
Based on the fire damage and the engineers' observations, oil spray from the banjo tube leak made contact with nearby hot surfaces on the starboard engine's exhaust manifold and ignited. To determine the cause of the banjo tube leak, investigators examined the no. 1 cylinder fuel injector pump and discovered a slight offset (misalignment) on the affected banjo tube assembly. The second engineer had replaced the no. 1 fuel injector pump earlier that day. Investigators found an offset on the banjo tube assembly, so it is likely that the engineer did not follow the manufacturer's reassembly procedure for the fuel injector pump, which required components to be tightened in a specific order to maintain alignment.

Left to right: Location of the turbo charger relative to the no. 1 fuel pump cover and location of fire on the starboard engine with fuel pump covers nos. 1 and 4 left partly opened. SOURCE: COAST GUARD

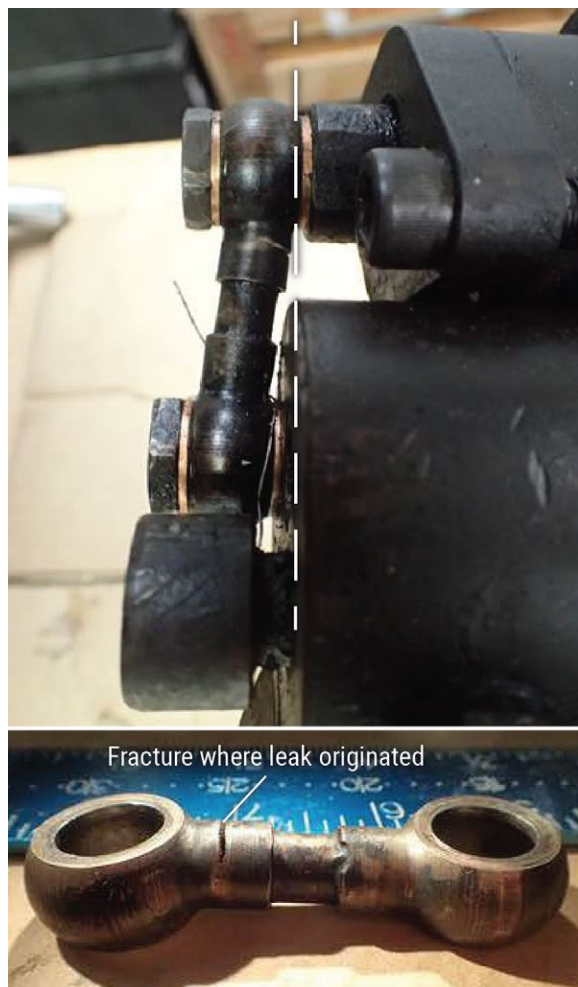
The banjo tube was sent for third-party metallurgical testing. The testing found that the banjo tube had bent to accommodate the offset; fractures on both ends of the tube where it connected to the sealing flange and lid were also found. Therefore, stresses associated with the offset likely caused the banjo tube to bend and fracture, causing the oil leak.

Banjo tube connected to the sealing flange and lid of no. 1 cylinder fuel injector pump assembly showing misalignment. Below: The fractured banjo tube.

After replacing the fuel oil pumps, the second engineer ran the starboard main diesel engine (under no load) to inspect for leaks and found no signs of leaks or other issues from the fuel oil pumps or associated piping. This is likely because the banjo bolts' sealing surfaces provided a sufficient seal during the short, no-load testing. But when the main engine was fully loaded with a full-ahead order, the expanding stresses (due to heat) caused the banjo tube to fracture. Therefore, although the second engineer properly tested the repair, the misalignment that led to the banjo tube failure only manifested once the engine was given a high load.

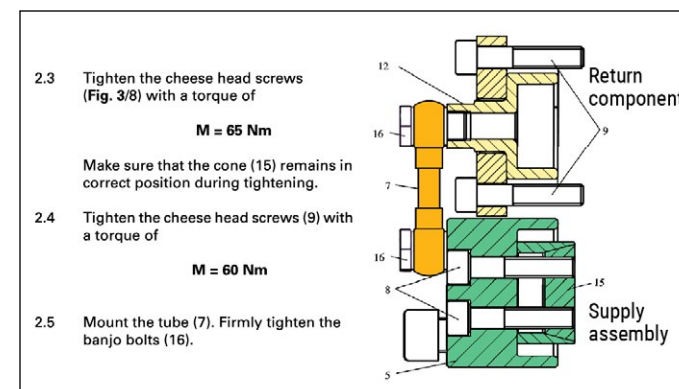
THE PROBABLE CAUSE of the engine room fire aboard the chemical tank ship *Endo Breeze* was a main engine fuel injector pump replacement that was not conducted in accordance with manufacturer procedures, which resulted in a high-pressure fuel spray that ignited off the engine exhaust components.

No. 1 fuel oil injector pump reassembly procedure and diagram of piping components. The banjo tube (orange) connects the fuel pump supply line assembly (green) to the return component (yellow).

The engine room fire in this casualty illustrates what can happen when equipment manufacturers' recommended maintenance procedures are not followed. In this case, not following the tightening sequence described in the diesel engine manufacturer's manual led to the misalignment and failure of a high-pressure fuel connection on an engine's fuel injector pump's assembly. Due to the high risk of fire associated with pressurized fuel, when working with diesel engine components, it's critical to carefully follow manufacturer assembly procedures and review manufacturer manuals and guidance on a regular basis to ensure familiarity with correct maintenance procedures.

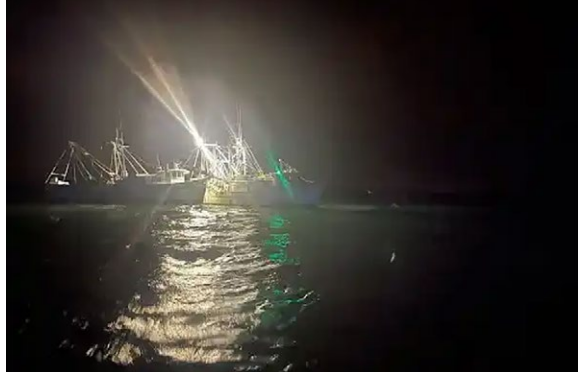
The captain and his friend connected the tow line to the aft boom on the *Carol Jean* and then passed the other end through the *Having Faith's* anchor chute (chain pipe), into an open hatch, and tied it around two fuel tanks located within the forward compartment. The captain did not use chafing gear to protect the tow line during the casualty voyage, likely causing the line to chafe against a structure, such as the edge of the hatch entrance through which the tow line passed, causing it to fray and eventually part when the vessel was about 11.5 miles east of Tybee Island. Had the captain adequately planned the tow—by using chafing gear and ensuring the tow line was in good condition and of adequate strength to tow the *Having Faith*—the risk of a tow line failure would have been reduced.

The *Carol Jean* at anchor with the *Having Faith* secured by tow line about 2245 on March 16.

As the captain attempted to reestablish the tow on March 16, the tow line fouled the propeller of the *Carol Jean*. Unable to operate the vessel, the captain let go the *Carol Jean*'s anchor in about 17 feet of water and secured the *Having Faith* alongside. The following day, the weather deteriorated, the *Having Faith* broke free, and the Coast Guard evacuated the captain and his friend. On March 18, the *Having Faith* was found aground on a jetty (and broke apart the next day).

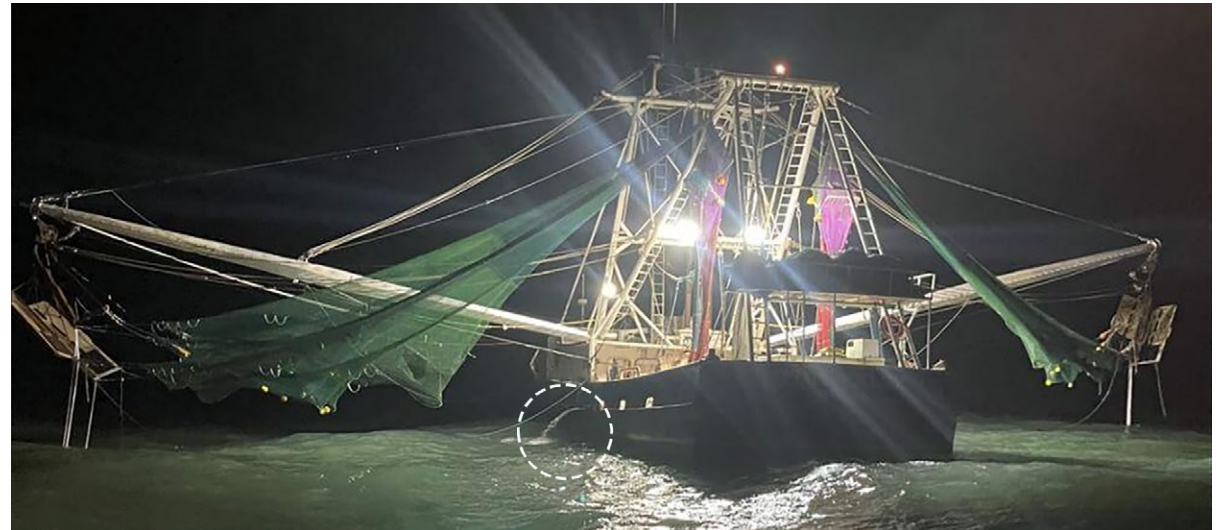
The *Captain Alex* with discharge stream from bilge system (circled) at 0317, just after CG 45630 arrived on scene.

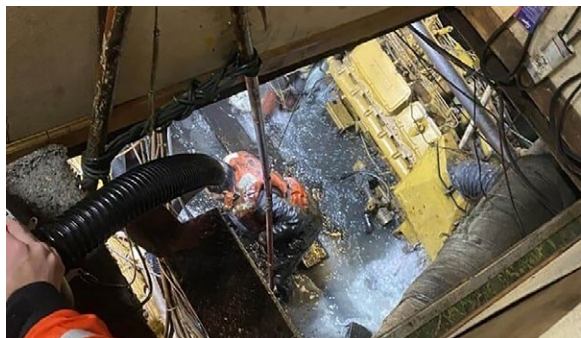
discharge overboard. Two Coast Guard crewmembers went aboard the *Captain Alex* to assist and noted that the fishing vessel crew did not prime the pump. When the Coast Guard machinery technician tried to prime the pump, the priming handle broke. Since the pump was not recovered, investigators were unable to determine why the handle broke. The coxswain ordered his crew to pack up the pump and recommended that the crew of the *Captain Alex* evacuate the vessel.

Looking down into the engine room of the *Captain Alex* at 0326, with the water midway up the starboard main engine and the captain of the vessel on the stairs. The suction hose to the portable dewatering pump (on deck) is on the left. SOURCE: COAST GUARD

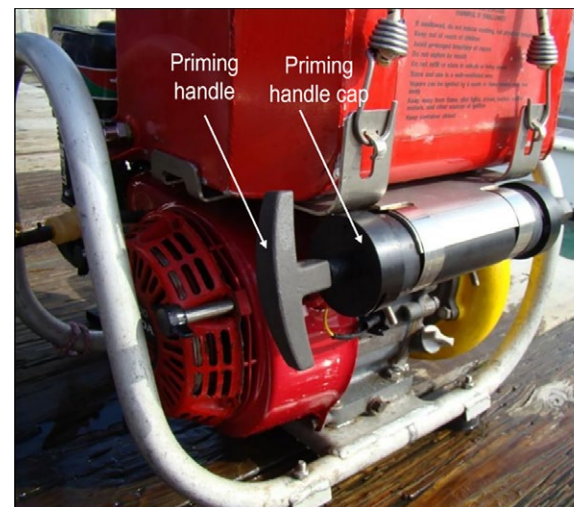
A P6 pump like the one sent to the *Captain Alex* showing the priming handle and cap. SOURCE: COAST GUARD

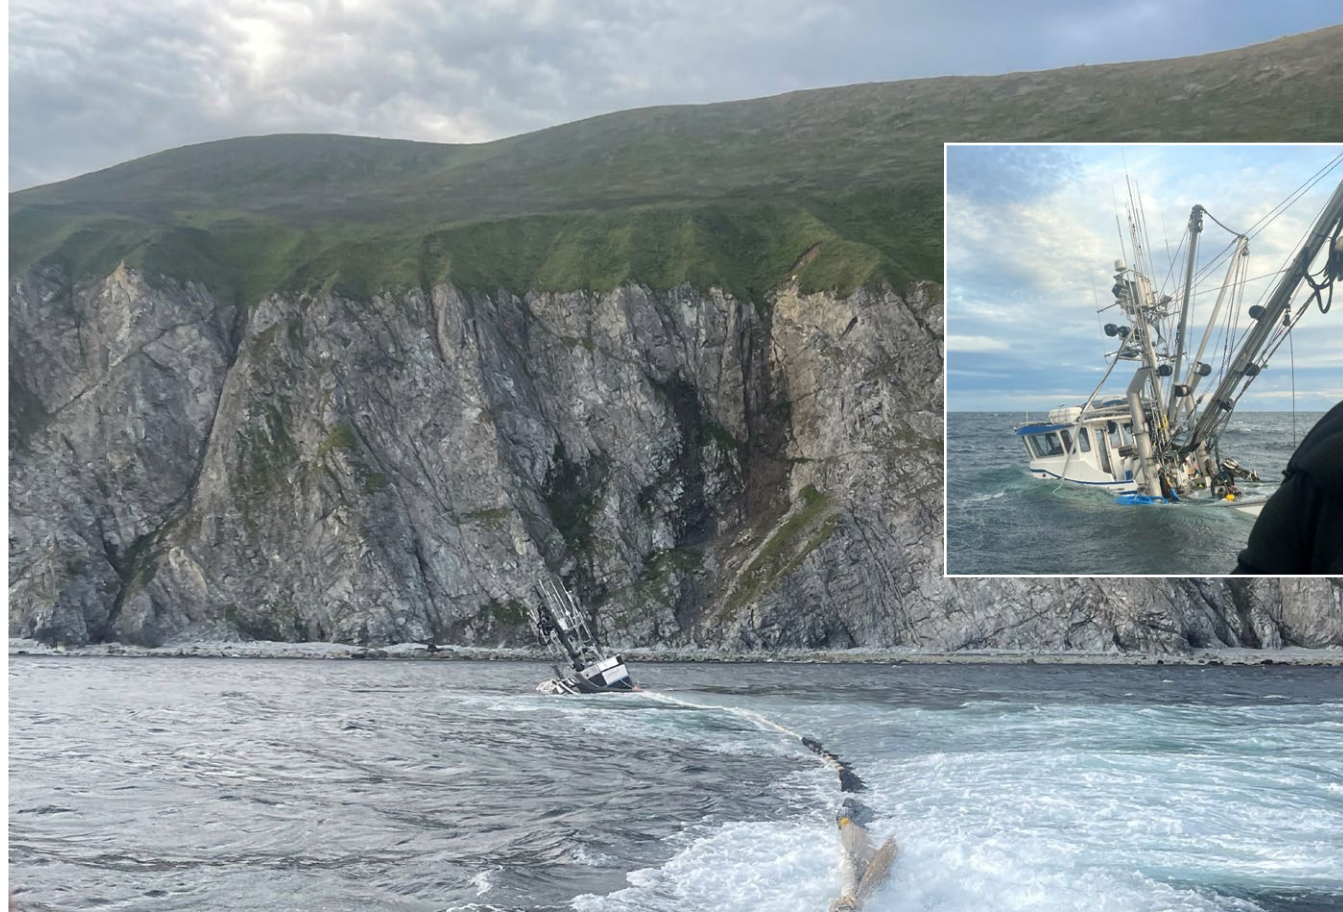
The *Challenger's* sein net as crewmembers in the vessel's skiff removed it from the stricken vessel. Inset: The partly sunken *Challenger*. SOURCE: ALWARD FISHERIES

On August 7, 2022, about 0700 local time, while transiting along the northwestern shore of Kodiak Island, Alaska, the fishing vessel *Challenger* struck a submerged rock and began taking on water. The captain and three crewmembers used onboard pumps to remove the floodwater, but the pumps were unable to keep up, and the crew abandoned the vessel. A nearby Good Samaritan fishing vessel rescued them. The *Challenger* eventually capsized. There were no injuries, and no pollution was reported. Damage to the vessel was estimated at \$600,000.

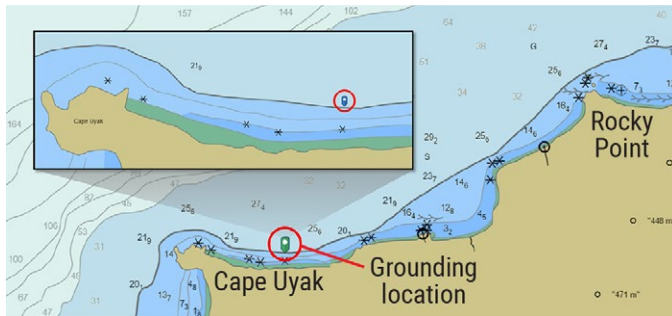
THE PROBABLE CAUSE of the grounding of the fishing vessel *Challenger* was the captain’s decision to navigate close to shore in an area known to him to have an uncharted rock. Contributing to the capsizing of the vessel was the lack of a watertight collision bulkhead and subdivision or compartmentalization below the main deck, which allowed for progressive flooding.

NOAA ENC for the area of the grounding. Annotations (circled markers) show the location of the uncharted rock as reported to investigators.

In addition to marking hazards on their own charts and charting software, mariners can report issues (errors or omissions) with the NOAA’s nautical charts and/or *Coast Pilot* through the Office of Coast Survey’s ASSIST tool at: <https://www.nauticalcharts.noaa.gov/customer-service/assist/>

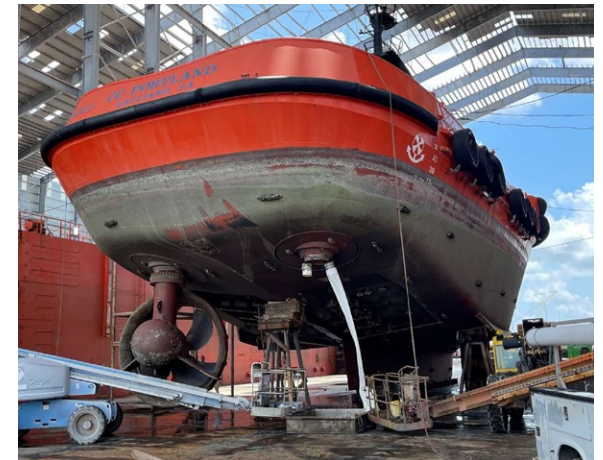
CC Portland in drydock showing the missing starboard Z-drive unit. SOURCE: COAST GUARD

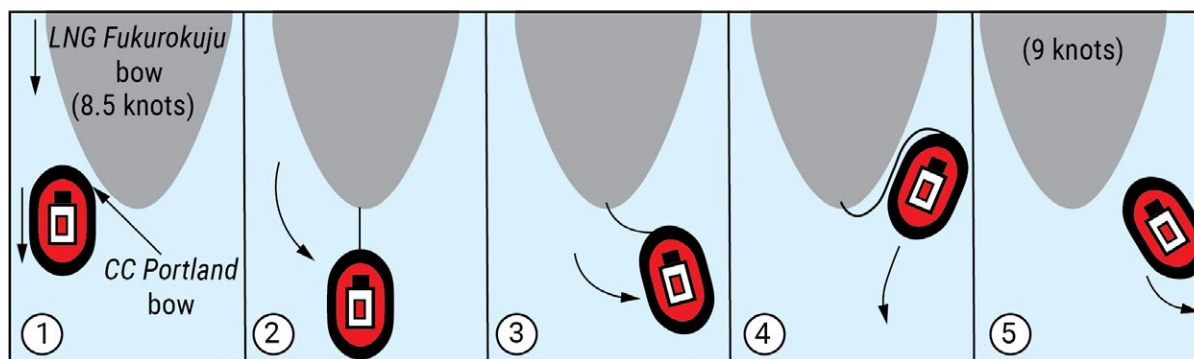
THE PROBABLE CAUSE of the grounding of the *CC Portland* was the mate's attempt to make up bow to bow with a liquefied natural gas carrier while the tugboat and liquefied natural gas carrier transited at a speed that was excessive for the advanced harbor-assist maneuver. Contributing to the casualty was the lack of a company policy regarding maximum allowable speed for bow assist maneuvers.

Sequence of events in the *CC Portland* grounding (scale approximate). (1) The *CC Portland* took a position underneath the starboard bow of *LNG Fukurokuju* (while moving astern with the ship) as the heaving line was lowered and the tow line was passed up. (2) As the tow line was pulled in by the crew on the *LNG Fukurokuju*, the *CC Portland* accelerated to reposition the tug ahead of the *LNG Fukurokuju* along the centerline. (3) While attempting to maneuver to the centerline, the *CC Portland* moved out of position to the port side of the *LNG Fukurokuju*. (4) As the mate attempted to correct the *CC Portland*'s position to the centerline of the LNG carrier, the tug lost speed and stabilized along the port bow of the *LNG Fukurokuju*. The position of the tug pulled the tow line to the stern and into the water as the heaving line parted. (5) As the *CC Portland* accelerated astern to regain position, the tug lost speed and directional control as it continued moving to starboard before leaving the channel and running aground. SOURCE: NTSB

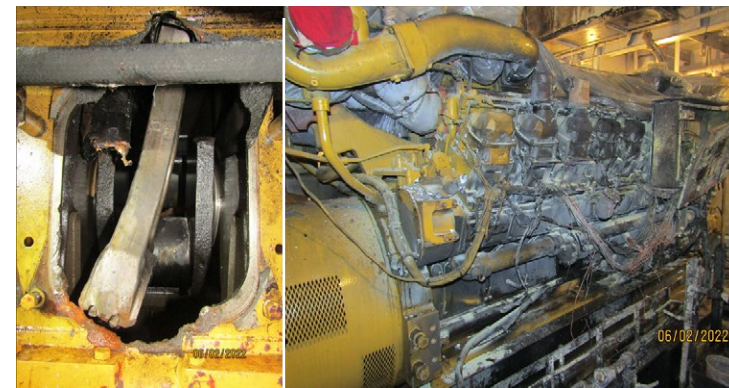
THE PROBABLE CAUSE of the mechanical failure of the no. 3 main engine and resulting fire aboard the offshore supply vessel *Ocean Guardian* was the replacement of a crankshaft main bearing with an incorrectly sized bearing during an engine overhaul due to the engine service technicians not identifying the removed bearing's part number, which resulted in the loss of lube oil pressure in adjacent connecting rod bearings.

Left to right: Damage to crankcase and connecting rod of no. 3 main engine and the engine. SOURCE: NTSB

When maintenance is performed, correct replacement of machinery components is critical to ensuring safe and reliable vessel operation. Vessel crews and equipment manufacturer technicians should carefully identify and document part numbers of all components removed from shipboard equipment. Tracking systems are an effective form of recordkeeping that can be used to ensure proper replacement part selection for reinstallation.

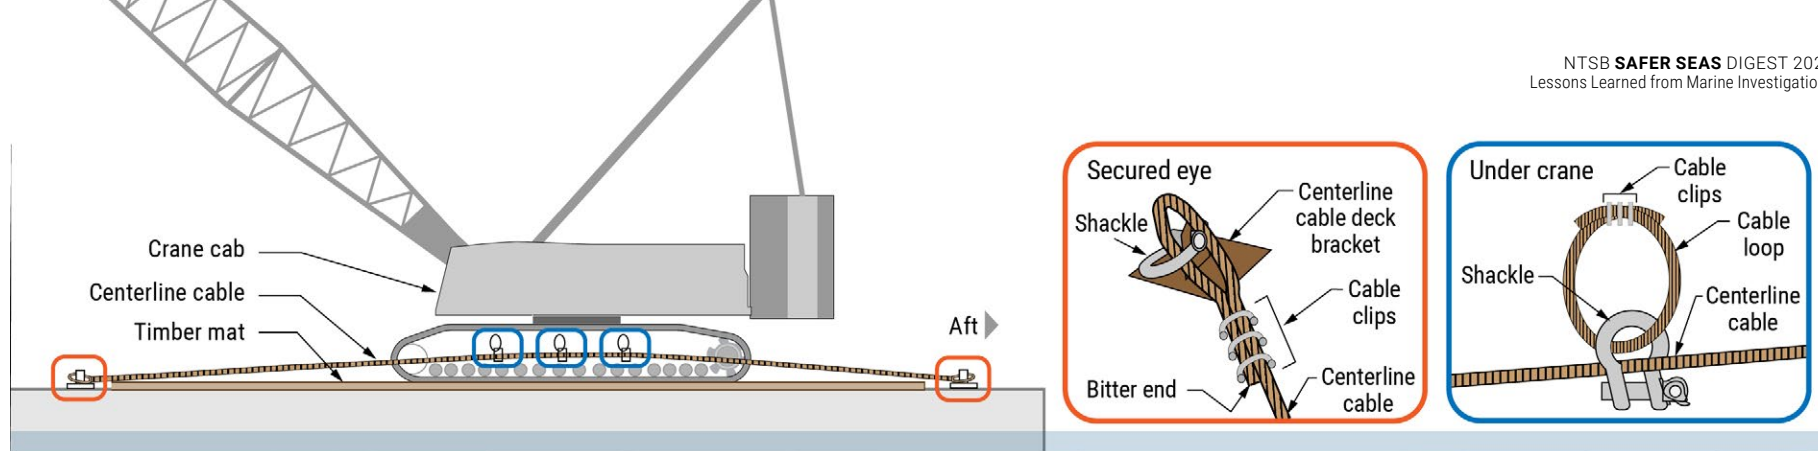
Depiction of centerline cable system, including details of the cable loops securing the centerline cable to the underside of the crane and the two eyes, each secured to the barge's deck bracket (scale approximate). SOURCE: NTSB

The cable disconnected due to the tension exerted on it as the crane moved aft, causing the bitter end of the cable to slip through the cable clips that closed the loop. A centerline cable system of sufficient strength, as was required by OSHA regulations, would have prevented the crane from being driven off the barge.

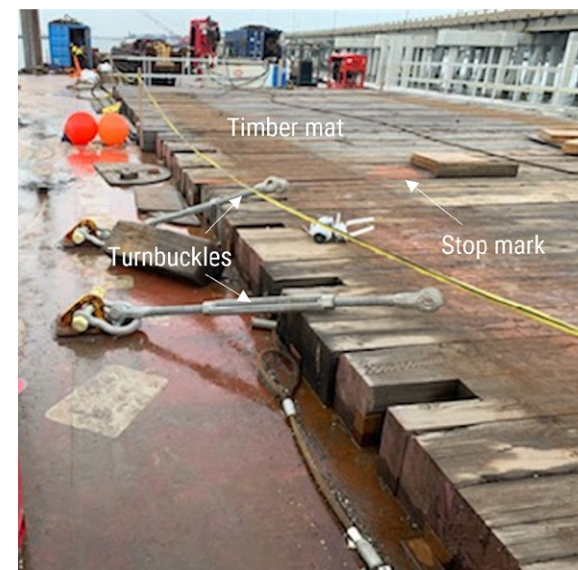
Location of turnbuckles near timber mat and stop mark painted orange on the mat.

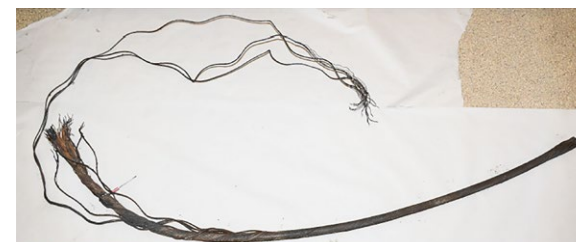
Samples of crane no. 1's hoisting wire rope were examined to determine what caused the wire rope to fail. The examination found significant external corrosion, as well as roughness and pitting, and "uniform corrosion of internal surfaces" of the hoisting wire rope. This corrosion and wear caused some of the individual wires comprising the strands of the hoisting wire rope to part (fail) when crane no. 1 lifted the nacelle unit, subsequently causing the strand and then the remaining wire strands to become overloaded and fail.

THE PROBABLE CAUSE of the failure of the hoisting wire on the cargo ship *Thorco Basilisk*'s crane was undetected corrosion and wear in strand wires.

Thorco Basilisk parted hoisting wire rope (crane side of fracture). SOURCE: ENGINEERING SYSTEMS INC

Saltwater and humid ocean air cause corrosion of metals, presenting challenges for the maintenance of high-strength steel wire ropes on vessels. A deteriorated wire rope directly affects a crane's ability to safely and reliably handle loads up to the crane's rated capacity (safe working load). Therefore, diligent inspection, maintenance, and management of wire ropes are essential. Working wires should be changed at recommended intervals, or more frequently, depending on operating conditions and use.

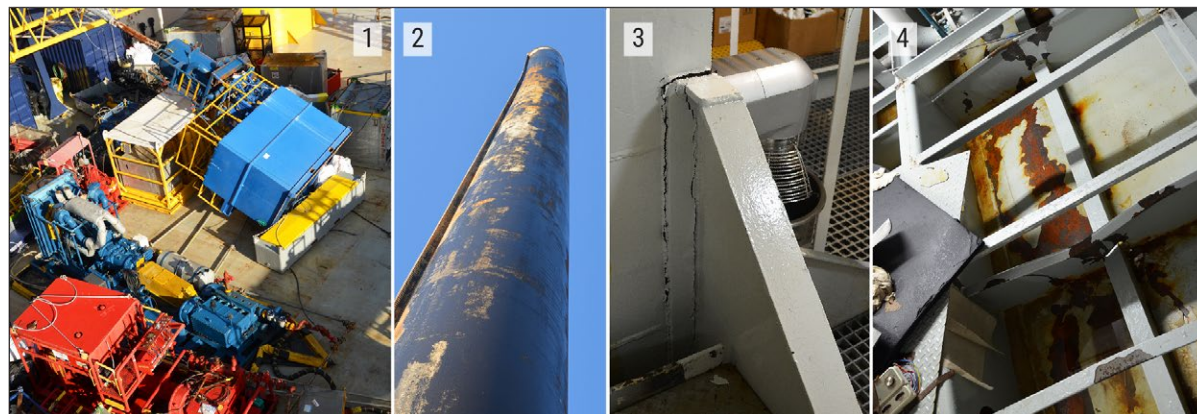
THE PROBABLE CAUSE of the tilting of the elevated liftboat *L/B Robert* was gale-force winds combined with waves that exceeded the vessel's air gap, causing vessel movement, which led to a leg sliding into an adjacent can hole in the seafloor.

Left to right: Damage sustained during the *L/B Robert* casualty, including (1) shifted deck cargo, (2) leg deflections, (3) starboard Z-drive room damage, and (4) port Z-drive room damage. BACKGROUND SOURCE: SEACOR MARINE

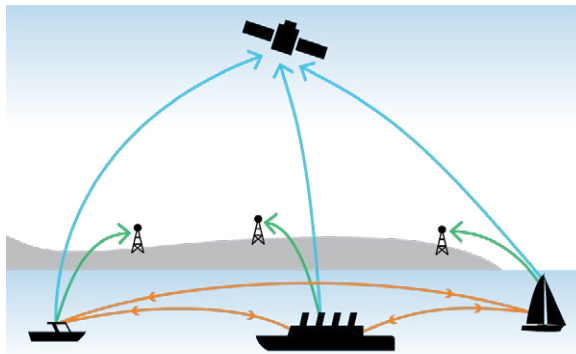
Safety Alert 087 is a result of our investigation and report on the collision between Coast Guard Cutter *Winslow Griesser* and center-console boat *Desakata*, in which one person died. In this casualty investigation, we noted that small vessels constructed of wood or fiberglass are difficult to detect by radar. Even if producing a radar return, small vessels can be obscured by the trough of passing swells and make for intermittent radar targets. Early detection of a vessel is one of the best ways to avoid collision.

AIS provides digital positional awareness, ship to ship, ship to shore, and ship to satellite. SOURCE: NTSB

Owners of recreational boats and small commercial fishing vessels can use devices such as radar reflectors and AIS Class B or B+ to improve their vessels' detectability by enhancing nearby traffic's awareness of their position.

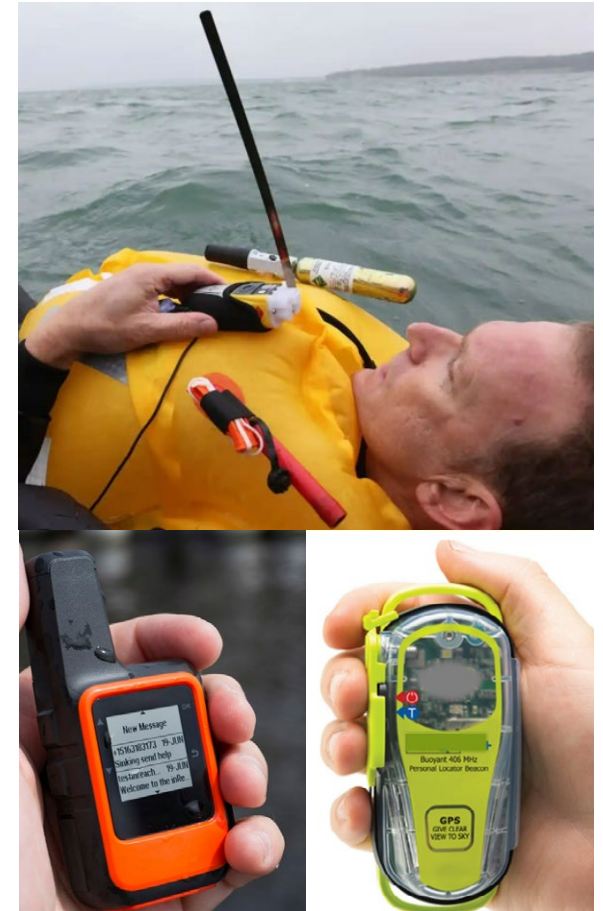
Safety Alert 089 is a result of our investigations of casualties in which crewmembers had to abandon a vessel without a means to communicate their individual locations to search and rescue assets. We found that currently available PLBs provide a location accuracy of about 300 feet and nearly instant search and rescue notification when activated.

Clockwise from top: PLB attached to lifejacket, exemplar PLB, and SEND. SOURCES: VAREN, POWERANDMOTORYACHT.COM, AND BLUEWATERSAILING.COM

Vessel owners and operators can enhance the safety of their crews by providing each crewmember with personal locator devices, such as PLBs or SENDs, to supplement EPIRBs.
