Report on the investigation of
the collision between the fishing vessel **Kirkella (H7)**
and harbour tug **Shovette**
resulting in pollution at King George Dock, Hull, England
on 24 June 2022

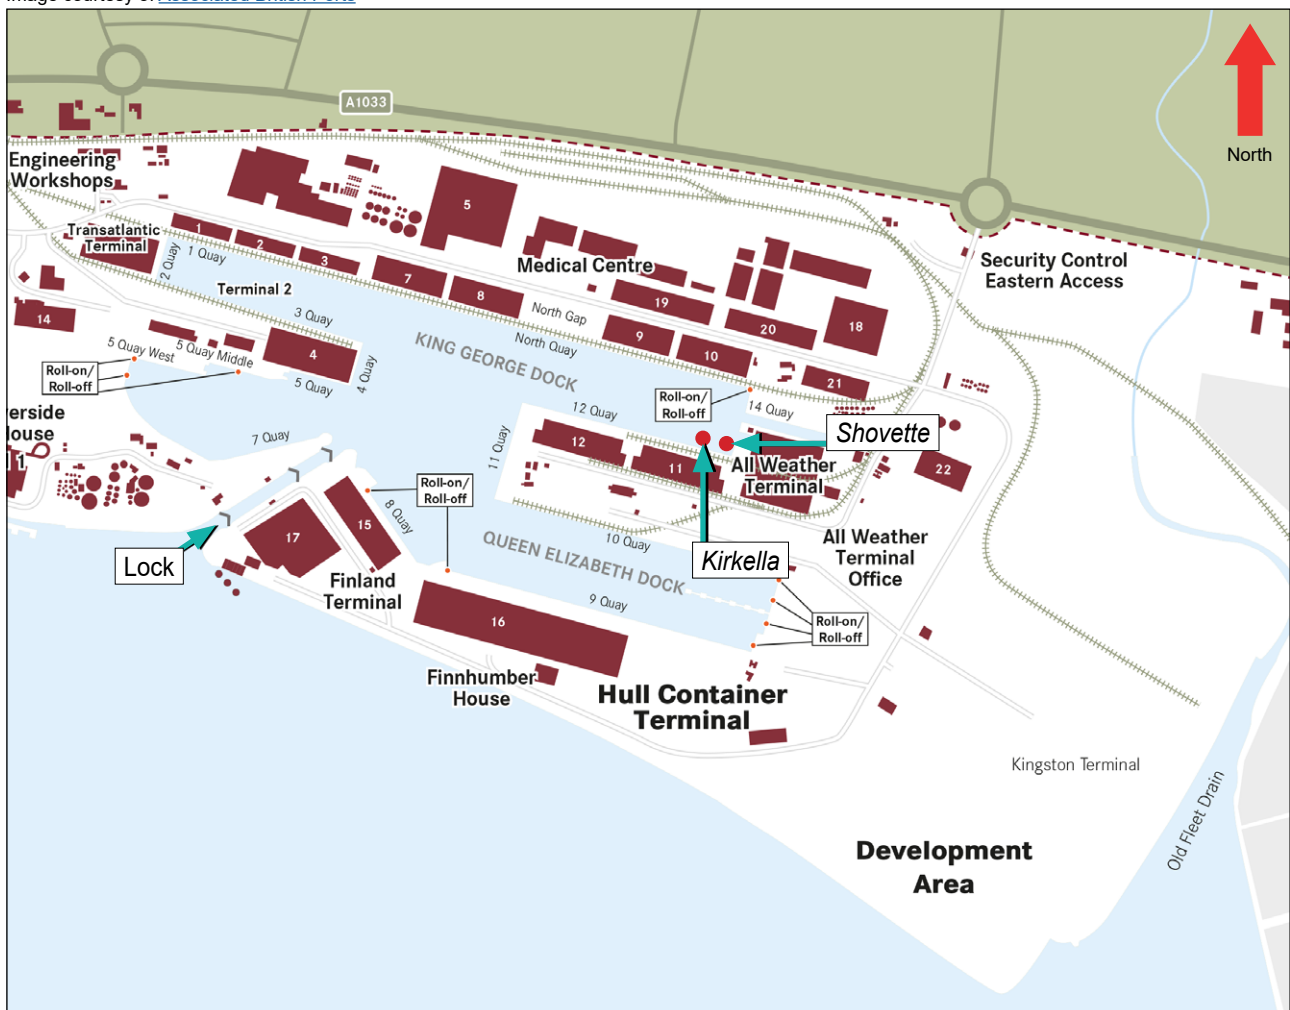
Figure 1: King George Dock

At 0531, *Kirkella*'s master manoeuvred the vessel from the lock towards the berth using the starboard helm station. The master then berthed the vessel starboard side alongside 12 Quay and adjacent to shed 11 (**Figure 1**).

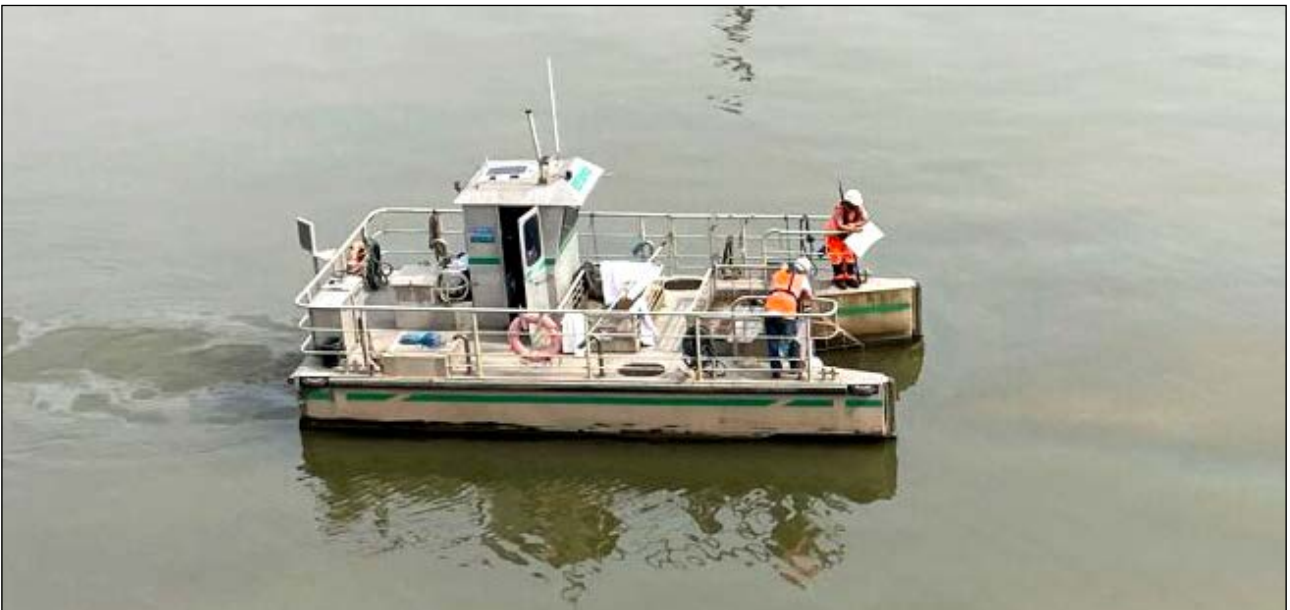
Figure 8: Oil recovery boat in operation

The dockmaster telephoned the port's oil spill response contractor whose team, once on site, deployed containment booms and absorbent materials to limit the extent of the pollution (**Figure 7**). The contractor used a variety of methods, including an oil recovery boat (**Figure 8**), to remove most of the oil within 3 weeks; the clean-up operation was completed after a further 8 weeks. The pollution response operation cost around £250,000, with unknown additional costs incurred for loss of business continuity and port personnel involvement.
