Bundesstelle für Seeunfalluntersuchung
Federal Bureau of Maritime Casualty Investigation

Summary Investigation Report 421/22

Grounding of the tanker STEN ARNOLD in the fairway of the River Elbe on 21 August 2022

31 July 2024

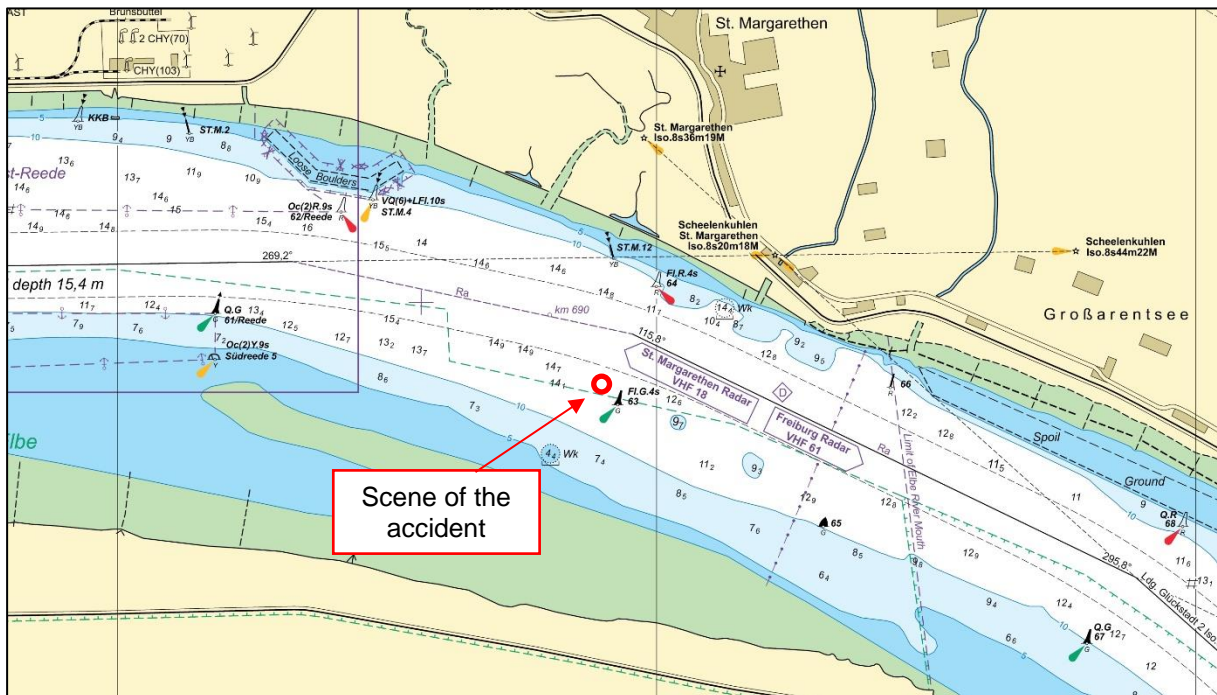
Type of marine casualty:	Less serious marine casualty, grounding in the fairway of the River Elbe
Date, time:	21 August 2022, 1504 ²
Location:	River Elbe, north-west of fairway buoy 63, Elbe-kilometre 689.7
Latitude/Longitude:	$\phi = 53^{\circ}52.447'N$, $\lambda = 009^{\circ}14.661'E$
Ship operation and voyage segment:	Fairway mode
Consequences:	Paint abrasion, no structural damage

Figure 2: Extract from Navigational Chart DE46³, showing the scene of the accident

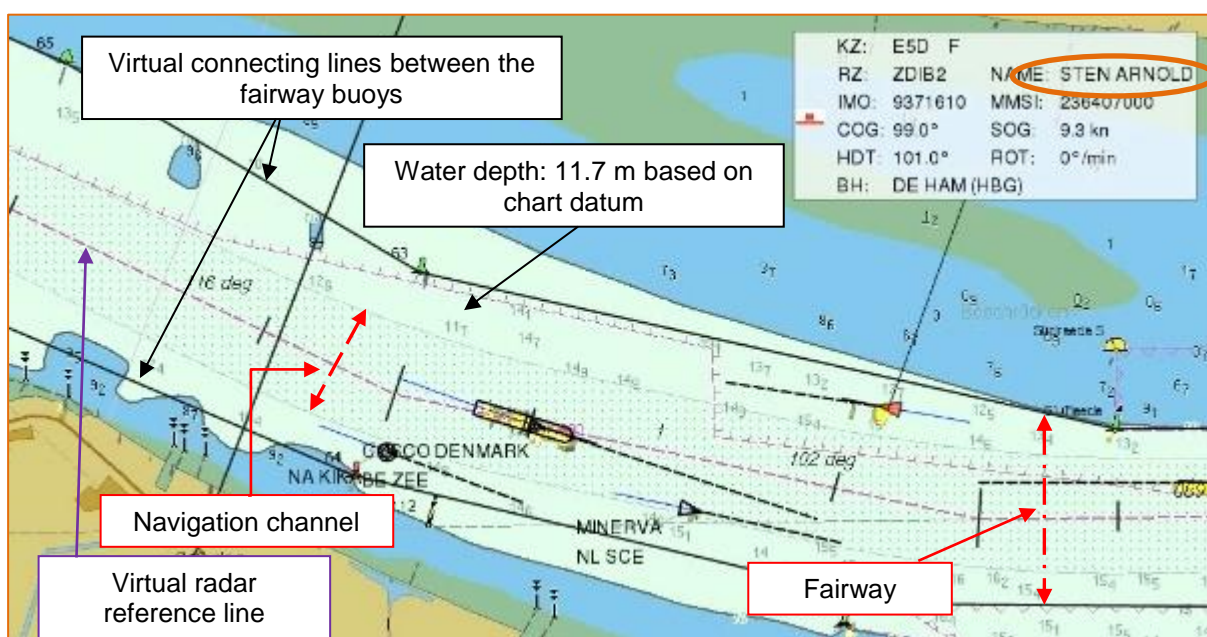
At 1504, the ship suddenly lost speed and came to a standstill (see Figure 3). Shortly afterwards, the ship's command and the pilot realised that the ship had grounded on an unknown shoal in the fairway. The ship was listing 2-3° to port. The lateral distance to the virtual connecting line between the fairway buoys (green buoy line) was about 120 m.

Figure 4: Explanatory notes to Figure 3⁶
