MARINE TRANSPORTATION SAFETY INVESTIGATION REPORT M21P0297

LOSS OF CONTAINERS OVERBOARD AND SUBSEQUENT FIRE

Container vessel *ZIM Kingston*
La Perouse Bank, British Columbia
21 October 2021

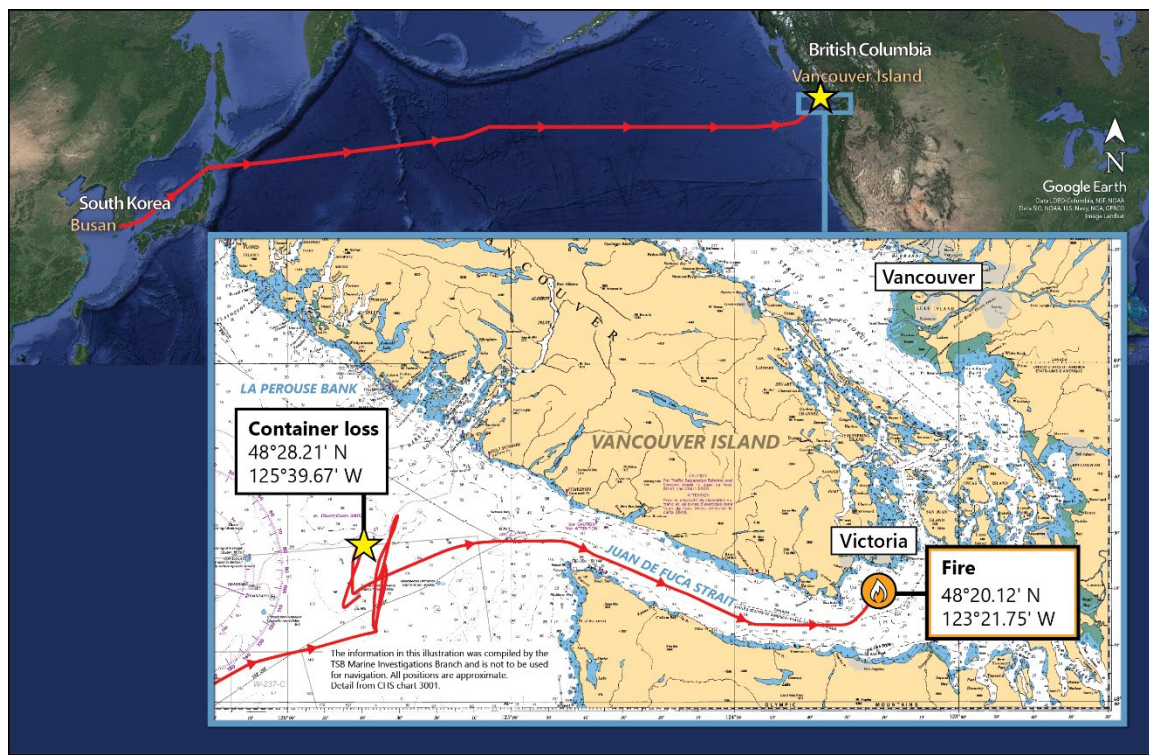
At 1800, the vessel began drifting northward for the 3rd time with the bow oriented southwesterly into the waves. The master was still on the bridge but was resting, and the third officer was the officer of the watch. At around 2229, the winds were southeasterly at 42 knots and the waves were 5 to 6 m from the southwest. The bow was oriented west-southwesterly into the waves, and the vessel was drifting northward at 2.2 knots. At this time, the vessel experienced heavy rolling and pitching that lasted for about 1.5 minutes. The vessel rolled heavily to both port and starboard approximately 4 times, with the maximum roll being 36°. The vessel was in position 48°28.21' N, 125°39.67' W at the time of the heavy rolling (Figure 2) and the crew noted that some containers had been lost.

Figure 2. Satellite image and chart showing the *ZIM Kingston's* position at the time of the heavy rolling and container loss (Source of main image: Google Earth, with TSB annotations. Source of inset image: Canadian Hydrographic Service Chart 3001, with TSB annotations)

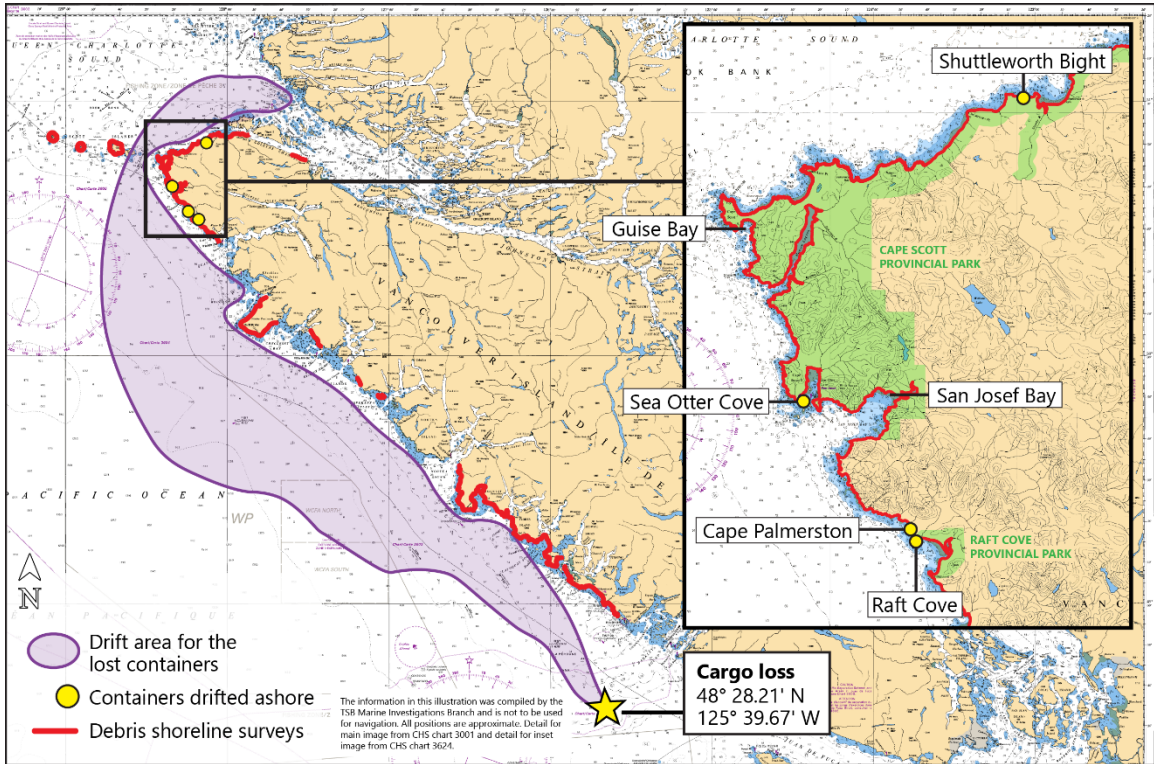
TC, the CCG, and the U.S. Coast Guard used various resources to track the containers that remained afloat. Overhead flights were carried out when the weather permitted, and tracking buoys were deployed to mark the location and potential drifting patterns of the floating containers. On 27 October, overflights identified 4 containers that had gone aground on the beaches of Cape Scott Provincial Park and Raft Cove Provincial Park on northern Vancouver Island (figures 4, 5, 6, and 7).

Figure 4. Charts showing the potential area in which the lost containers drifted, the location of the 4 containers that went aground, and the shoreline that was surveyed as part of debris surveys (Main and inset image source: Canadian Hydrographic Service, with TSB annotations)

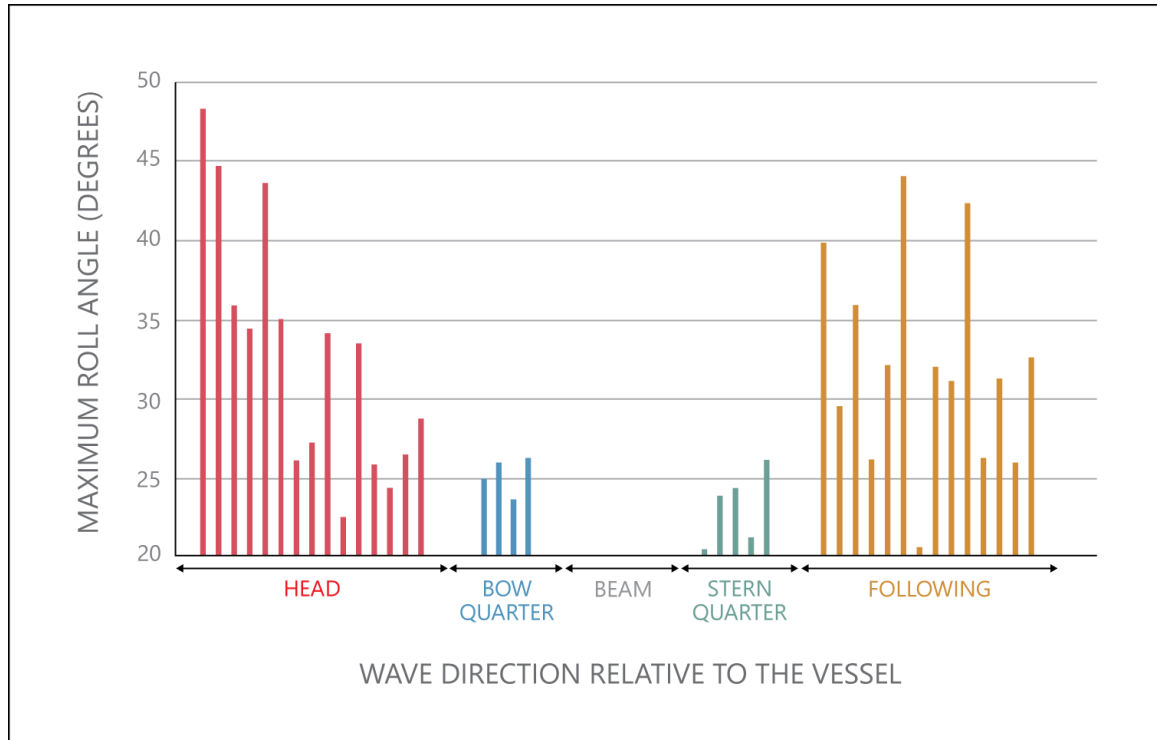
Out of the 114 successful tests, 38 (37%) resulted in the model developing roll motions greater than 20°. The maximum roll motions recorded were 48°. In all of the operational modes, the largest roll motions were observed when the model was in head and following sea conditions (Figure 17). No significant roll motions were observed in beam sea conditions.

Figure 17. Test results showing roll angles greater than 20° in relation to the wave direction relative to the vessel (Source: TSB, from National Research Council of Canada data)

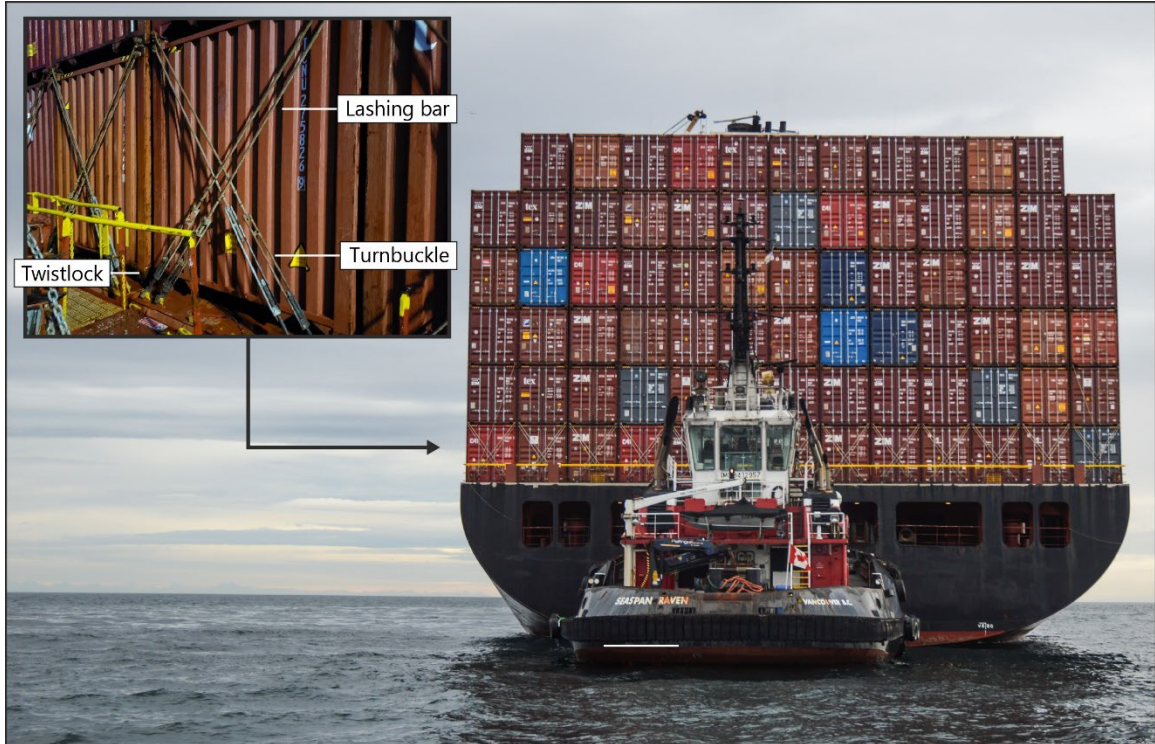
On the *ZIM Kingston*, similar to most container vessels, the 40-foot containers were secured on deck using components that included lashing bars, turnbuckles, twistlocks, and deck-mounted foundations (Figure 23). Twenty-foot containers were secured using similar components, as well as midlocks that secured the 20-foot containers end-to-end. The foundations were fixed to the deck or deck hatch covers and served as blocks on which the container stacks rested. The lashing bars were used in combination with turnbuckles and twistlocks to secure the containers on the lower 2 to 3 tiers.⁶⁴ The containers in higher tiers were secured one on top of the other using twistlocks. Containers beside each other were

Figure 23. Lashing components used to secure containers on the *ZIM Kingston* (foundations not shown) (Source for main and inset images: TSB)

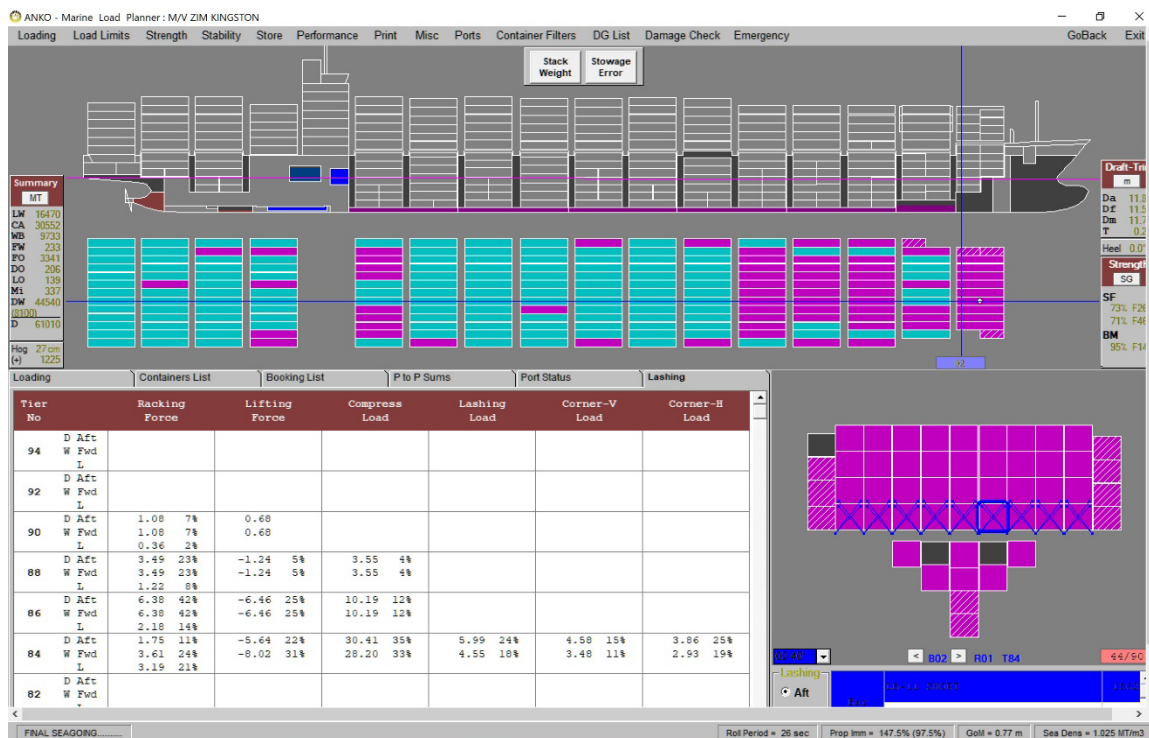
The vessel's load planning software provided a graphical display of the vessel's loading plan with interactive capabilities on the bays and tiers. It allowed crew members to verify that the loading plan met the class-approved parameters for stability, stress on the hull, stowage, and segregation of dangerous goods. The software could also calculate the lashing forces that would be exerted on the containers if the vessel encountered its nominal roll angle. For the occurrence voyage, the nominal roll angle was 19.91°. The software could then compare these lashing forces against the safe working load of the container securing components and identify any containers calculated to exceed the safe working load of one or more of their securing components at the nominal roll angle. These containers were then flagged as having excessive lashing forces as shown in Figure 24.

Figure 24. Screenshot of the *ZIM Kingston* load planning software showing containers with excessive lashing forces for the nominal roll angle (indicated in aquamarine) (Source: TSB)
