September 23, 2024

MIR-24-30

Contact of *Cindy B* Tow with Dock

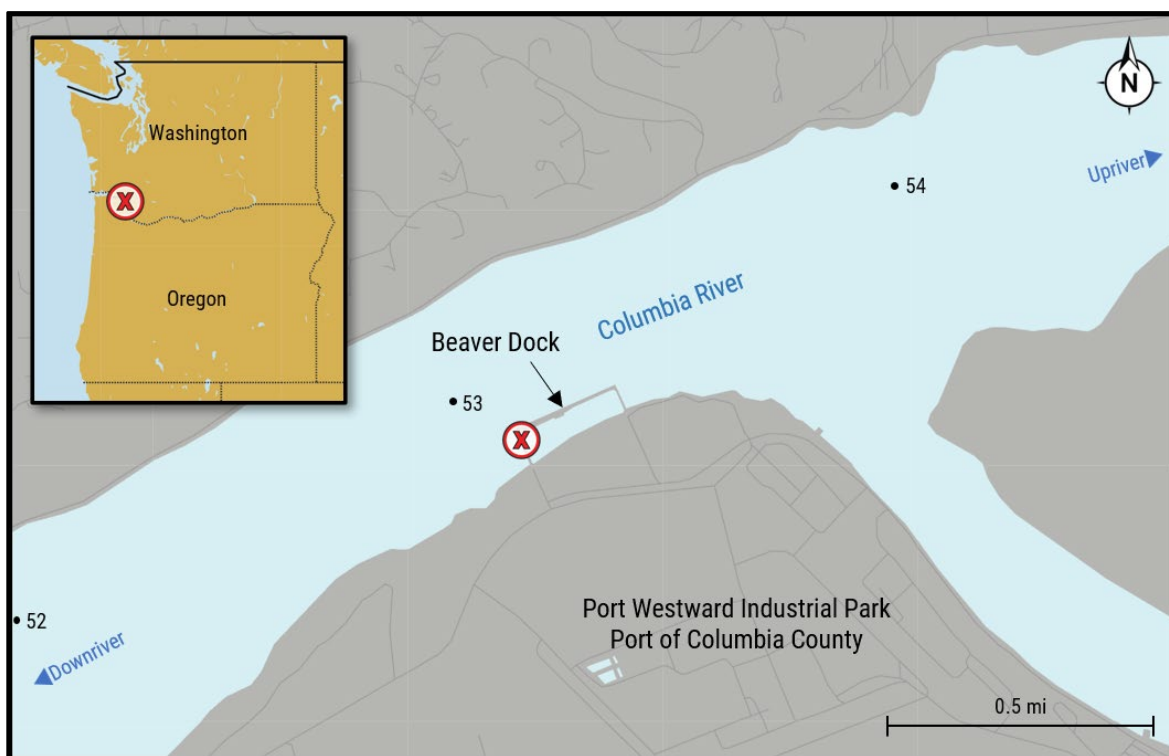
Figure 2. Area where the *Cindy B* tow contacted the Beaver Dock, as indicated by a circled X. (Background source: Google Maps)

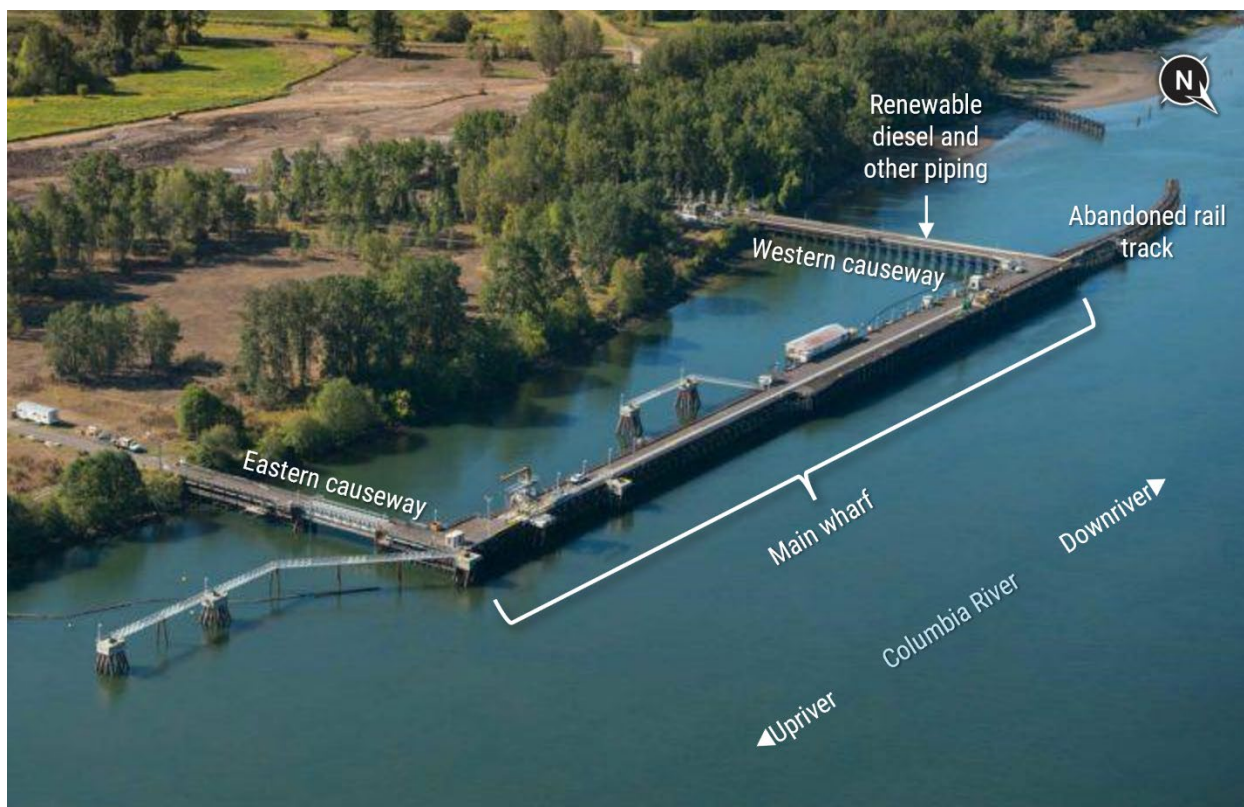
The Port Westward Beaver Dock, located on the southern bank of the Columbia River, was constructed by the US Army in 1942 and used as an ammunition shipping hub during World War II and the Korean War (see figure 3). In the mid-1960s, the Port of Columbia County acquired the property and developed it for commercial use.² At the time of the contact, the dock was primarily used for onloading renewable diesel fuel to bulk liquid cargo vessels (tank ships and barges).³ The main wharf, which ran parallel to the shoreline, was 1,600 feet long. Piles supporting the remnants of an abandoned rail track extended westward from the wharf and curved shoreward. Causeways connected the main wharf to shore at each end. The causeway at the western (downriver) end was constructed of wood piles and wood decking. Piping systems for the renewable diesel cargo and other liquids ran atop the causeway and main wharf.

Figure 3. The Beaver Dock at an undetermined date before the contact by the *Cindy B* tow. (Background source: Port of Columbia County)
