Bundesstelle für Seeunfalluntersuchung
Federal Bureau of Maritime Casualty Investigation

**Allision with an offshore wind turbine in the
Gode Wind 1 wind farm by the PETRA L on
24 April 2023**

Investigation Report 192/23

30/01/2025

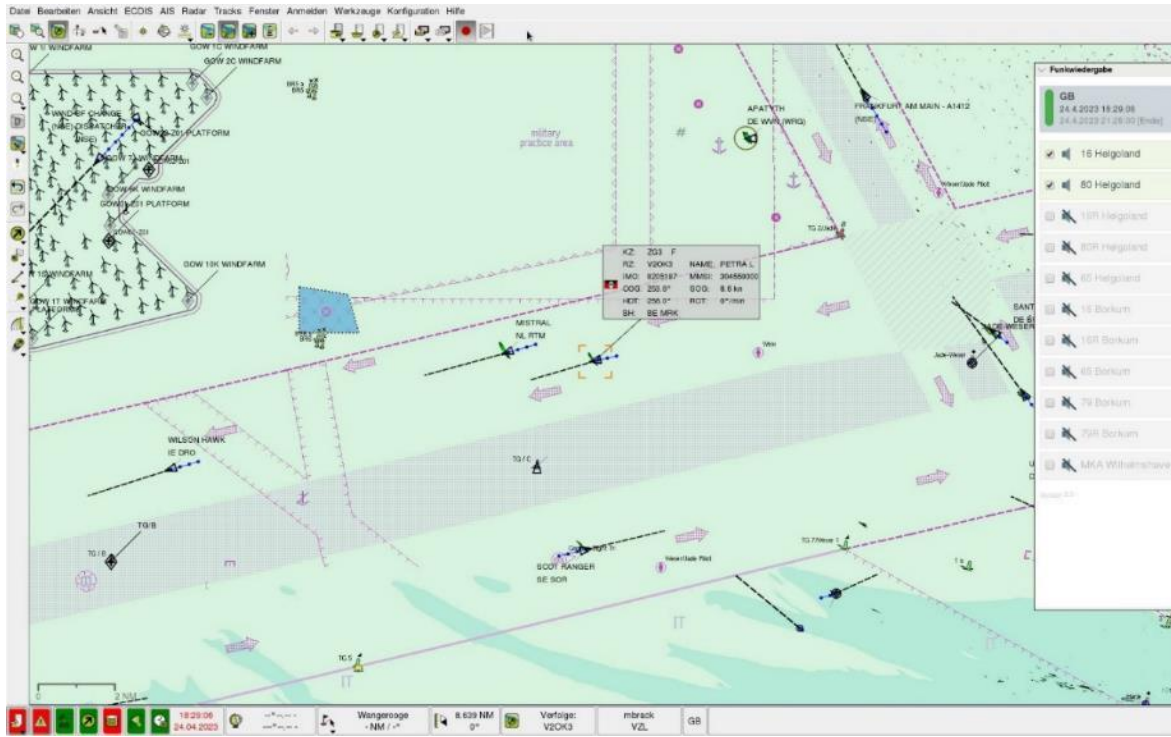
Figure 8: 1829 – the PETRA L navigates the TSS in compliance with regulations¹⁰

While Figure 8 still shows the regular course of the PETRA L at 1829, Figure 10 shows the beginning of the ship's course alteration to starboard.

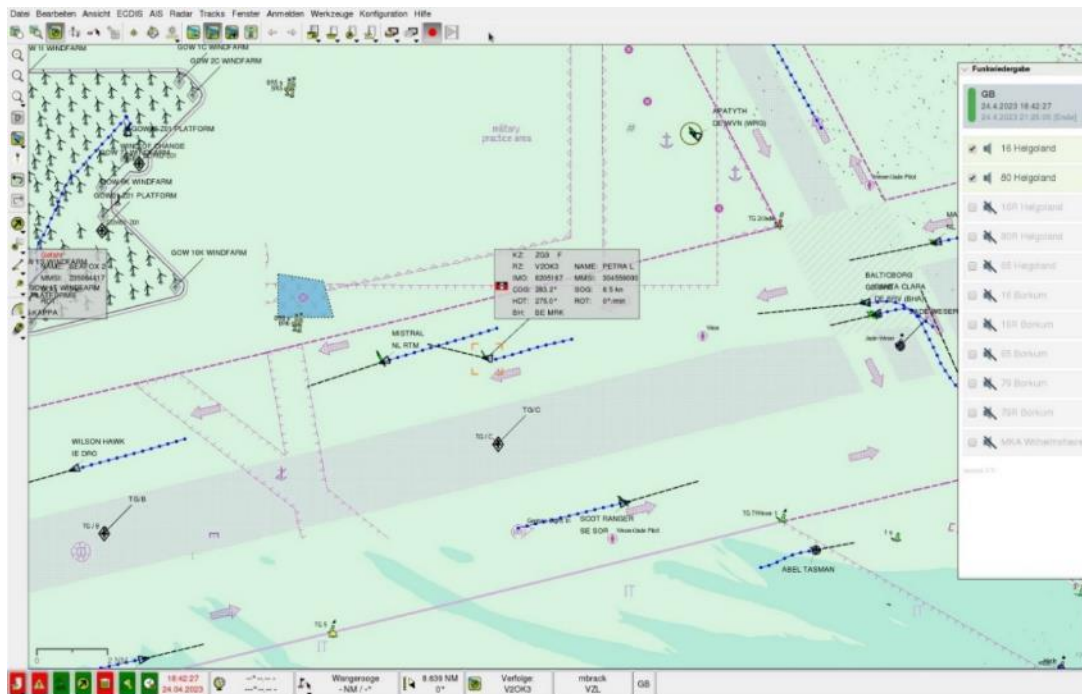
Figure 10: 1842 – 20° course alteration completed¹²

Figure 10 shows the point at which the course alteration by about 20° appears to have been completed. The PETRA L maintains this new course of approximately 280° (COG) until her allision with the wind turbine.

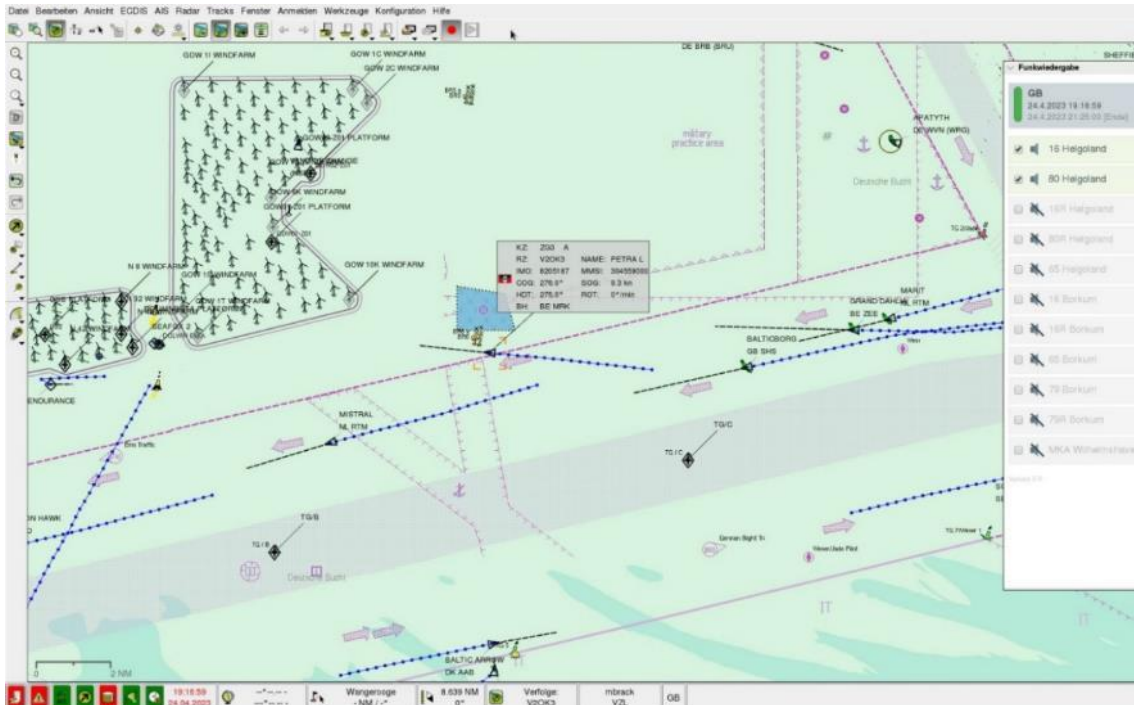
Figure 12: 1917 – the PETRA L leaves the TSS¹⁴

The ship leaves the traffic separation scheme at 1917 and maintains a steady course and speed toward the wind farm.

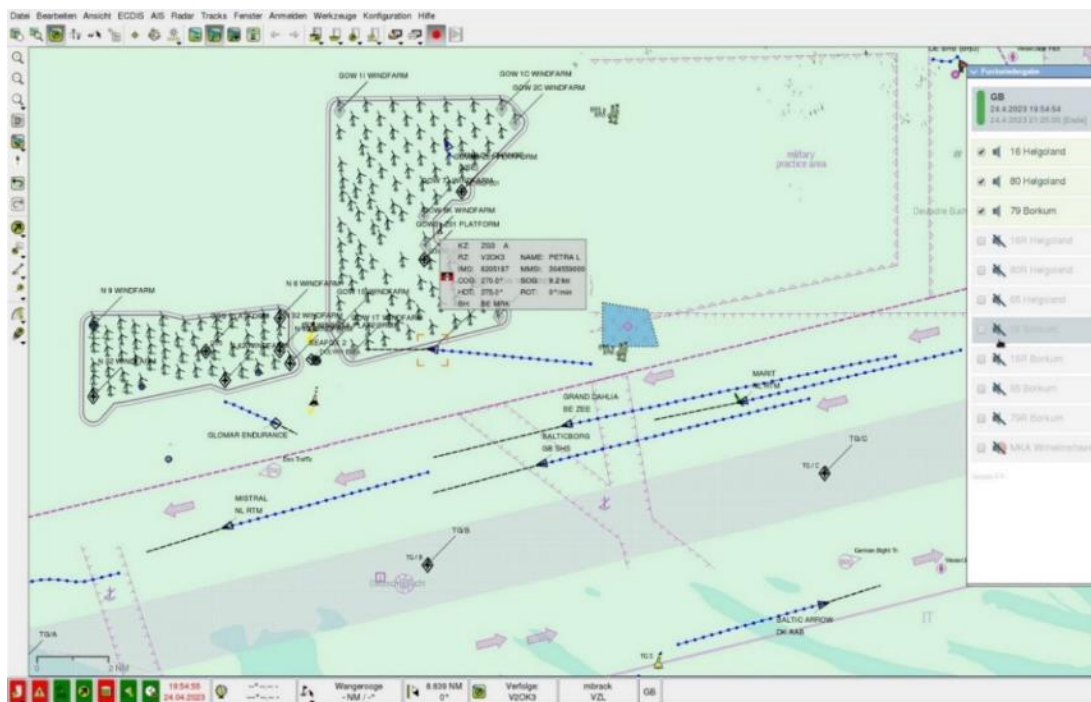
Figure 14: About 1955 – the PETRA L reaches the 500 m boundary¹⁶

At approximately 1955, the PETRA L reaches the Gode Wind 1 wind farm's 500 m safety zone and continues.

before entering the OWF safety zone, and the last upon entering the OWF safety zone at about 2002. However, according to the VTS AIS recordings, the PETRA L reached the safety zone at about 1955 (see Figure 14) and then followed a diagonal course through the wind farm towards the OWT. According to the analysis of the AIS data, the allision occurred at 2004.

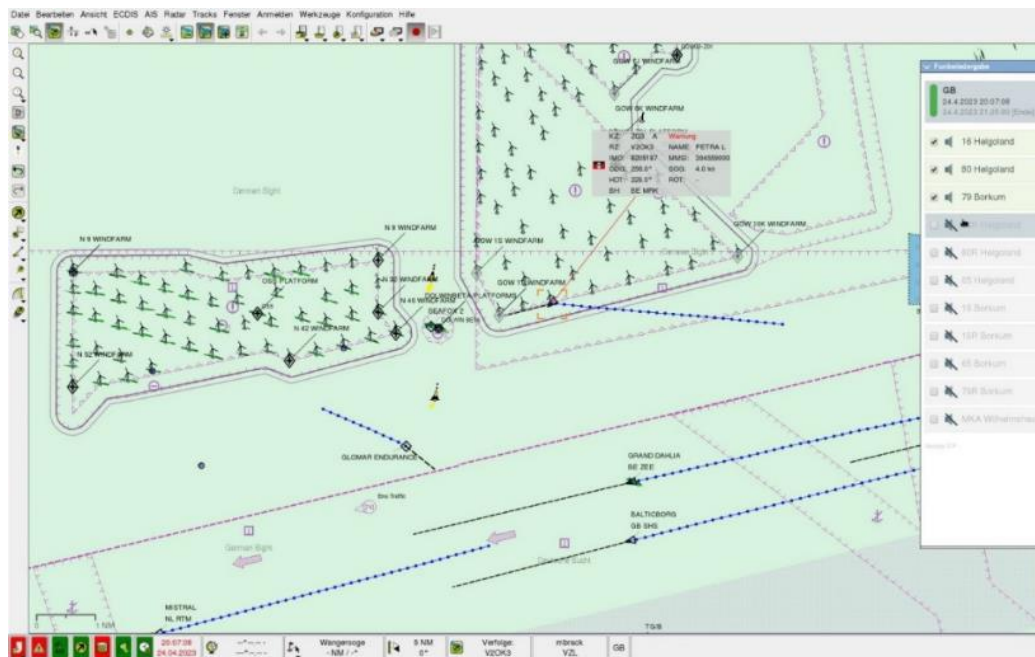
Figure 16: 2007 – the PETRA L picks up speed and leaves the wind farm¹⁸

Figure 15 shows the time of the accident. At 2004, the PETRA L sails into the wind turbine OWT GOW R04. This is clearly evident from the sudden drop in speed. The ship picks up speed again shortly afterwards and leaves in a westerly direction.

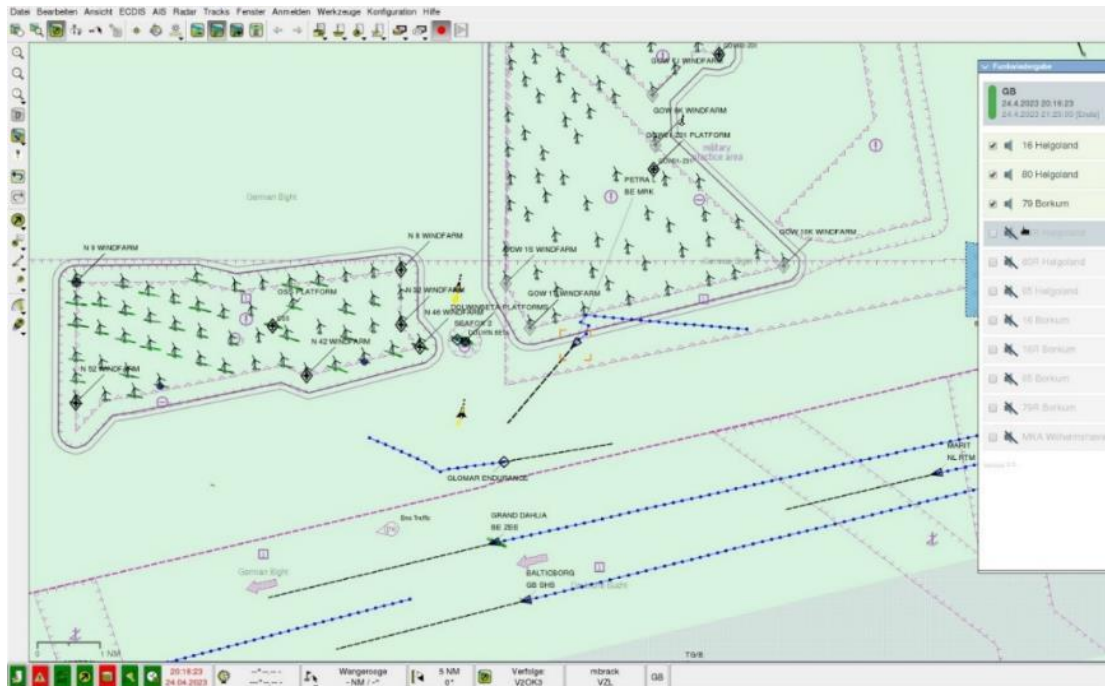
Figure 17: 2016 – the PETRA L crosses the 500 m boundary¹⁹

Figure 17 shows how the PETRA L crosses the 500 m boundary again and approaches the TSS.

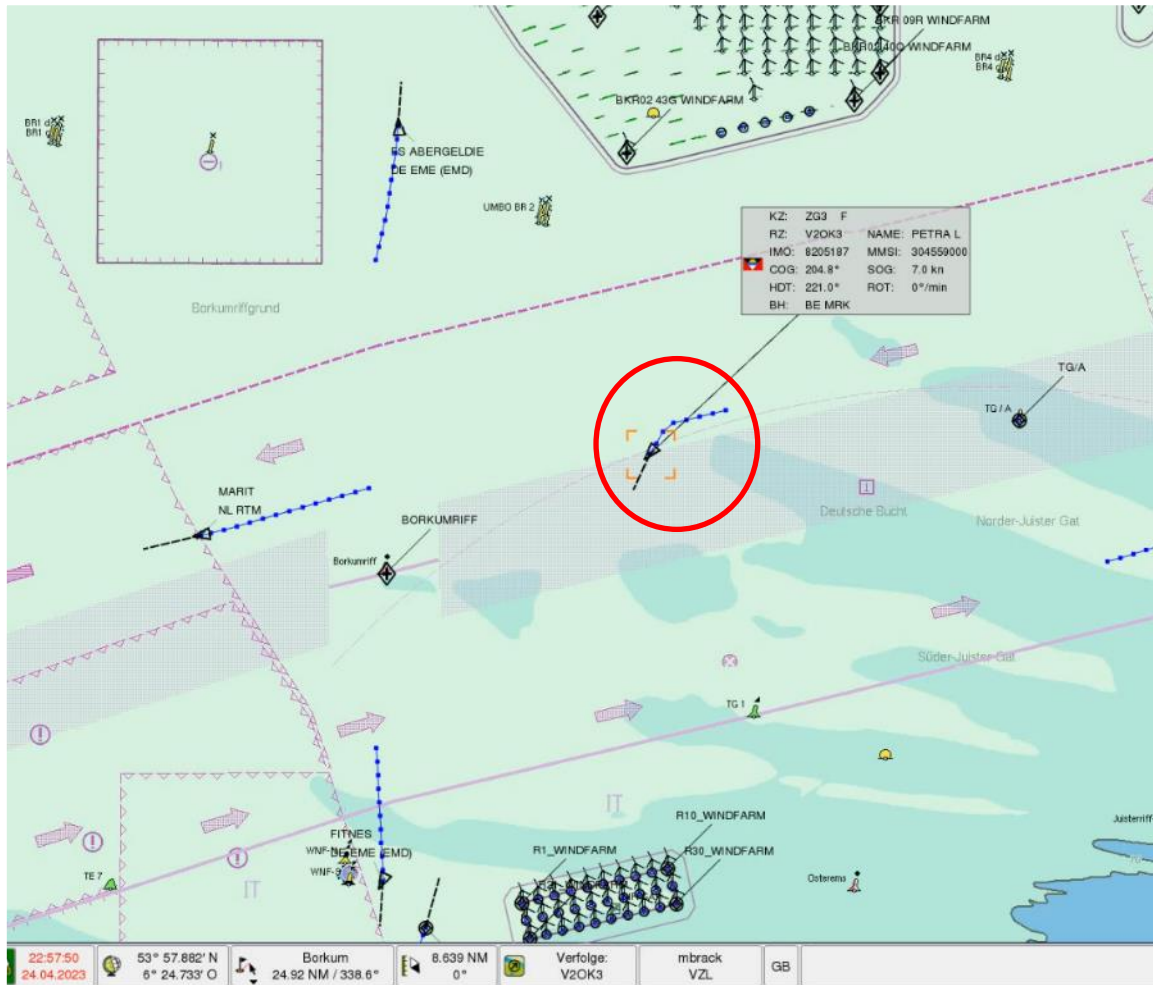
Figure 27: The PETRA L calls GBT at 2257⁴³

"We change my course. We are going to Emden and I would like to report about accident to 2007 we touched windfarms. [sic]"

The NvD did not respond to the final remarks but repeatedly stated that the PETRA L must first continue westward to the Borkumriff buoy and only then turn southward (see Figure 27).
