January 16, 2025

MIR-25-02

Contact of Crane on Deck Barge *BMI 209* Towed by *Nickelena* with Mackinac Bridge

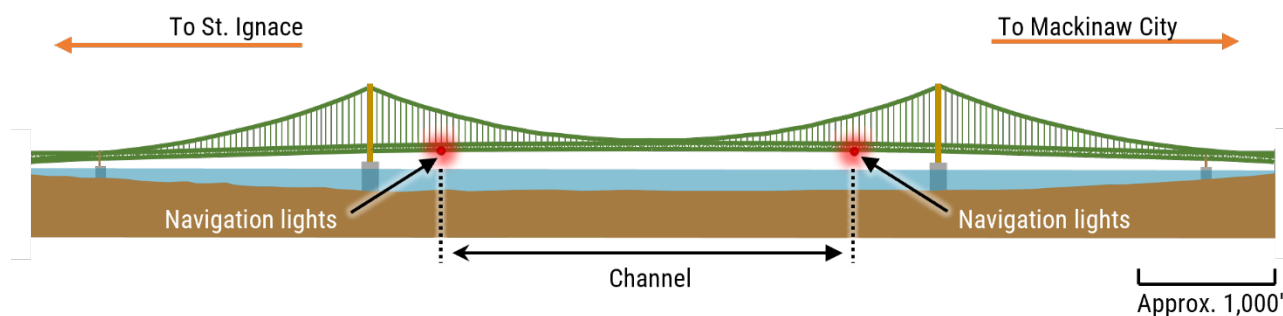
Figure 3. Diagram of the west elevation of the Mackinac Bridge.

The *Nickelena* was to transport a Terex-American HC 275 crawler crane with a 160-foot-long boom and a 5-foot “rooster” sheave attachment on the deck barge from Escanaba to a construction project at Sault Ste. Marie, Michigan, where the barge and crane would remain until the project was completed. This transit required passing eastward beneath the Mackinac Bridge. The Mackinac Bridge, a four-lane vehicle suspension bridge spanning the Straits of Mackinac, connects Michigan’s upper and lower peninsulas (see figure 3). The structure of the bridge was 26,372 feet long and 68.6 feet wide; the main span was 3,800 feet long, supported by two main suspension cables. The main suspension span consisted of a steel-framed stiffening truss, which was 38 feet deep. The stiffening truss supported the roadway deck above. According to the *US Coast Pilot 6* (Chapter 11), the vertical clearance (the distance from the water to the lowest point of the bridge) was 148 feet at the center of the main suspension span and 135 feet at the boundaries of the 3,000-foot-wide navigation channel. According to the Michigan Department of Transportation, the vertical clearance was 155 feet at the center of the main suspension span under normal conditions. Changes in vertical clearance depended on the amount of vehicle traffic crossing the bridge, lake water levels, and wind.

At 0212, just before the contact, there was no traffic and minimal wind effect; however, the National Oceanic and Atmospheric Administration water levels for

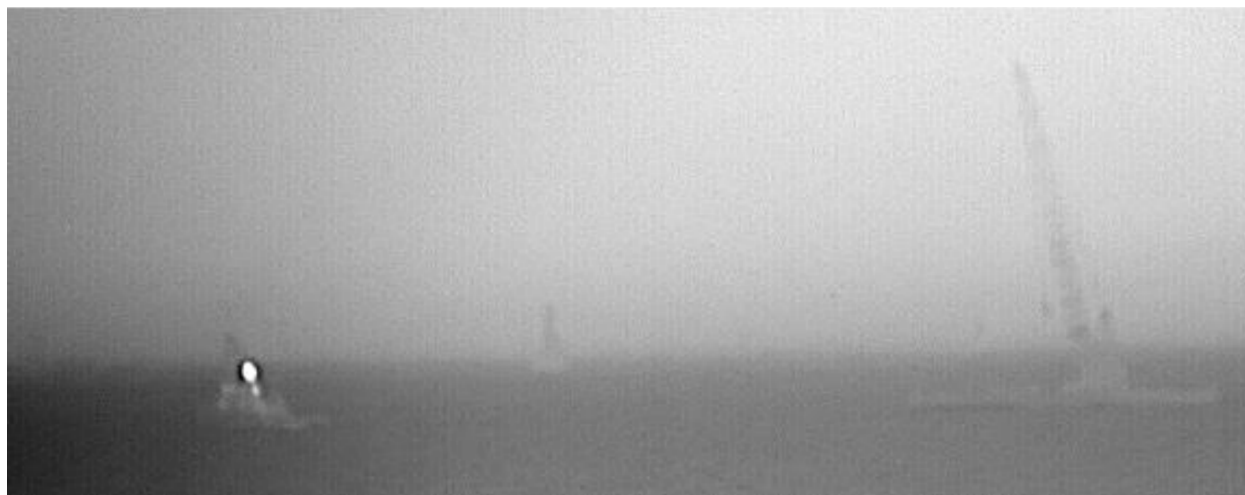
Figure 4. Infrared footage of the *Nickelena* towing the deck barge *BMI 209* with the crane on board at 1226 the night of the contact. (Source: Enbridge Straits Maritime Operations Center)

On May 6, at 1400, the *Nickelena* departed Escanaba towing the deck barge *BMI 209* astern, heading east towards Sault Ste. Marie. Once the towing vessel and the barge were out of the harbor, the captain ordered the length of the tow line be increased to about 500 feet for the voyage (see figure 4). At 2300, the captain was relieved at the wheel by a crewmember and went below to rest in his stateroom; he planned to return to the pilothouse before the towing vessel and barge passed under the bridge.

The NTSB conducted a study of the crane boom angle based on an infrared surveillance image of the crane from before the casualty (see figure 4) to estimate the height of boom at the time it contacted the Mackinac Bridge.³ The study determined, based on a 3-D Terex American HC 275 crawler crane/deck barge simulation model, that the boom angle during the voyage and before contact with the bridge was $62 \pm 1^\circ$, which equated to a height of 162.3 feet (see figure 8 and figure 9).
