**Bundesstelle für Seeunfalluntersuchung**  
Federal Bureau of Maritime Casualty Investigation

# Grounding of the MUMBAI MAERSK while entering the Neue Weser fairway on 2 February 2022

Investigation Report 37/22

26.03.2025

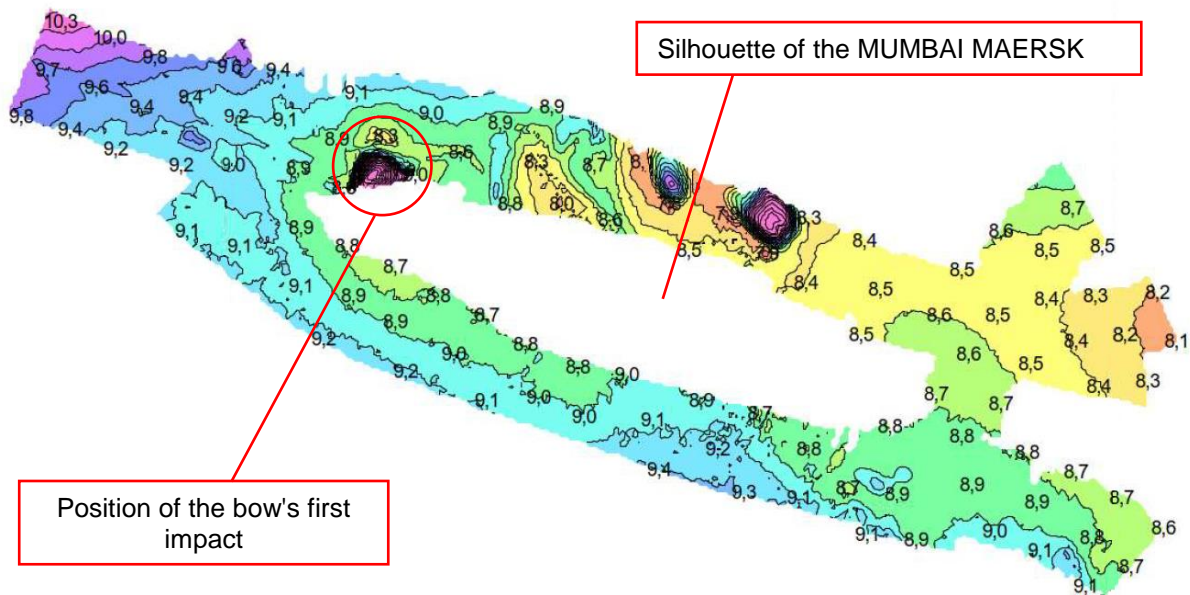
Figure 20: Water depths at the scene of the accident  
measured immediately afterwards<sup>41</sup>

Firstly, this concerns up-to-date water depths, which are measured around the ship by the sounding vessel ZENIT (Figure 20).

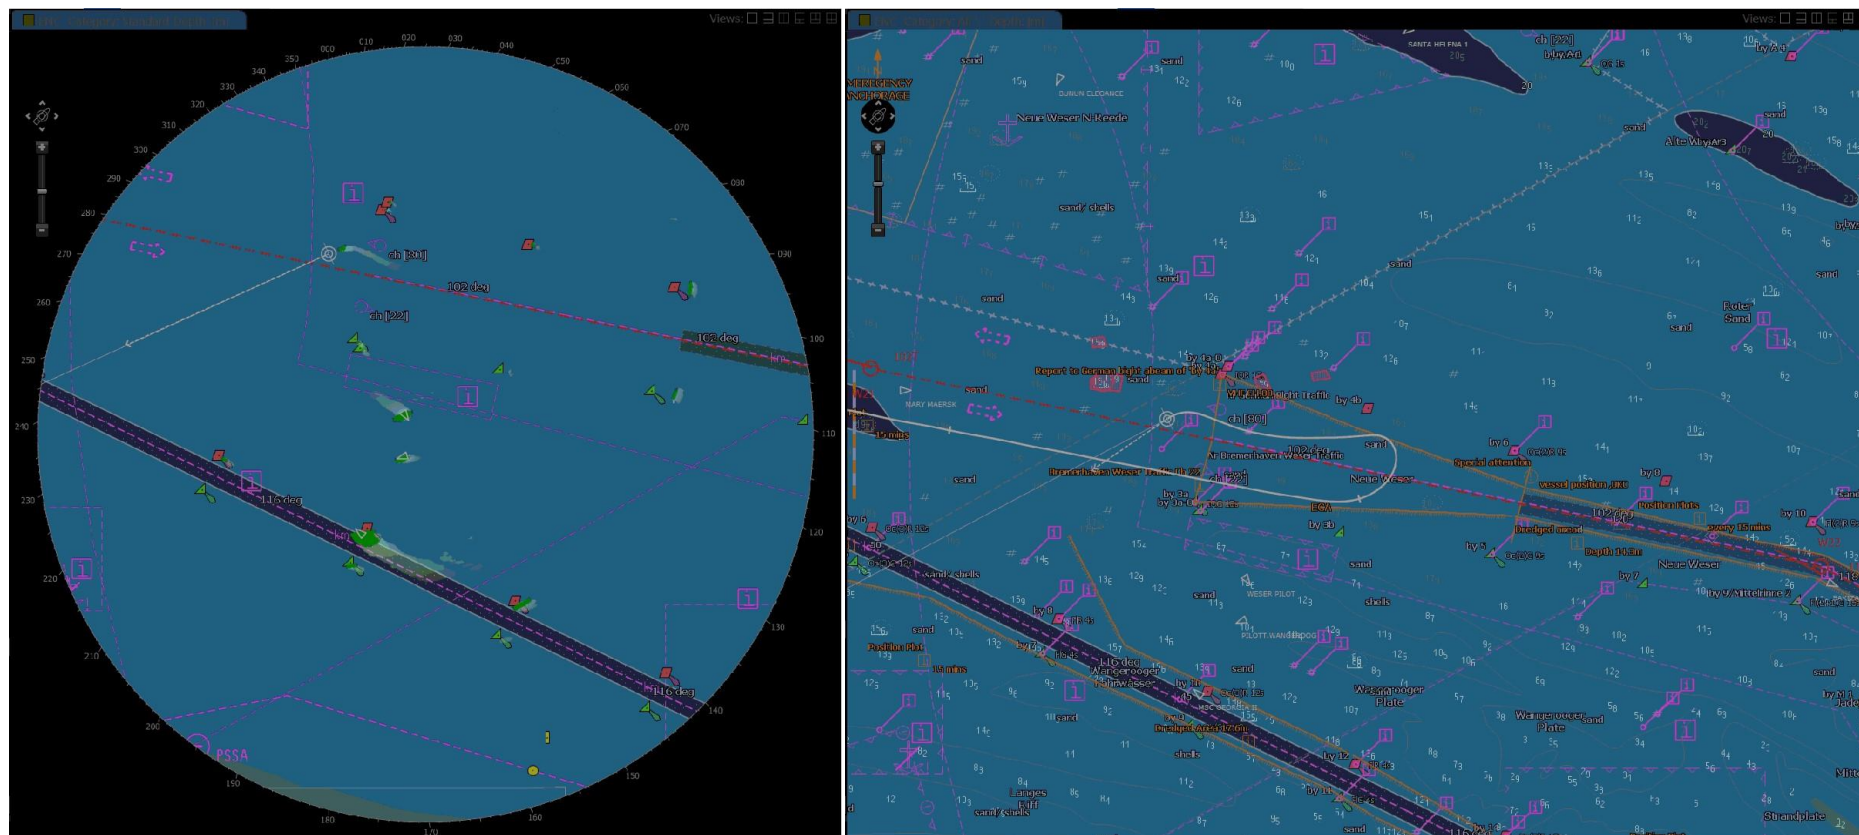
Figure 31: The pilot's radar and ECDIS display (MFDs 01 and 05) at 2256<sup>67</sup>

Figure 29 and Figure 30 show the effects of the settings listed in Table 1 regarding the presentation of information on the radar and ECDIS displays. As can be seen in the images, the radar echoes of the aids to navigation in the pilotage area were sometimes extremely weak, or not recognisable at all. This is because both radar displays were using the same S-band radar, and anti-clutter sea was left unchanged at approximately 25-30 %. Contrary to the master's own instructions at the "Bridge Discipline Meeting" on 13/11/2021, an X-band radar was not used.

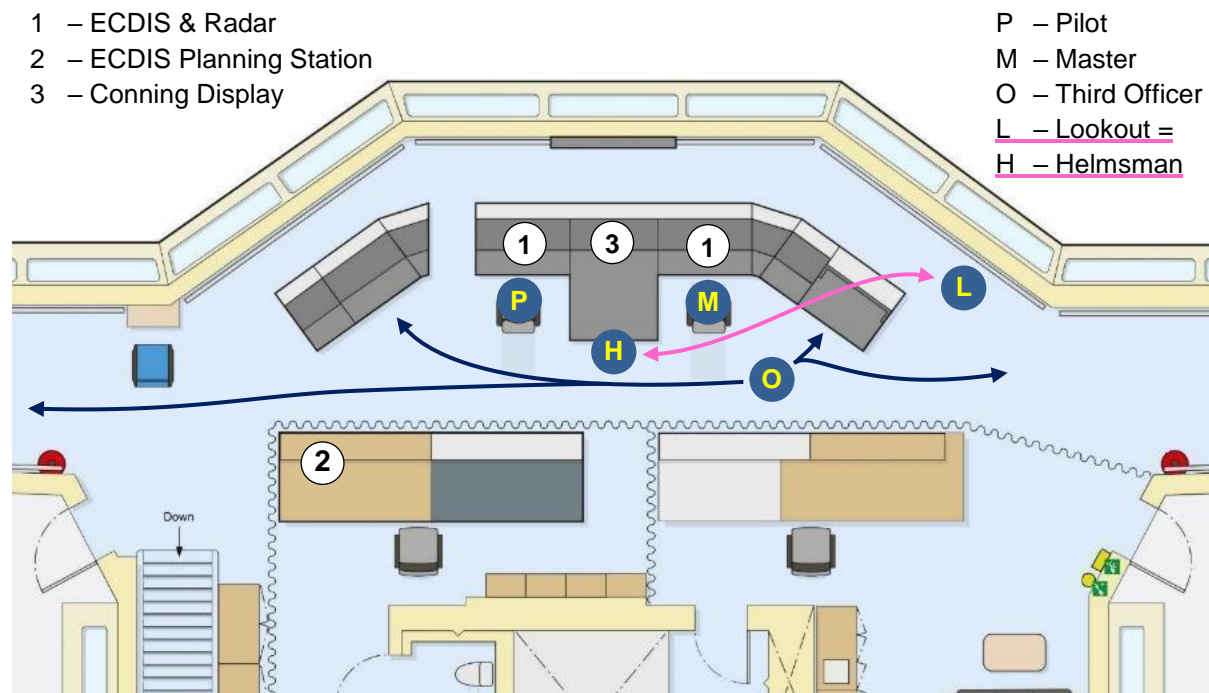
Figure 32: Bridge layout, equipment and manning<sup>71</sup>

The third officer did not have a radar display at his disposal. He could only track the ship's position on the navigational chart and monitor progress along the route on the ECDIS planning station (see Figure 32), for example. Accordingly, it was not possible for him to perform his role as co-navigator properly at all times. Language barriers also contributed to this. It was difficult for him to get involved, as the manoeuvres executed were not discussed within the team early on, no new passage plan was developed, and manoeuvres were initiated on the spur of the moment.

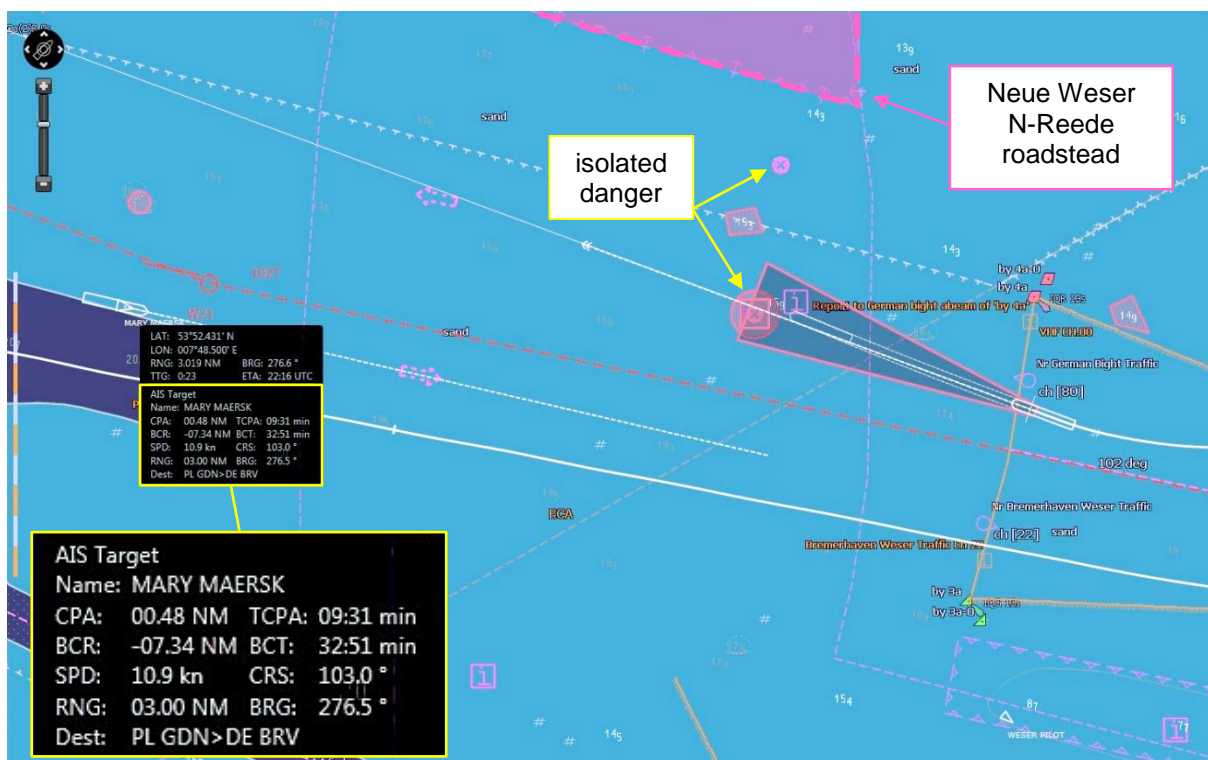
Figure 33: The master's ECDIS display (MFD 04) at 225337<sup>76</sup>

During the autopilot course alteration to 290°, the lookout was ordered back to the helm by the pilot. At 2253, the new HDG was 290° (equivalent to approximately 290° COG; SOG = STW<sup>75</sup> = 8.0 kts). The master viewed the MARY MAERSK's AIS data and informed the pilot of her SOG of 11 kts.

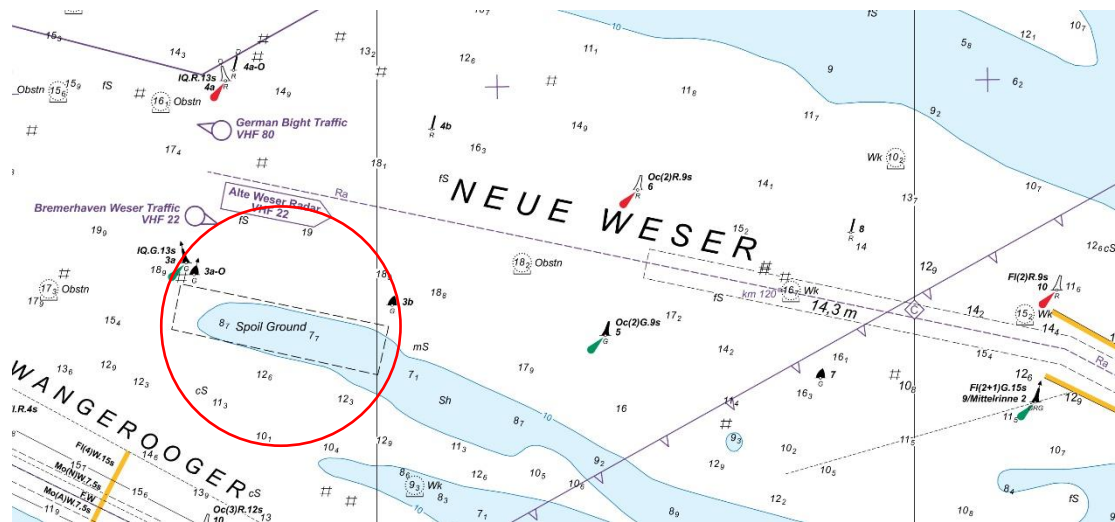
Figure 34: Jade-Weser spoil ground in Chart 1230<sup>84</sup>

The WSV's internal designation for the dumping ground on which the MUMBAI MAERSK ran aground is 'Umlagerungsstelle Jade-Weser' [Jade-Weser spoil ground]. It has been marked as a dumping ground on relevant navigational charts since 1981 (e.g., Overview Chart 1230 covering the mouth of the Jade and the Neue Weser – Langeoog to Wangerooge, see Figure 34). Since it is not located in a fairway, it is

considered a secondary area for depth soundings and sounded once each year. One million cubic metres of sediment have been deposited there every year since 2012.

3. A spoil site is an area in which the water depth is subject to change and significantly shallower than that of the immediate surroundings. It is marked in ENCs with a magenta-coloured, dashed and inwardly jagged contour line, as well as a [ i ] symbol, but not with the label 'Spoil Ground' as on paper charts. However, immediately adjacent to the fairway it would have been appropriate to be able to identify the spoil site quickly. A user symbol would have been a suitable way of highlighting this. The low contrast between the magenta lines and indications in night mode within the shallow contour (see Figure 30 and Figure 31), combined with an overload of additional magenta chart information on the ECDIS (see 4.3.2.2), may have contributed to the discharge area not being recognised as a hazard.

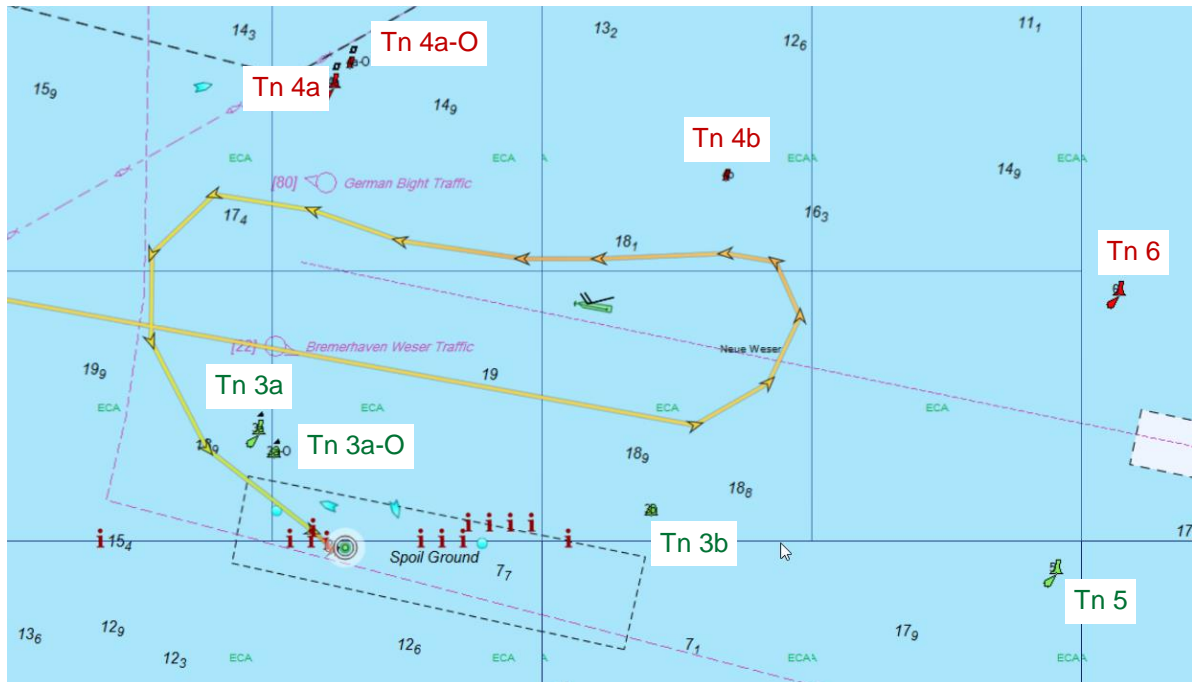
Figure 37: Track up to the grounding, incl. both turning manoeuvres<sup>97</sup>

the LAMARTINE would soon vacate her berth. However, because the turn was completed before the vessel passed buoy pair 5/6, when it would have entered the narrow channel of the Neue Weser, as well as in consultation with the VTS, which issued a spoken approval of the procedure, both chairmen of the Weser II/Jade Pilots' Association rated the manoeuvre as unproblematic (see Figure 37 below).

The timing of the second turn was dictated by the perceived pressure of the closing tidal window and at the same time by the directly oncoming MARY MAERSK. The fact that the MUMBAI was scheduled to sail into Bremerhaven before the MARY had only been finalised minutes earlier. Since the pilot had not anticipated a fast U-turn, the MUMBAI MAERSK was closer to the radar reference line than to the northern buoy line (see Figure 37).

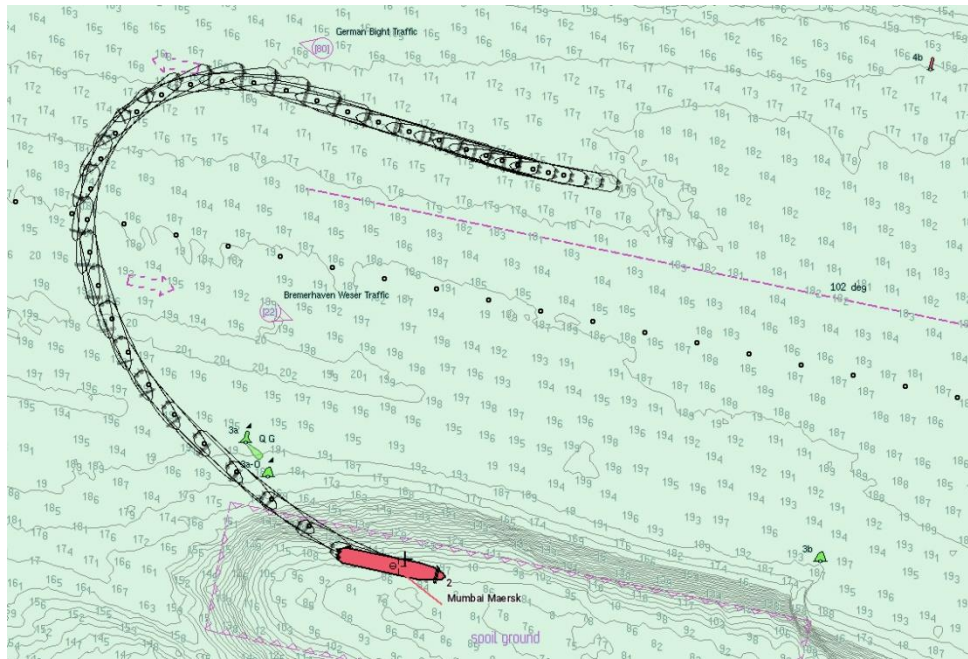
Figure 38: Simulated original manoeuvre<sup>100</sup>

To enable the investigation team to develop a feeling for the ship and her manoeuvring characteristics, the track navigated on the evening of the accident was followed twice, with the same actions being taken at the correct positions (same rudder angles at the same speed at the same time, etc.) wherever possible. A few tweaks to the model (see above) made it possible to achieve a good approximation of the actual course of the voyage on the second run.

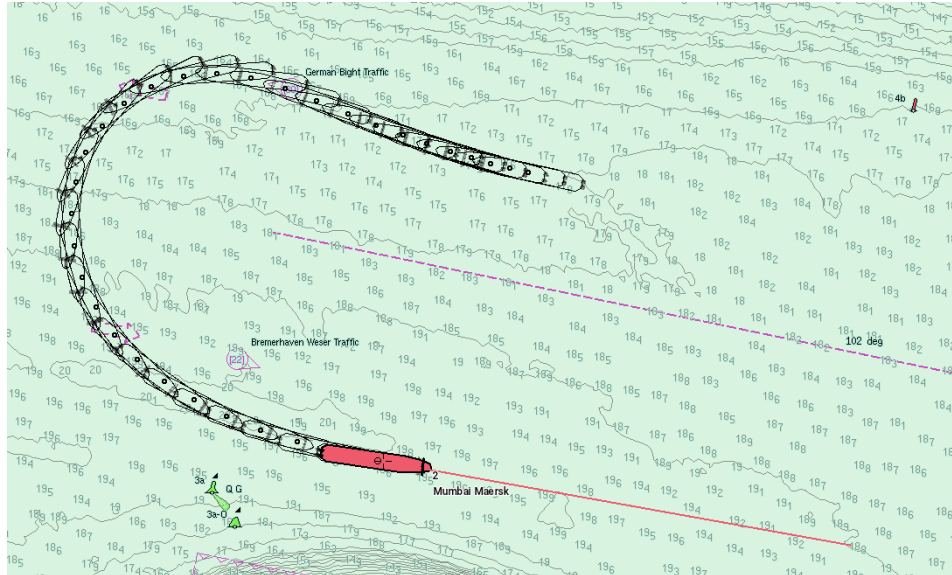
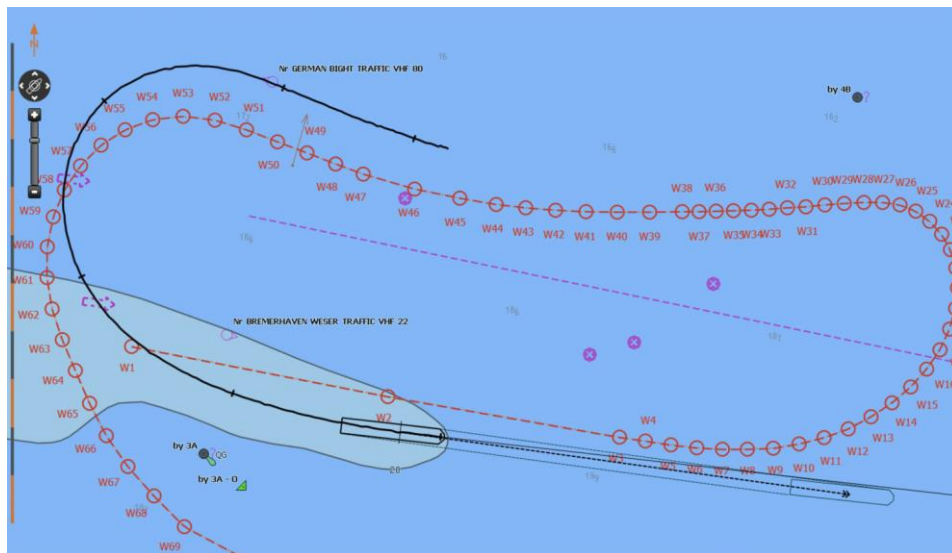
Figure 41: Start further north: track navigated during the simulation<sup>103</sup>

The manoeuvre began at the same position as the previous one, but approximately 200 m further to the north. The ship remained well clear of the buoys, which stayed in sight the entire time.

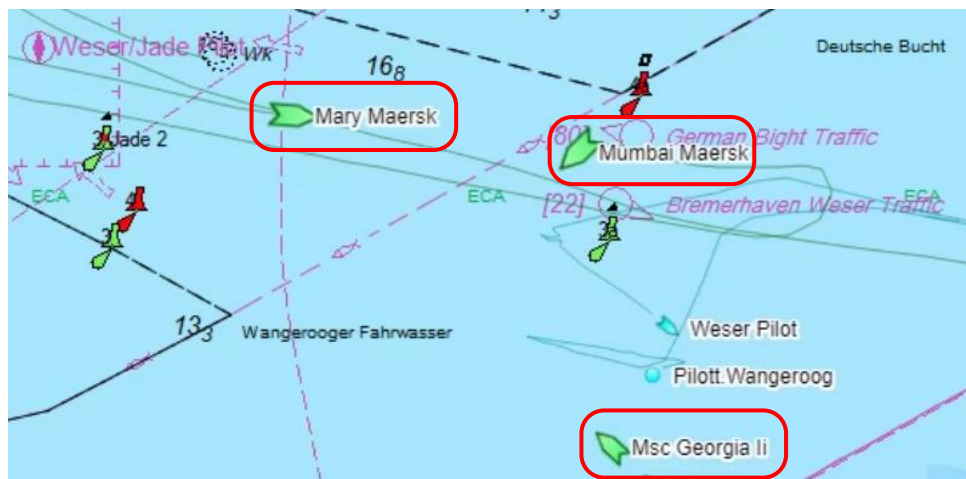
Figure 43: Further west: actual traffic situation before the second turn<sup>105</sup>

The position and timing of the U-turn had to be chosen with consideration of the traffic situation. Before the manoeuvre was initiated, the MUMBAI MAERSK's sister ship, the MARY MAERSK, was approaching on a reciprocal course, and the much smaller container ship MSC GEORGIA II approached from the south-east during the last 90° course alteration.

For an assessment of the spatial conditions, the tracks of the other two vessels (sailing automatically, as mentioned) were not altered. The MARY MAERSK turned away from the MUMBAI at a distance of approximately three ship's lengths.

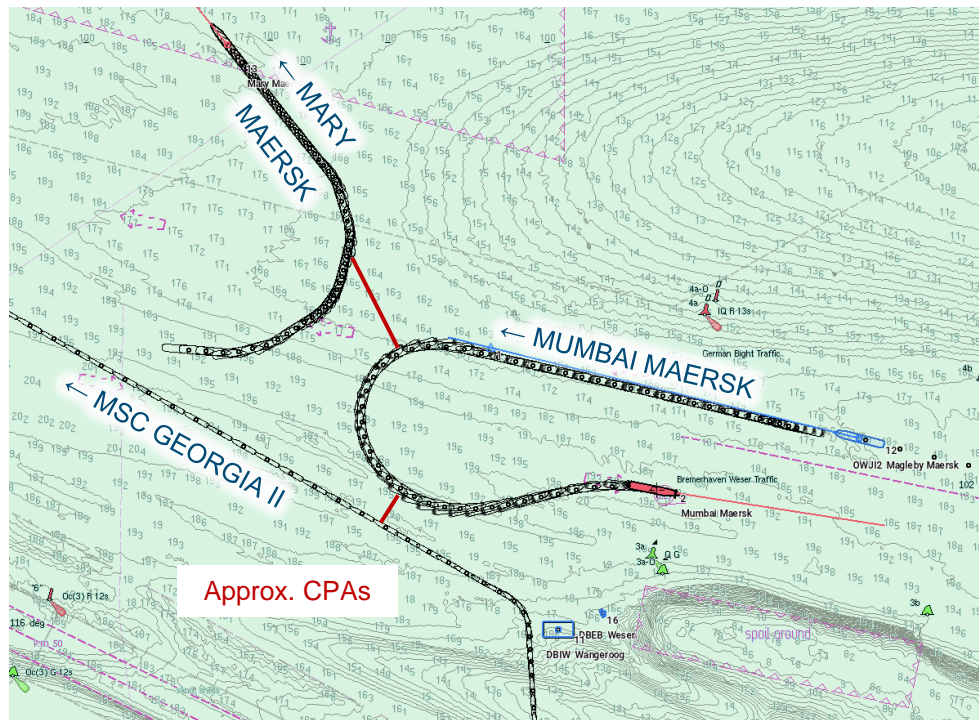
Figure 46: Further west: closest points of approach

The closest passing distance to the MSC GEORGIA II was small (about twice the breadth of the MUMBAI, see Figure 45), but the manoeuvre did not result in a collision. The investigating team assumes that, in reality, such a close approach would have been anticipated and avoided, e.g., through mutual consultation and a course adjustment by MSC GEORGIA II.

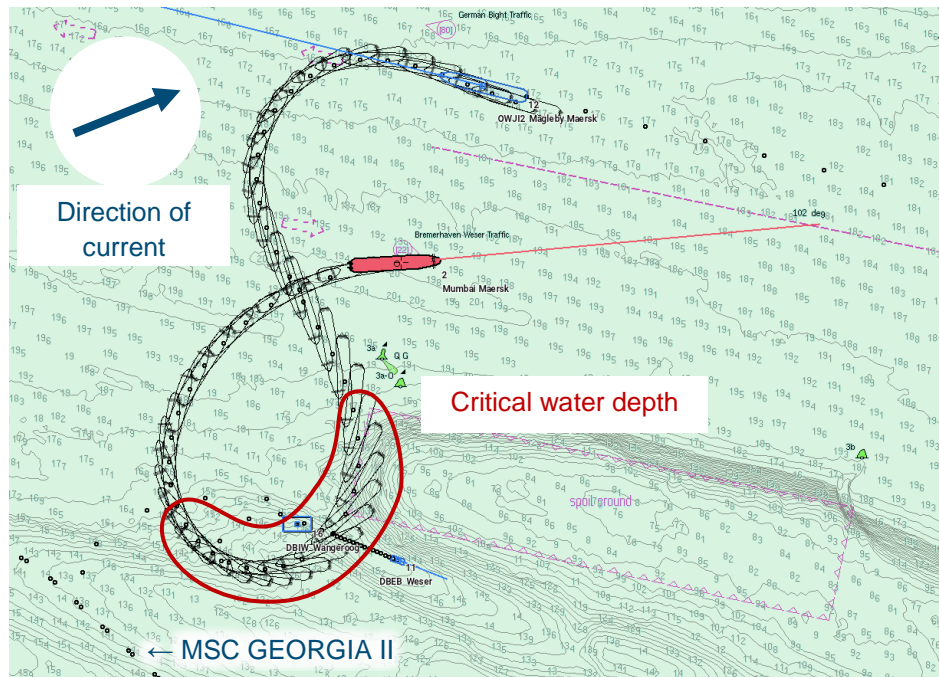
Figure 47: 270° turn: set and drift, spoil site

The current offset the ship, especially her stern, toward the spoil site with considerable force. Although the simulation could be completed without grounding, the lowest depth of water beneath the keel was about 1.8 m, which cannot always be regarded as safe (possible risk of propeller and/or engine damage due to significantly increased propeller resistance caused by churned-up silt, etc.). The speed dropped from about 11 kts to 6 kts due to the shallow-water effect over the spoil site.

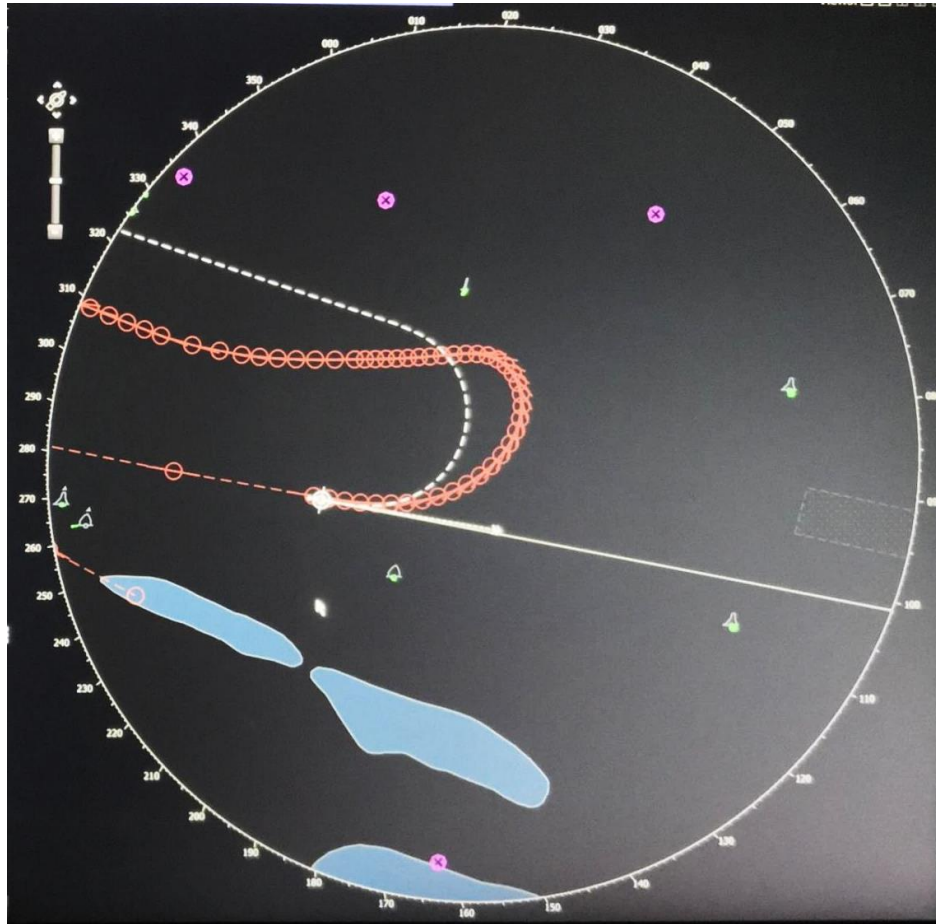
Figure 49: Curved heading line, heading mode: planned track (white) <sup>112</sup>

When making the first turn, it was noticeable that the ship did so with an offset to the east, i.e. further east than originally planned, apparently due to the control algorithm. The radius was larger than intended (planned: 0.4 nm). In the north-eastern 'corner' of the loop, when the influence of the flood tide stream on the MUMBAI MAERSK's stern should have reduced the turning radius (as it did on the evening of the accident), the control system altered the rudder angle such that the radius continued to be sailed evenly. However, since this happened with an easterly offset and with a radius enlarged by the flood tide stream, the ship ran over buoy 4b.

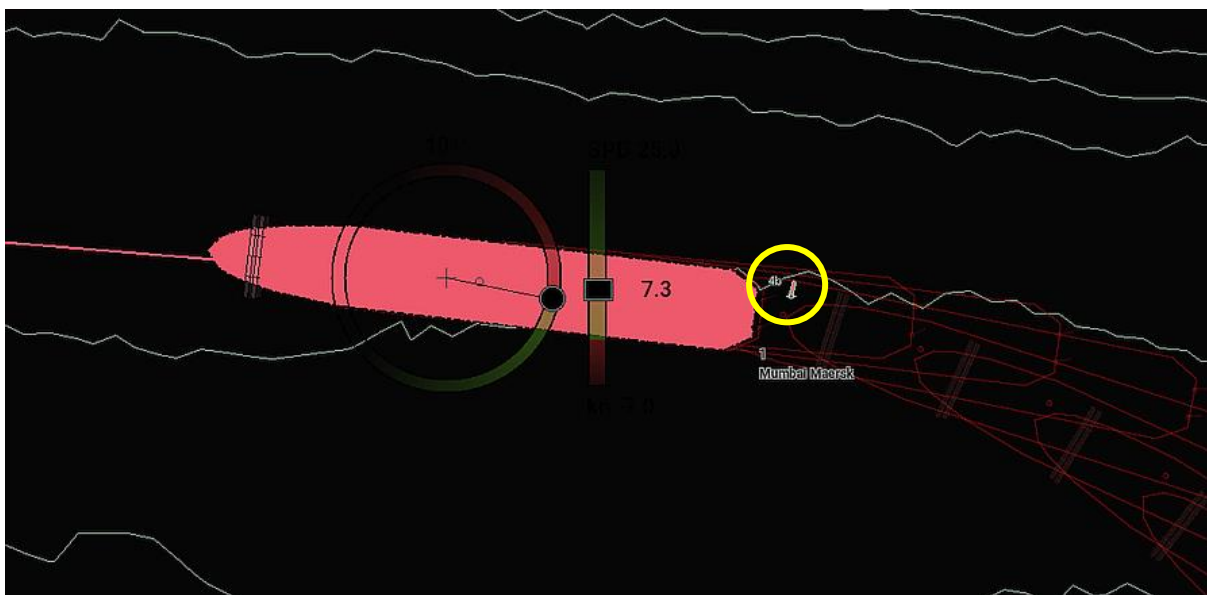
Figure 51: Curved heading line, heading mode

Track with ship's outline; run-over buoy 4b (see yellow outline)<sup>114</sup>

The simulator team explained that the underlying algorithm in HDG mode does not work with GPS positions, but rather with the speed through the water (from the speed log) and rate of turn. This means that the control system would not “notice” the offset and drift in this situation, and that these factors should have been considered by the operator in advance.

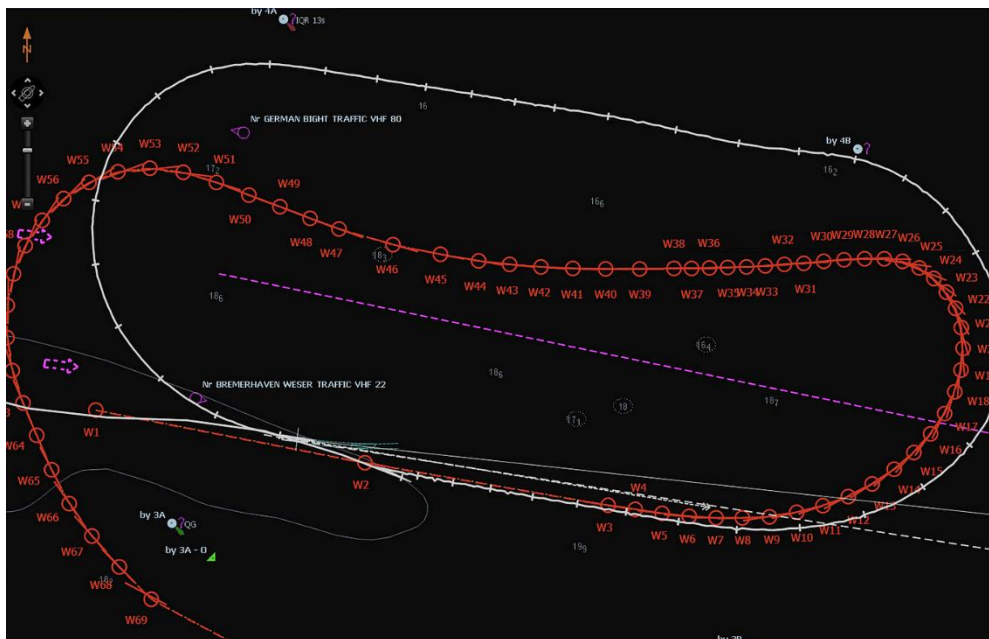
Figure 52: Curved heading line, course mode

Based on the experience gained during the first turn, the second (the U-turn) was executed in course mode<sup>115</sup>, also using the curved heading line. This manoeuvre was carried out without any problems.

When comparing these two methods of turning (with autopilot and the track planned in advance), course mode (the method that compensates for set and drift due to current and wind) obviously delivers the more successful result. This was especially true under the prevailing tidal conditions: As described, the flood tide stream acted on the MUMBAI MAERSK's stern during both turns on the day of the accident.

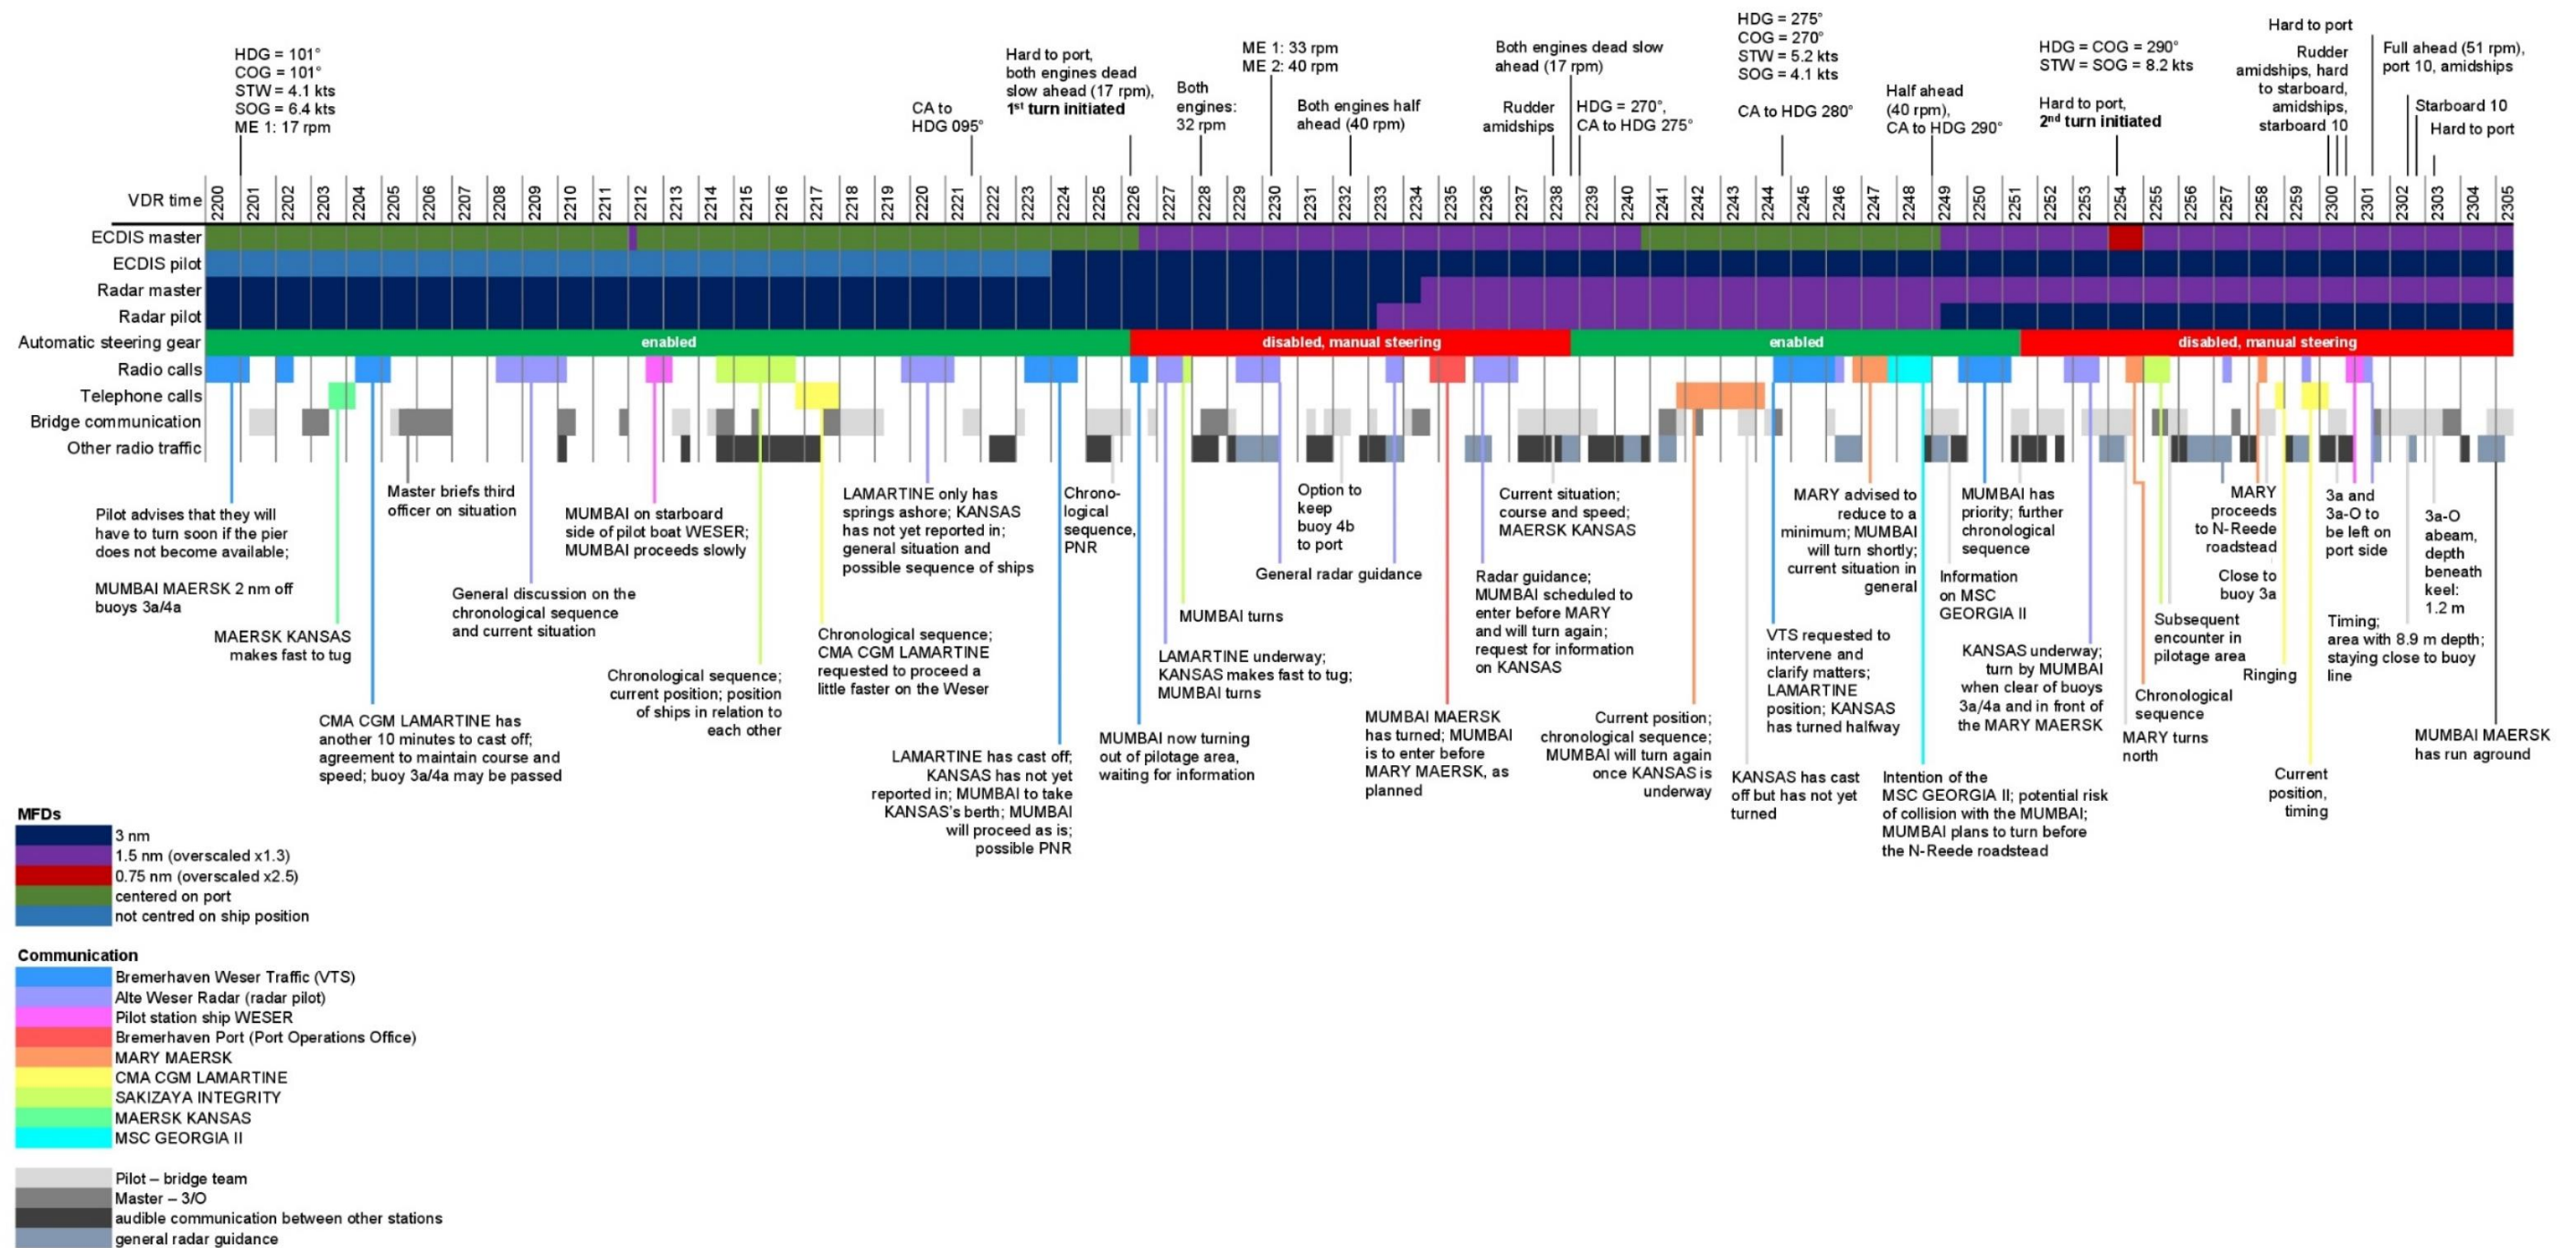
Figure 53: Timeline for navigation and communication from 2200 onwards<sup>116</sup><sup>116</sup> Source: VDR of the MUMBAI MAERSK, sensor data, 2022. All times are VDR time.

The timeline covers the period from 2200 until the grounding at 2305 and can be viewed in Figure 53:

This was also the situation in the case at hand. Between 2200 and the grounding at 2305 (VDR time), the pilot spent almost half of his time engaged in external communication on VHF or his mobile phone (see Figure 52).

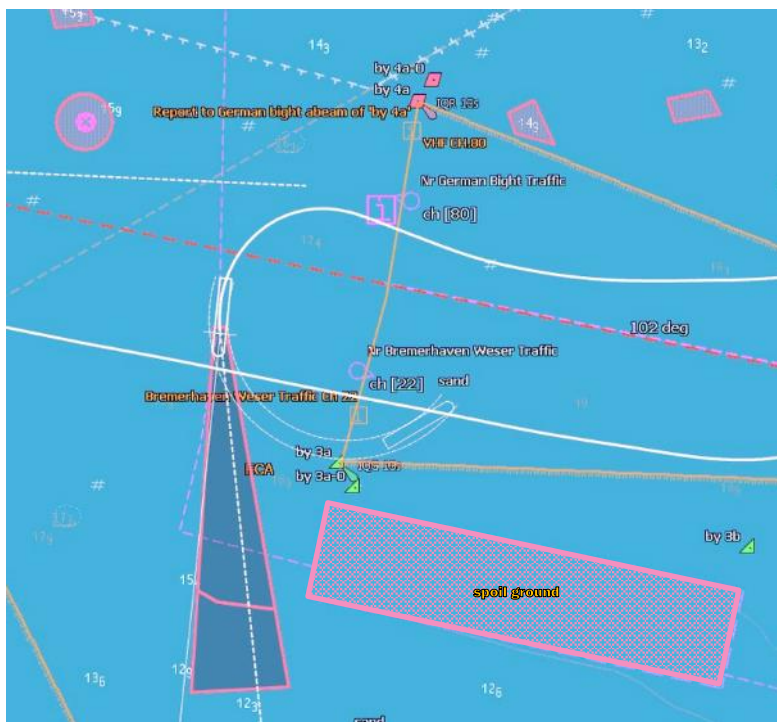
Figure 54: Spoil ground with highlighted user symbol<sup>117</sup>

The look-ahead sector is limited in that it is based on the current course over ground (COG). Accordingly, if the ship is turning during a course change, it is possible, especially in pilotage areas, that the look-ahead sector will generate alarms when dangerous areas or objects that are still ahead are touched. However, with the rate of turn during the course alteration, these would never be reached. In a pilotage area, especially in narrow, winding fairways, it can therefore be useful to switch off the corresponding alarms and to only keep visual highlighting of the ECDIS hazards enabled, for example. Moreover, during a course alteration away from a planned route – as in the present case – it is also possible that dangerous areas and objects (such as buoys 3a and 3a-O and the dumping ground beyond them) will not be recognised by the look-ahead sector function in time, because the vector of the ship (over ground) is calculated from speed and current COG, and therefore, unlike the curved heading line or prediction based on the rate of turn, does not 'point around the corner'.

Accordingly, even if the ECDIS alerts and hazards had been activated, the system would not have issued a timely warning during this course alteration situation. It would
