Propulsion failure and near stranding of *Portland Bay*

On the coast 22 km south of Port Botany (Sydney), New South Wales, on 4 July 2022

ATSB Transport Safety Report Marine Occurrence Investigation (Systemic) MO-2022-006 Final – 15 May 2025 Cover photo: Svitzer Australia

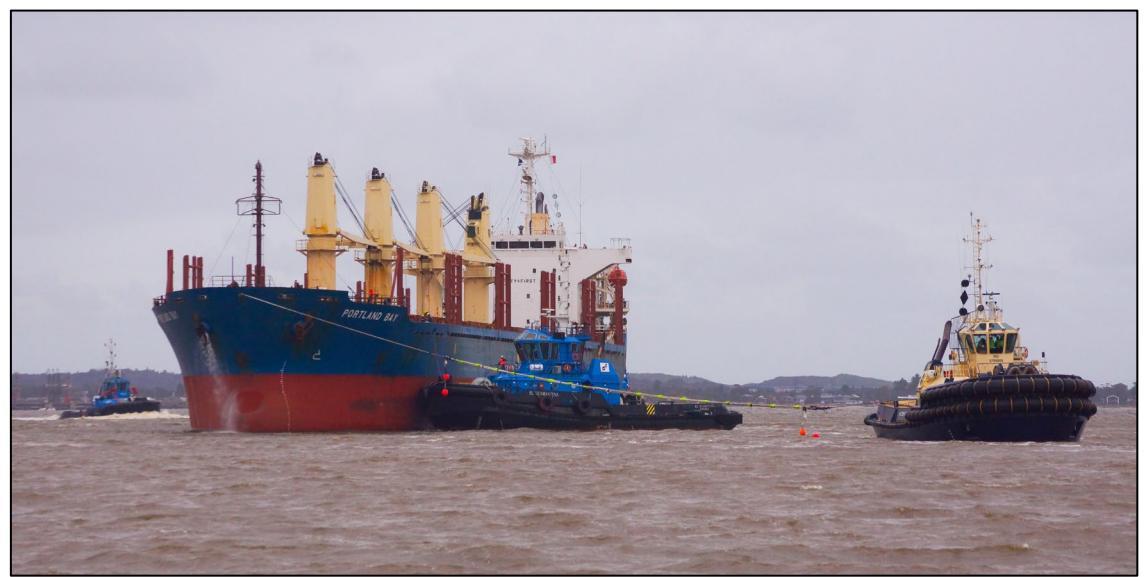
Figure 2: *Portland Bay* under tow on 6 July

On 6 July, at about 1100, the ETV and 2 harbour tugs began towing *Portland Bay* to shelter in Port Botany (Figure 2). By late afternoon, the ship had been safely berthed in the port. Over the following week, the main engine was repaired to make the ship seaworthy.

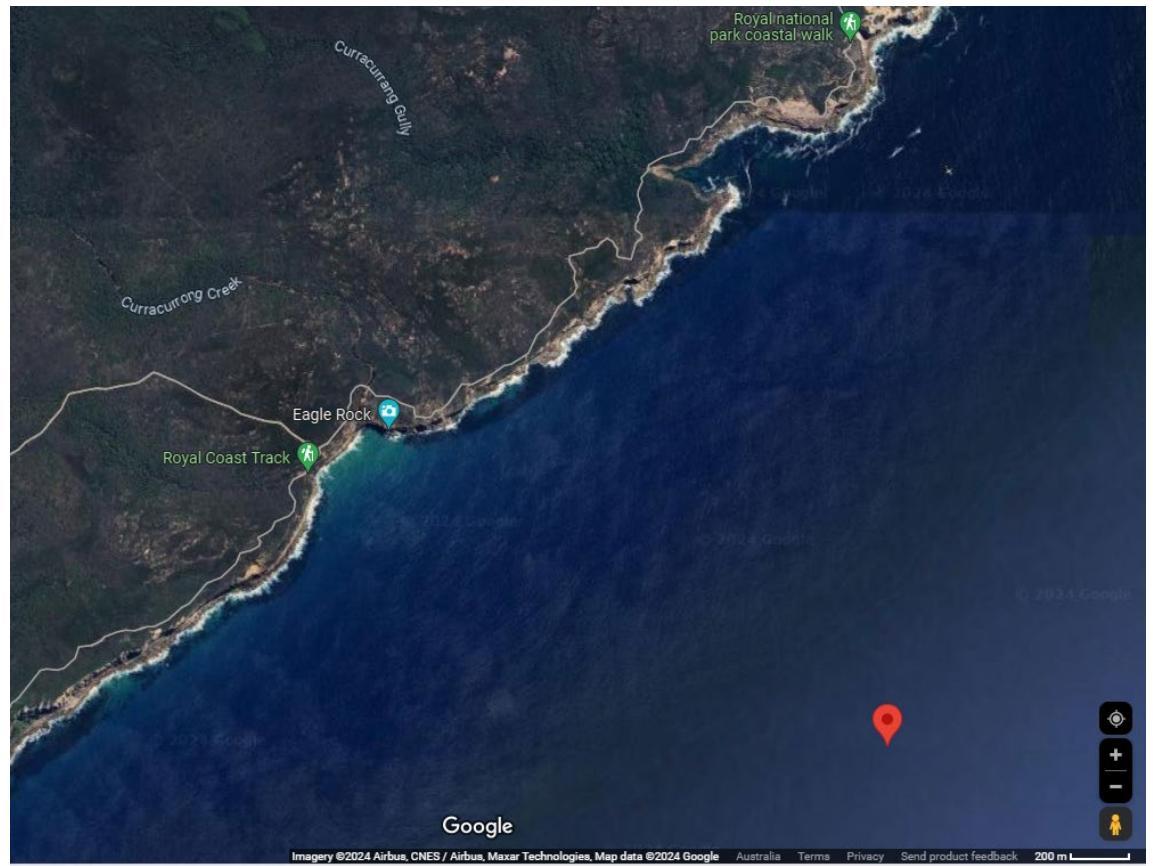
Figure 5: Ship's anchor position (red marker) off Eagle Rock

go at 0909 and, by 0915, its cable had been secured with 7 shackles out. Soon afterwards, the engine was stopped. The ship was anchored in depths of 45 m with a sandy seabed about one mile from the shore (Figure 5).

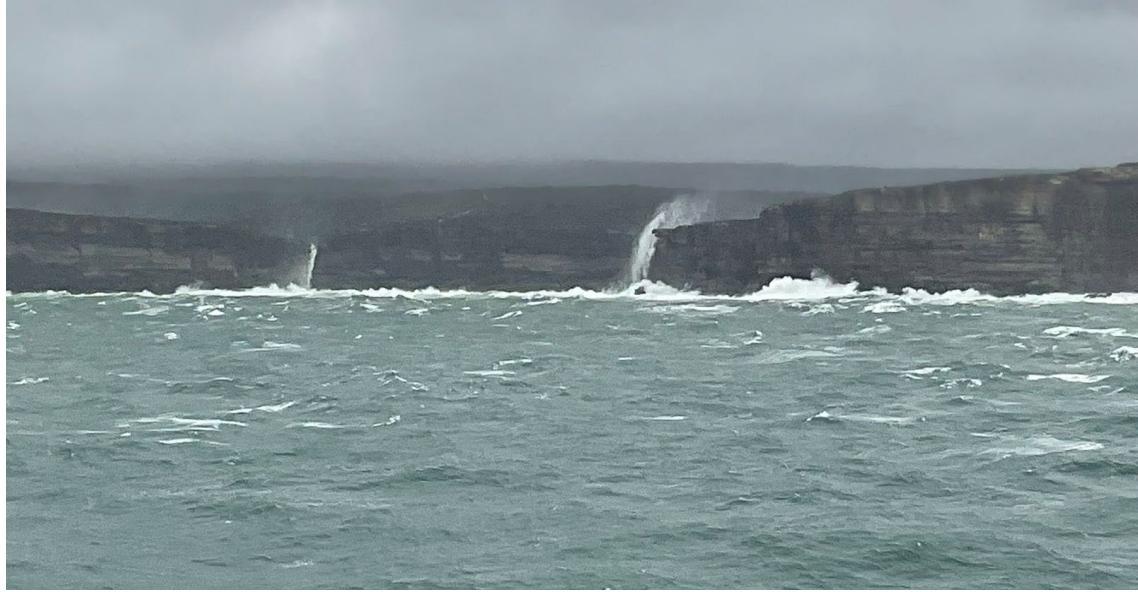
Figure 6: The shore seen from the ship's bridge

Meanwhile on the ship's bridge, at 0937, the third mate informed the master that the distance to the shore had reduced to 9 'cables'²⁹ (Figure 6). The master was still discussing the situation with Pacific Basin and suggested evacuating all non-essential crew, including the 2 trainees on board.

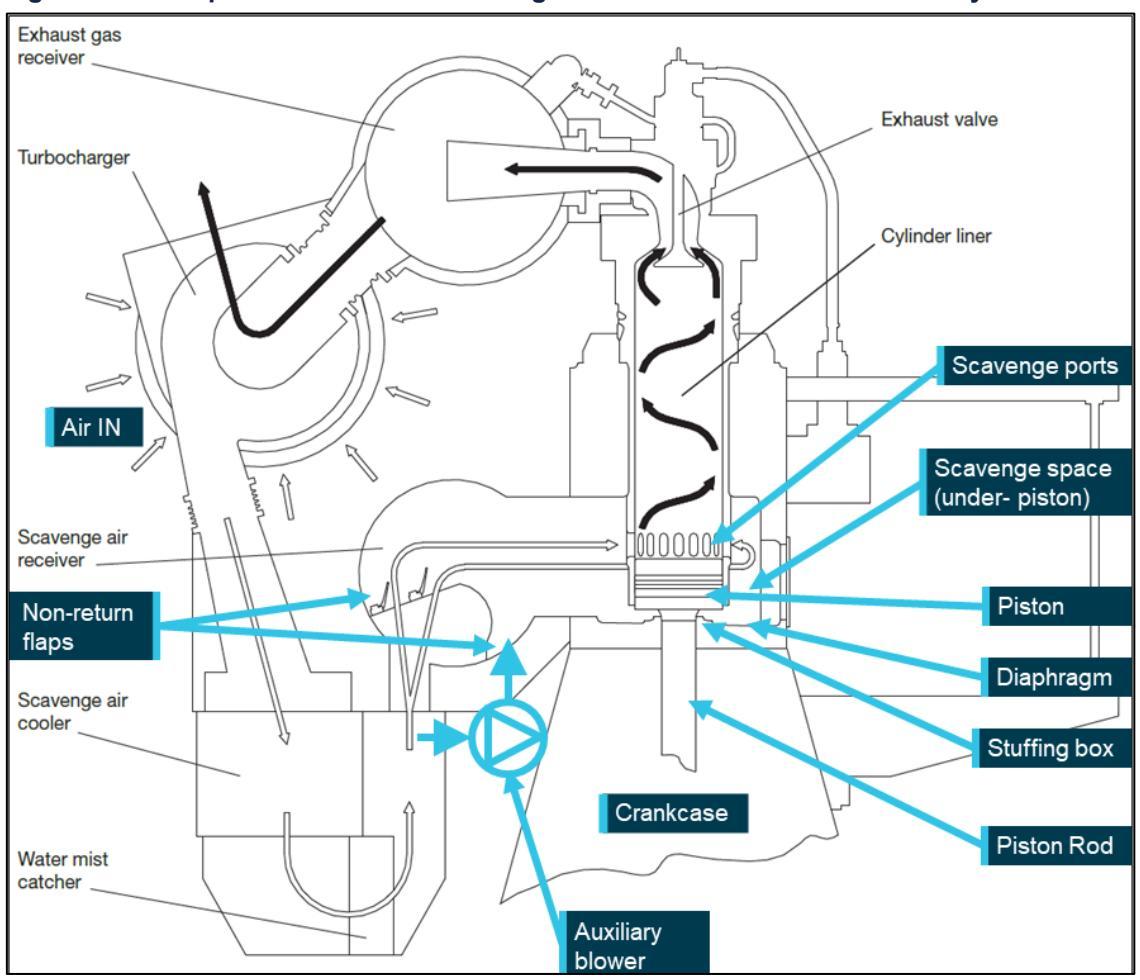
Figure 7: Slow speed MAN B&W diesel engine combustion air and exhaust system

Air for fuel combustion (scavenge air) was drawn from the engine room through filters into the turbocharger compressor (Figure 7). The turbocharger compressed the air and discharged it to the scavenge air cooler, which cooled and dried the air before passing the outlet via non-return flaps.

Pressurised air from the cooler went into the scavenge air receiver or trunk, which extended the entire length of the engine and was connected to each cylinder through a pipe in the under-piston scavenge space. As the piston came down, scavenge ports (cutouts) in the lower cylinder liner were exposed, allowing air into the cylinder above the piston. In combination with the now open exhaust valve at the top of the cylinder, the scavenge air cleared the cylinder of combustion gases and provided fresh air for the next combustion cycle. As the cycle continued, the piston moved up, blocking the scavenge ports, the exhaust valve closed, the air was compressed (increasing its temperature), atomised fuel was injected in and when the piston reached top dead centre, combustion occurred. Expanding gases then forced the piston down for the repeat cycle.

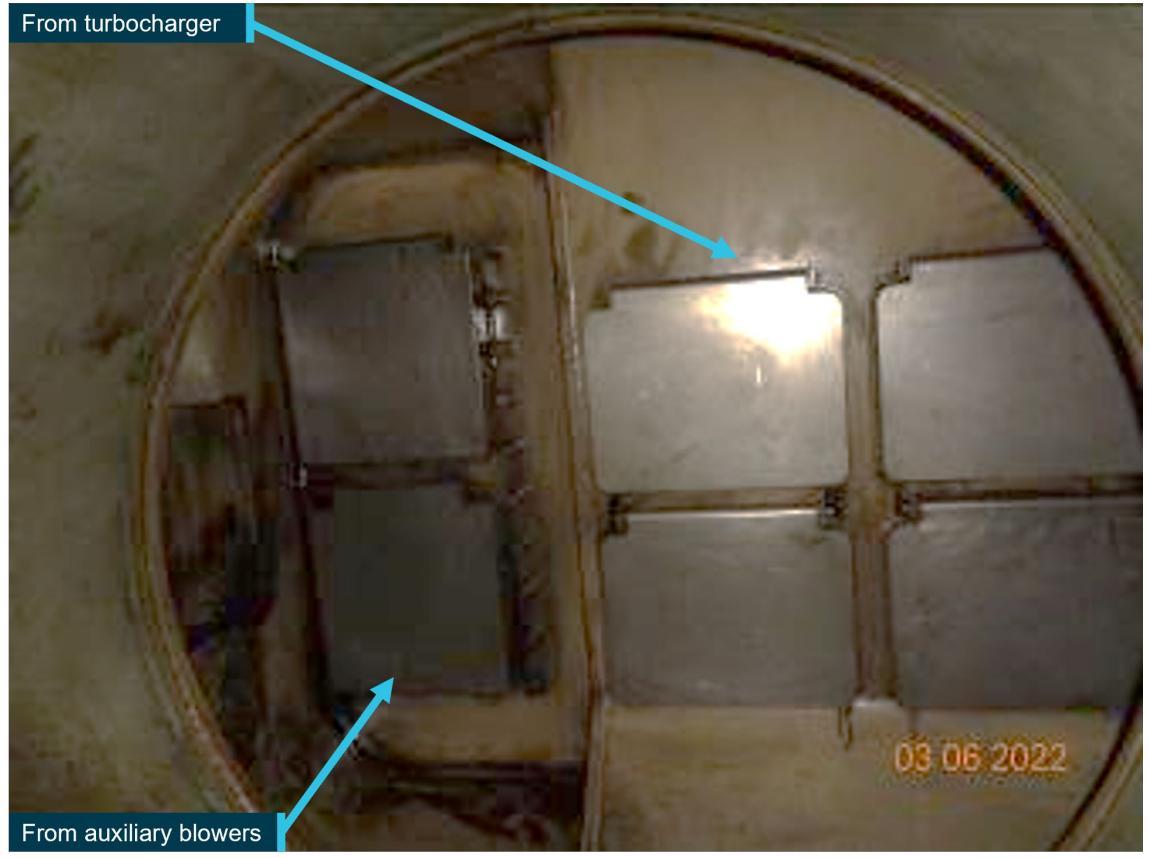
Figure 8: Air system non-return flaps

providing air at low engine load (speed) and stopped operating at higher load (speed) when the exhaust gas-driven turbocharger could meet the demand for air. The blowers drew air from the charge air cooler outlet and discharged it through non-return flaps, directly into the scavenge trunk (Figure 8). In effect, the blowers pumped air around the turbocharger non-return flaps.
