Navigational Claims

2020

1. Introduction

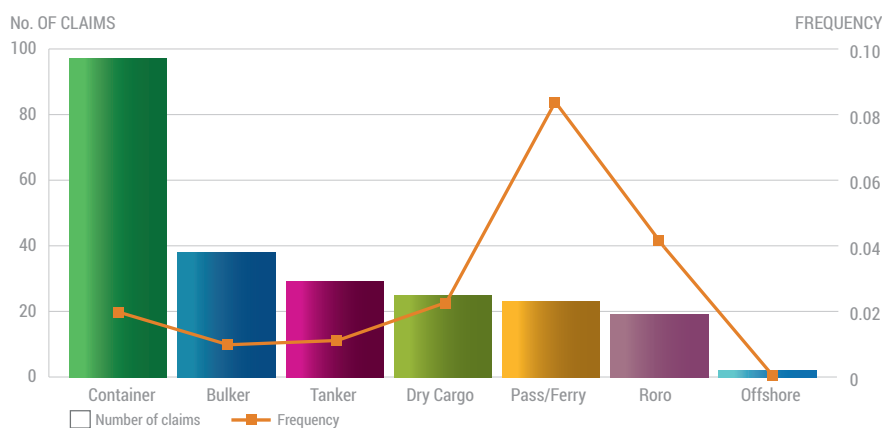
GRAPH 16

H&M contact: Number of claims and frequency by vessel type (2014 – 2018)
Claims cost > USD 10,000 – non capped
As per 4/2/2019

Container vessels experience most contact claims followed by bulkers and tankers. Passenger ferries and RoRos show the highest frequency which is similar to collision graph 8. It is no surprise that the risk for a contact will increase for a vessel the more it sails in and out of port, and this has been highlighted in our statistics. Some RoRo and passenger ferries depart and arrive at a port several times a day.

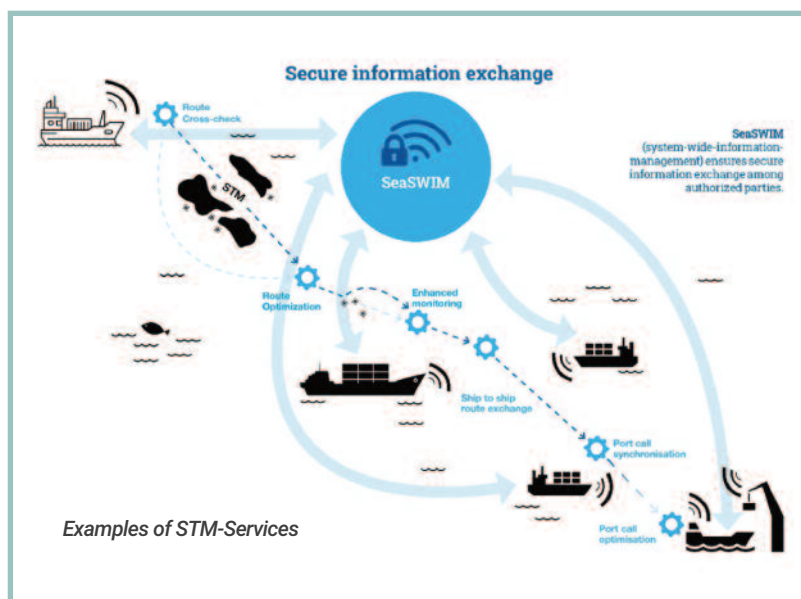
Today's bridge officers use a great deal of digital information to build their situational awareness - GPS, radar, AIS, and ECDIS. However, one important piece of the jigsaw is missing - the intentions of the other ships in the area. Whilst mind reading could come into play, STM uses an easier method: information sharing. The intended route in the ECDIS of the ships is shared over AIS, allowing officers an insight into the intentions of all ships in the vicinity.

As all vessels have access to the same information, a common situational awareness is established. Instead of worrying what others might do, the crew actually knows their planned route, and can choose to receive a notification if other vessels deviate from their plan. In order to avoid information overload, the officer can also choose which ships' intentions to display.
