# REPORT MARINE 2022/06

***Work accident on board ‘Stavanger Bliss’  
off Yeosu in South Korea on  
5 November 2020***

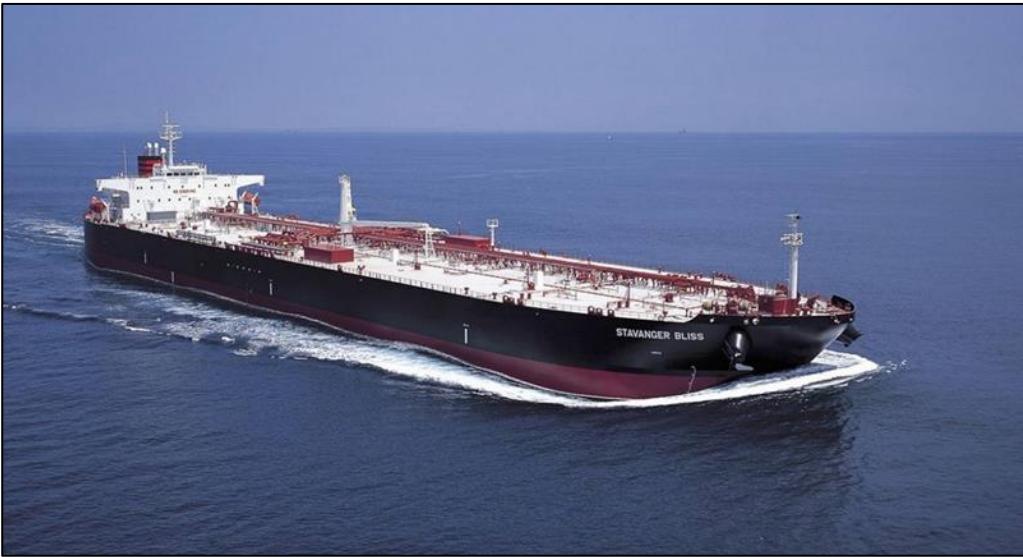
Figure 2: The oil tanker 'Stavanger Bliss'. Photo: Wallem Ship Management/DSD Shipping
