Bulker focus

Carriage of grains and soya beans

1. Introduction

In this guide we focus on cargo claims in relation to grains and soya beans. To be included in the statistics the claims must have generated a cost of at least USD 5,000 and have been made between 2018 and 2022

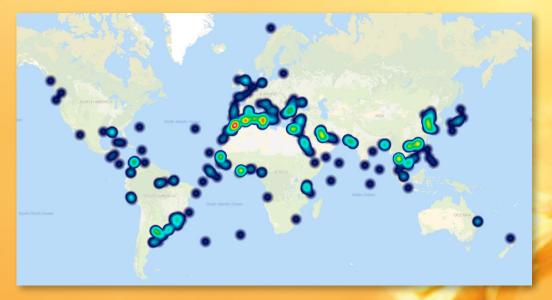
GRAPH 1

Grain cargo - geographical location of claims 2018-2022

A high density of claims is indicated in red.

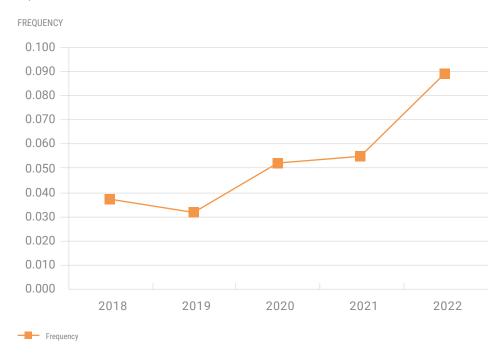
GRAPH 2

Grain cargo - frequency per year

The graph shows that the average frequency for the five-year period is 0.056, which means that 5.6% of all bulk carriers have made a grain claim. Since 2019 there has been a steady increase in frequency of claims.

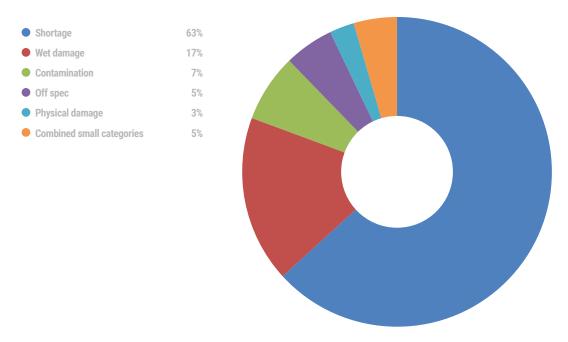
During the five year period of the report the most common claims were for shortage (63%) especially during discharge (68%) and these were seen most commonly in North Africa and China.

About 70% of shortage claims occur due to discrepancies between the vessel's figures and shore figures. In this five-year period there were few claims in China until 2021, but since then we have seen a steady increase in the region. Over the entire five-year period, however, most claims were in North Africa (see page 13).

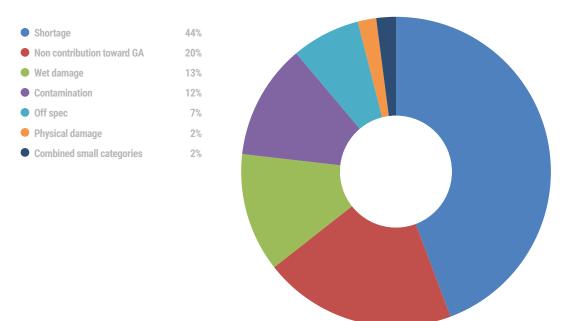
- Shortage contributes to 44% of the total claims cost, with an average claim cost of USD 35,000. Although shortage claims appear to be of relatively low value, the aggregate cost of these claims is, in fact, significant as they are common.
- Non contribution towards GA contributions make up 20% of the total cost, with a high average claim cost USD 800,000. (This type of claim takes place when the cargo owner does not contribute to GA, for example, during a salvage operation.) Fortunately these kinds of claims are few.
- Wet damage makes up 13% of the total cost, with an average claim cost of USD 37,000.

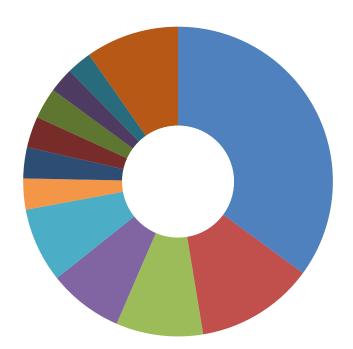
Grain cargo - cause of damage, number of claims

- The most common cause of damage is an error in calculation which is effectively a shortage claim. This category makes up 35% of total claims and more than 80% of incidents have happened at the discharge port.
- The second most common cause is improper cargo handling on shore side contributing to 12% of claims. This is equally likely to happen at either the discharge port or loading port.

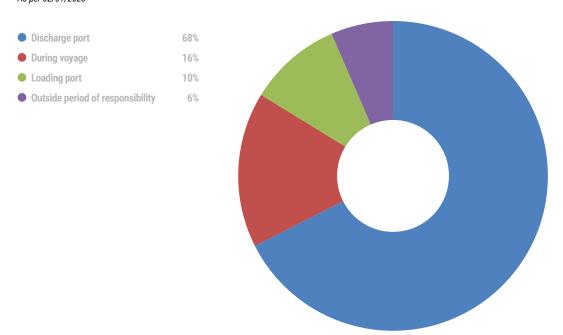
Grain cargo - where the claim occurred Claim cost: USD 5,000 - 3,000,000 2018-2022

It can be seen that most claims occur at the discharge port. These contribute to 68% of all claims and are mainly driven by shortage. Claims during the voyage account for 16% of these, and only 10% of claims take place in the loading port.

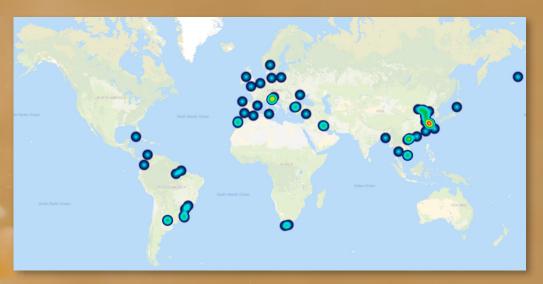
Soya bean cargo - geographical location of claims 2018-2022

The majority of claims have been recorded during discharge in China, with a number of claims from Europe

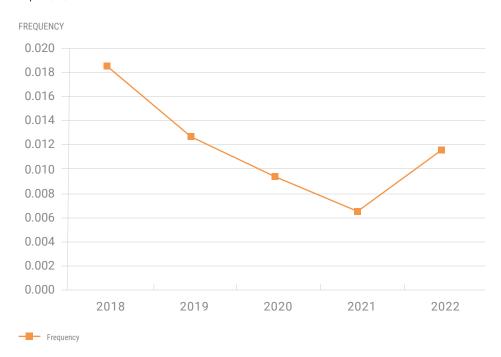
.GRAPH 8

The graph shows that the frequency for the five-year period is 0.011 which means that 1.1% of all bulk carriers have had a soya bean claim. The average claim cost is USD 54,000.

The impact of the pandemic can be seen, with vessels forced to stay at anchor for extensive periods. These delays can lead to heat damage which is a significant concern with soya bean cargoes.

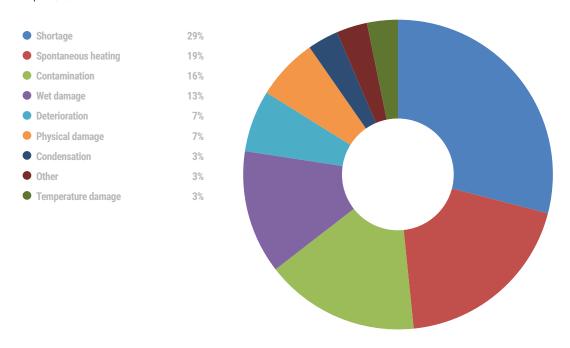
The most common claim is for shortage at 29%, followed by spontaneous heating at 19% and contamination at 16%.

When compared with grains, shortage makes up a considerably smaller percentage of claims (29% vs 44%). This is partly a trading issue (see section 2.2) but in addition the statistics have been influenced by COVID delays.

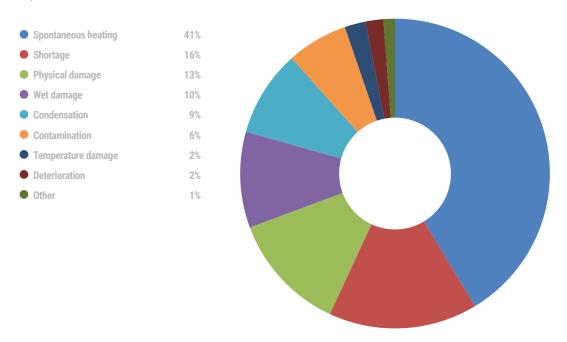
- Spontaneous heating accounts for 41% of the Club's total claims cost in this category, with an average claim cost of USD 115,000.
- Shortage makes up 16% of the total cost, with an average claim cost of USD 29,000.
- Physical damage contributes to 13% of the total cost, with an average claim cost of USD 103,000.

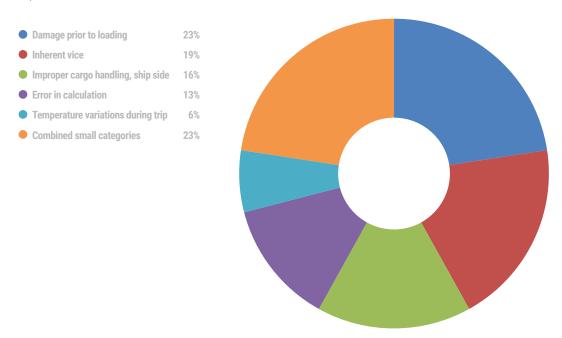
Soya beans - cause of damage, number of claims

- The most common cause of damage claim is is damage prior to loading, at 23% of total claims. When considering the damage that leads to these claims, 43% of these claims were observed in the loading port, 29% during the voyage, and only 14% at the discharge port.
- The second most common cause is inherent vice, at 19%. This manifests at the discharge port 50% of the time and during the voyage at 33%.
- The third cause is improper cargo handling ship side, at 16%. This category of claim relates to heating damage and wet damage, often caused by rain during loading and discharge.

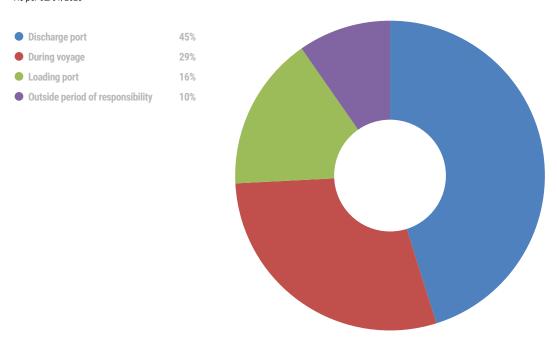
Soya beans - where did the claim occur? Claim cost: USD 5,000 - 3,000,000, 2018-2022

Most claims have been recorded at the discharge port at 45%, with 29% occurring during the voyage and only 16% in the loading port.
