The Swedish Club

## MONTHLY SAFETY SCENARIO

# Injury while climbing

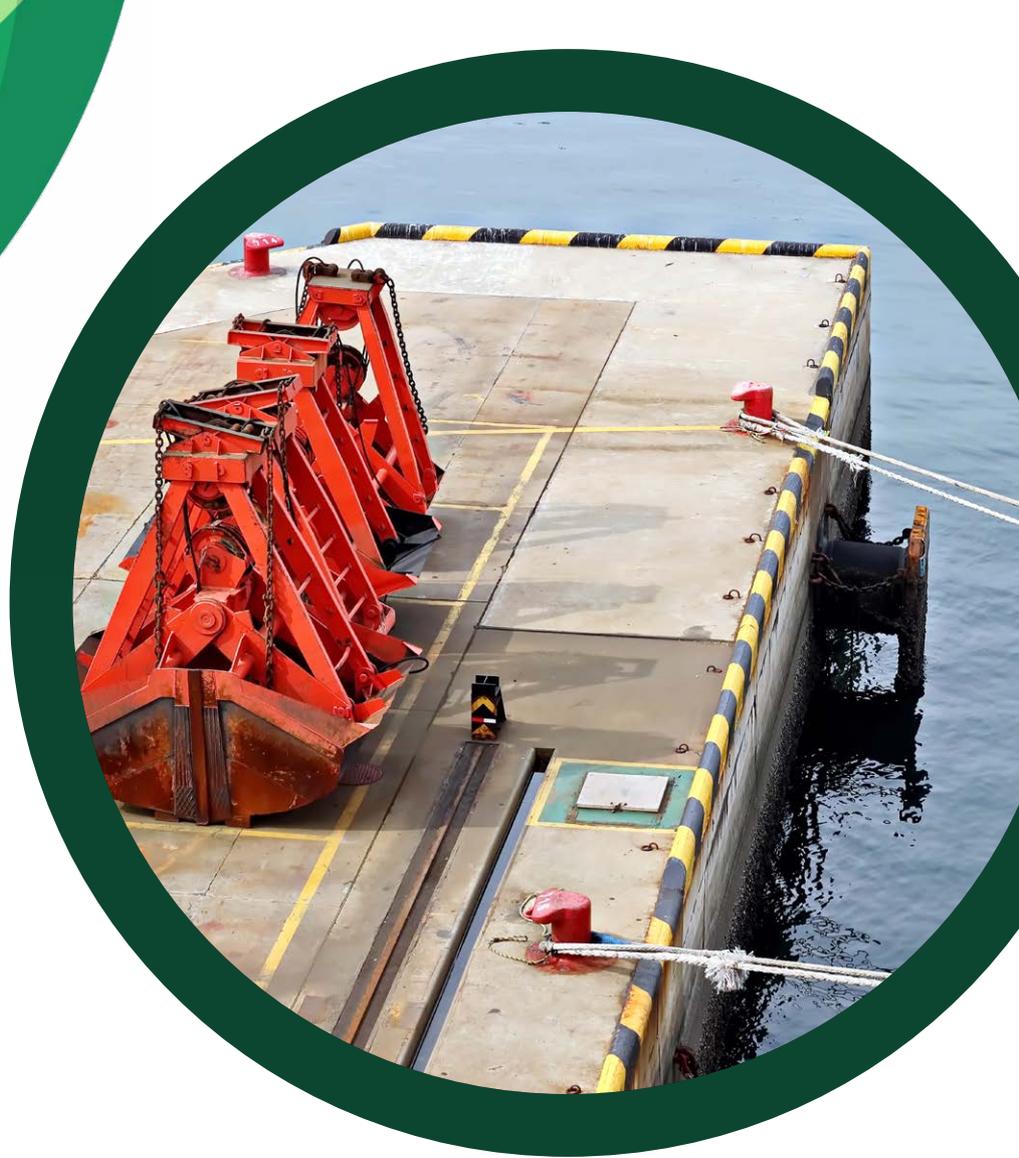
The AB operating the crane landed the grabs on the trailer in the open position with the bucket in a forward and aft direction. As soon as the grab was landed on the trailer one of the cadets climbed onto the grab to release the wires. The superintendent shouted to the cadet to get down at once.

It was observed that when the grab was on the trailer, the total height of the vehicle was about 10 metres, which was above the height restriction at the shipyard and on the roads, and so the plan had to be changed.

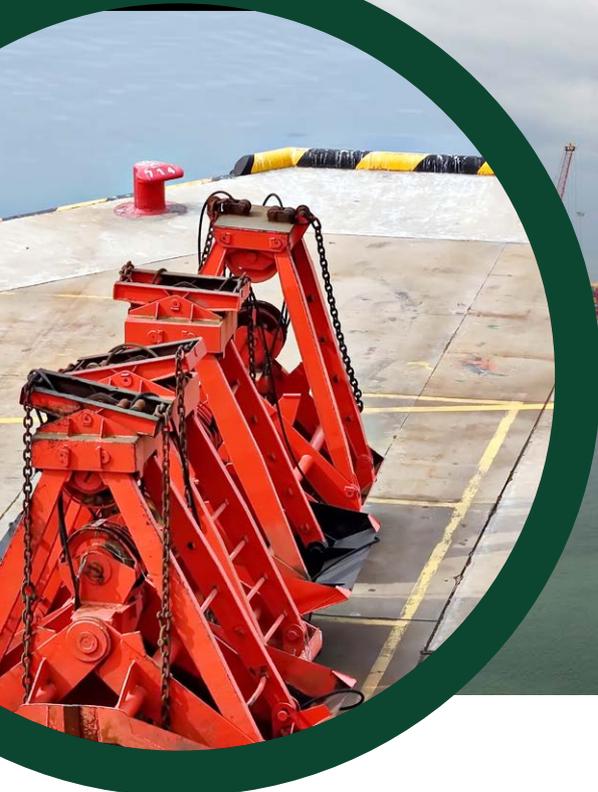
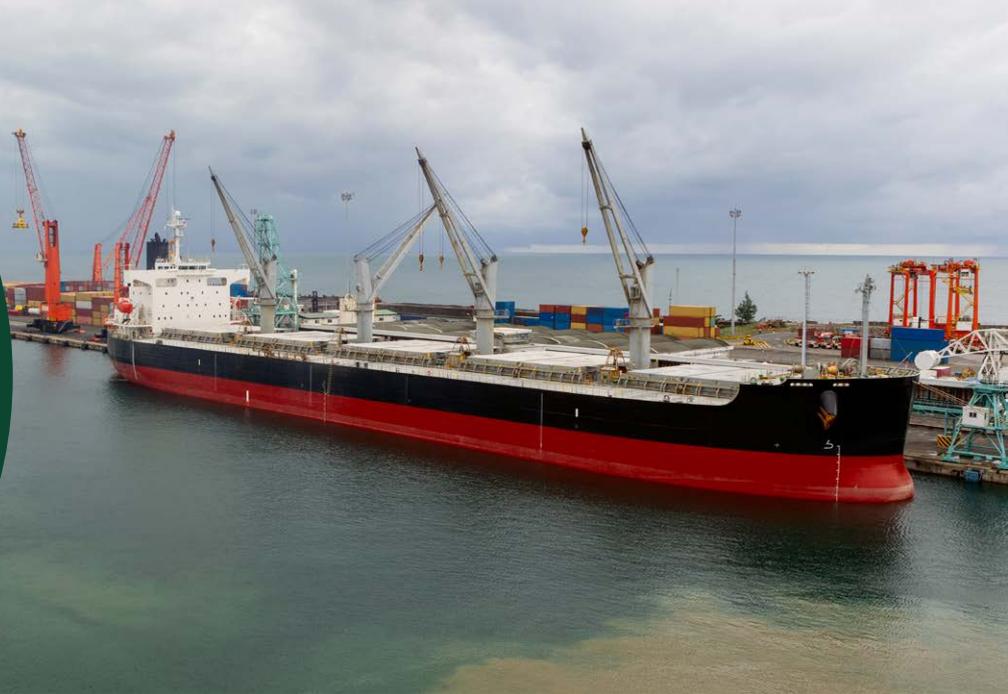
The decision was made to lay the bucket in the closed position with one side resting on the trailer bed. The bucket was closed and the grab was lifted and swung to stow the bucket in an athwartship direction. When the grab was landed it was secured by thick wooden planks below the bucket sides. Once the grab was stable the cadet once again climbed up on the grab to release the two hoisting wires from the crane. This was not noticed as the superintendent's focus was elsewhere and the other ABs and cadet were working with other wires on the trailer and didn't notice that the cadet had once again climbed up.

The cadet removed the wires from the grab. He had originally secured his safety harness to the grab but released the harness when he was climbing down. Instead, he had secured a rope to the top of the grab to assist him in climbing down. The grab appeared to be stable but was actually top heavy as it was in the closed position.

While the cadet was climbing down from the grab it suddenly shifted and fell into the water with the cadet.
