Ship Recycling in Turkey

Challenges and Future Direction

20 December 2023

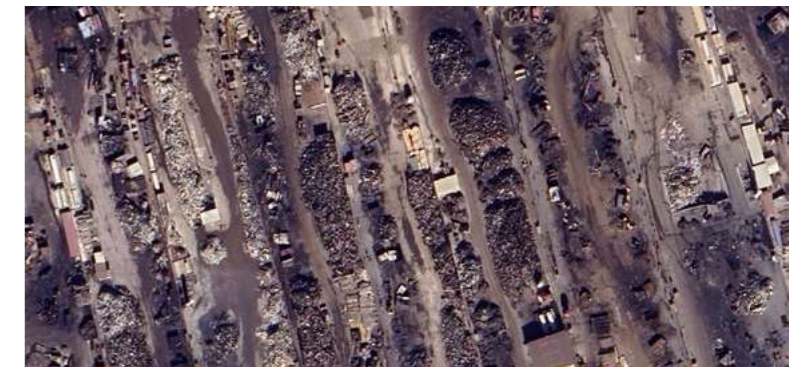
Discolourations

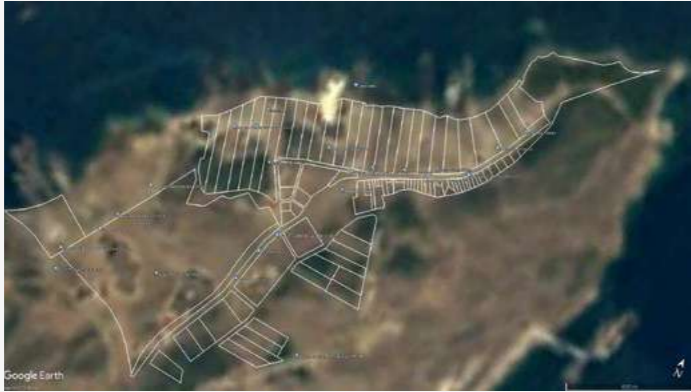
The area estimated from this blurry satellite view is relatively compact, the surface of yards is soil, the dumpsites were hard to observe, the scale of ships seems relatively smaller.
2006 66.4 (Ha)	 	The area of the ship recycling yards is similar to today, yet it is underused while the storages and administrative buildings are nearly nowhere to be found. Small dumpsites lie to the south of the area. The ships are of a smaller scale and the surface of yards seems to be soil.

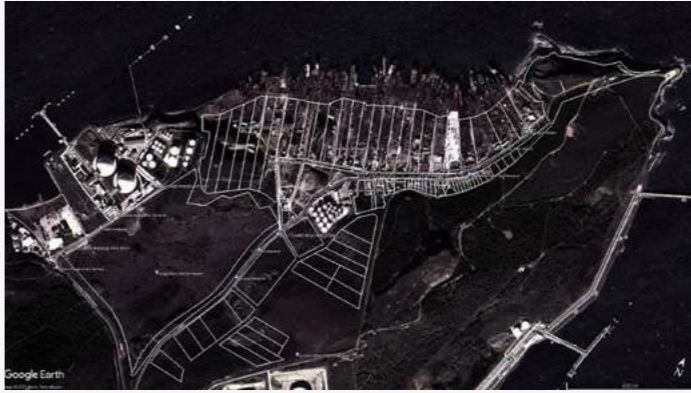
The area of shipyards has reached its maximum and nearly all area is used. Dumpsites are slightly sprawled and the surface seems to be discoloured concrete. The scale of ships are still small, while the number of storages and administrative buildings have increased.
2013 81.82 (Ha)

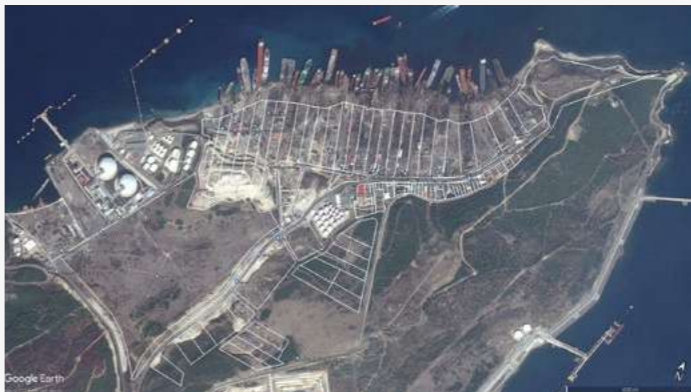
The expansion of the shipbreaking yards has stopped. The scale of ships has become slightly larger. A dumpsite right below the shipyards on the left is substantially expanded. The number of administrative buildings and storages have increased slightly, as well as the area fringed to the south on the path of the connection road.
2015 86.21 (Ha)

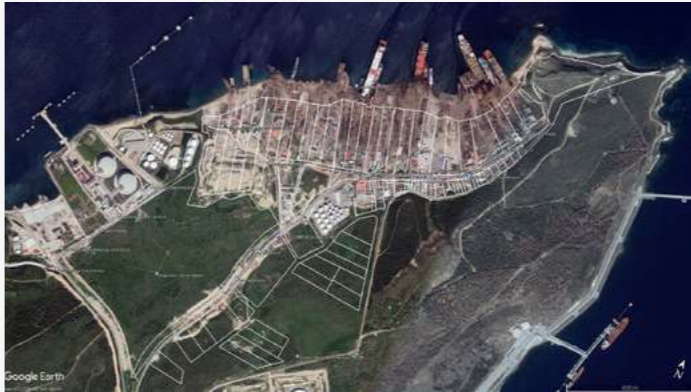
The area of shipbreaking yards has remained the same, while the outskirts to the south now have more storage areas and facilities. The dumpsite is not expanded but now has more layers. Administrative buildings have nearly reached their peak. The ships are now definitely larger.

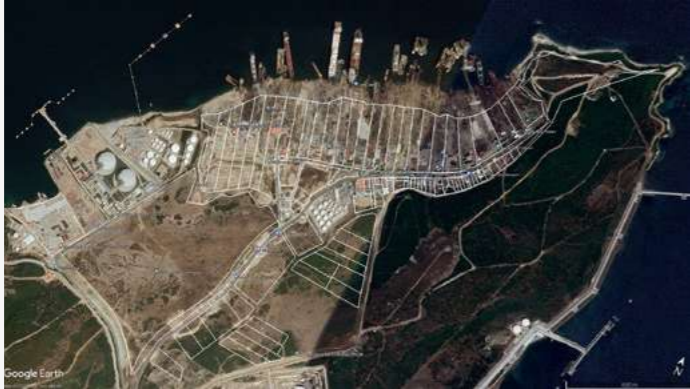
Some parts of the dumpsites are covered with vegetation and have become invisible from the satellite perspective, this could indicate a slowing down in activity, but otherwise not much has changed.
2019 89.18 (Ha)

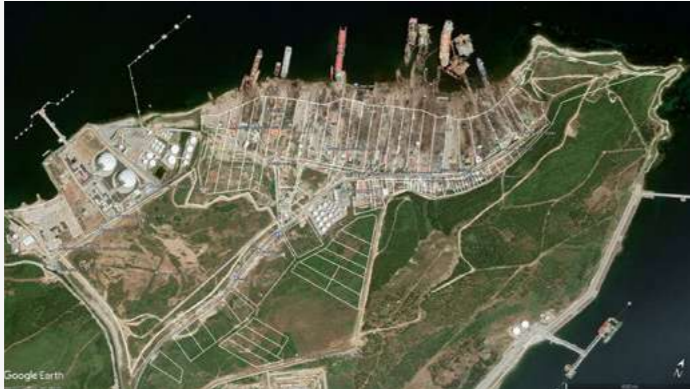
The outskirts on the southern part of the area seems to be expanding while other areas have remained nearly the same. The dumpsite appears less used in the last two years.
2021 91.91 (Ha)

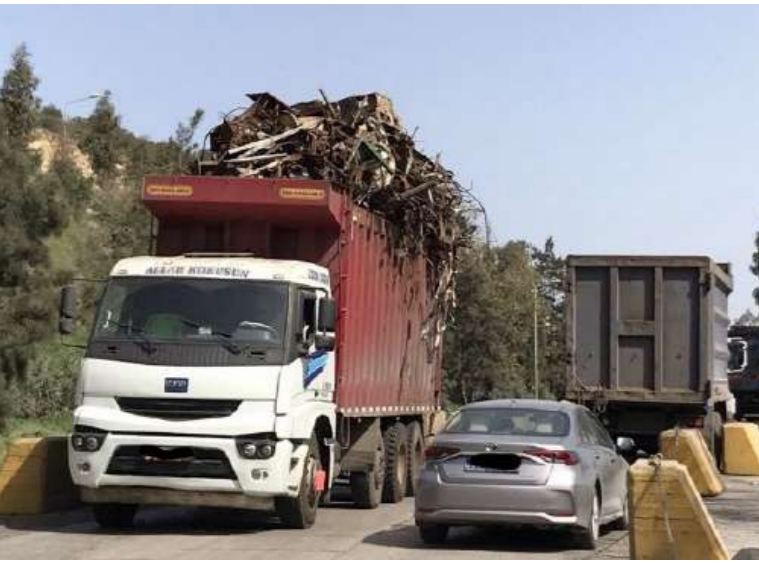
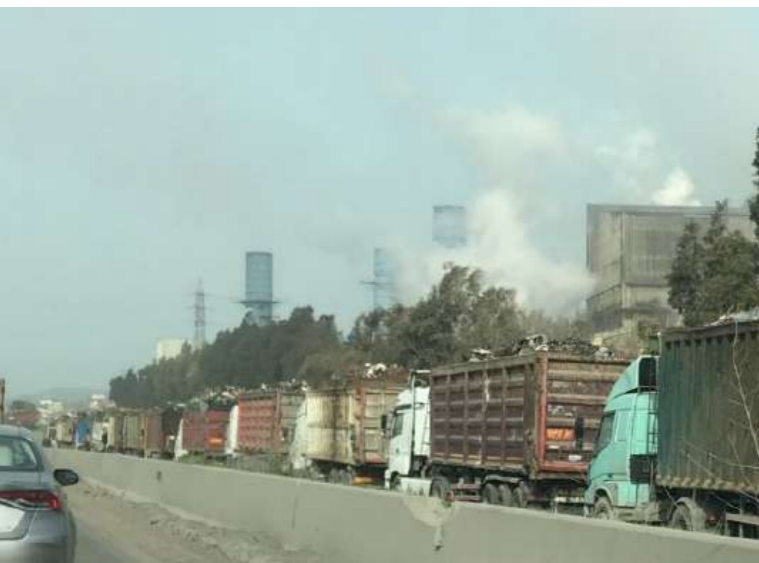
In addition, trucks from the ship recycling area are often loaded with scrap beyond their capacity and frequently spill materials along their way.¹⁰⁷ These overloaded trucks create risks for by-passers and traffic, pollute the environment and damage the road network. In 2020 alone, 35 traffic accidents were reported in the area, and 1.372 drivers were issued traffic fines.¹⁰⁸

Overloaded Trucks and Traffic Congestion

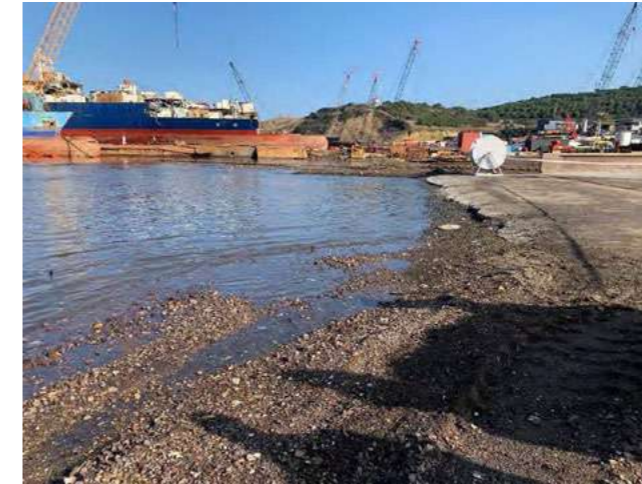
Foreshore

During their first inspections, EU evaluators furthermore noted that some facilities lacked sufficient measures to control leakage to water and soil,¹²⁵ such as adequate concrete and impermeable flooring.¹²⁶ In

addition, they found the intertidal zone to be polluted¹²⁷ with various debris,¹²⁸ "including all sorts of plastic, metal, wood, cables, chipping, rubbers, foams etc."¹²⁹ Whilst these deficiencies were since found to have been alleviated upon subsequent inspections at the concerned yards, with some facilities having extended

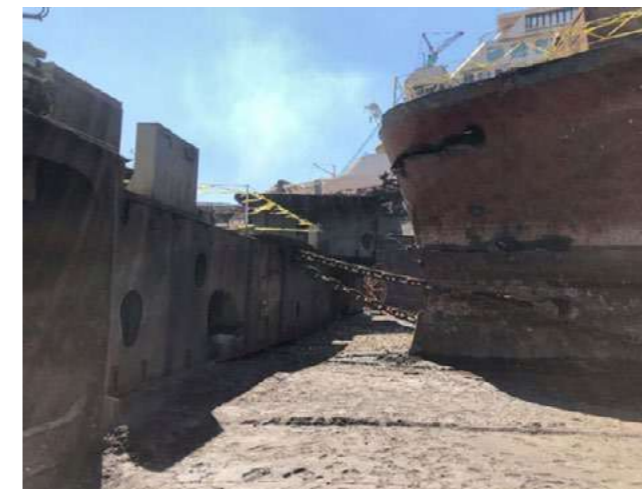
Aft part of the ship cut off on the beach

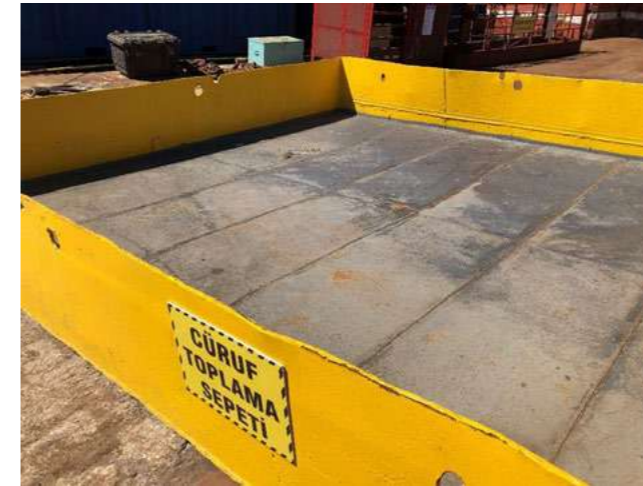
Slag collector

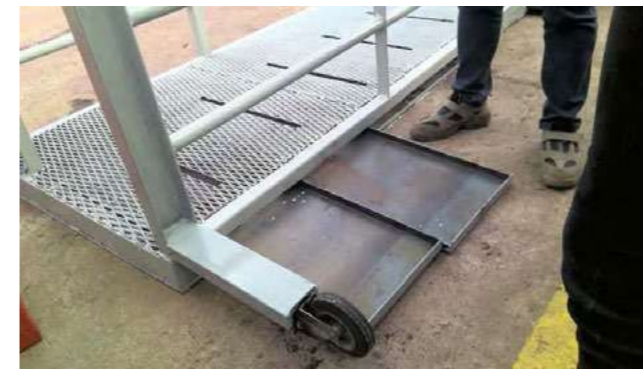
Prototype working basket with slag collection system

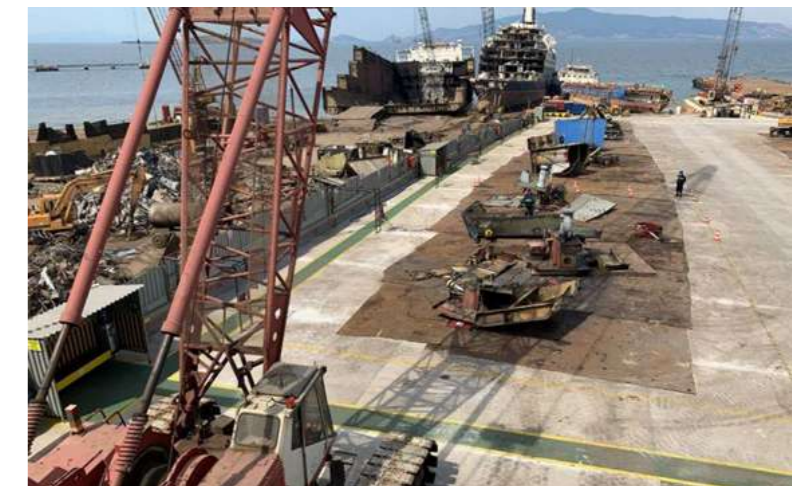
Secondary cutting area

The EU SRR requires that materials cut from the vessel and needing further cutting, be transported onto secondary cutting areas where cutting can take place on a concrete impermeable floor with drainage connected to storage tanks.¹³⁸ However, EU evaluators have found that some yards use steel plates instead of concrete flooring and have raised concerns.

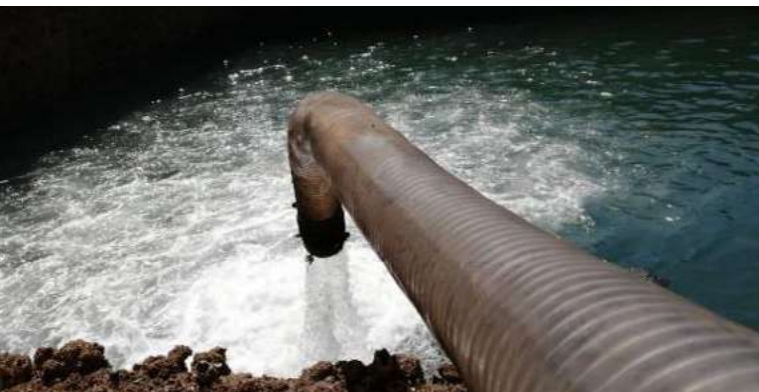
Discharging the ballast water to the sea

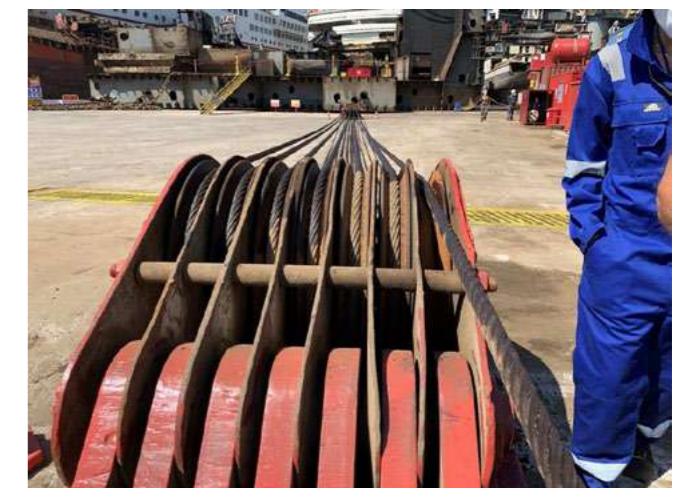
Pulley arrangement

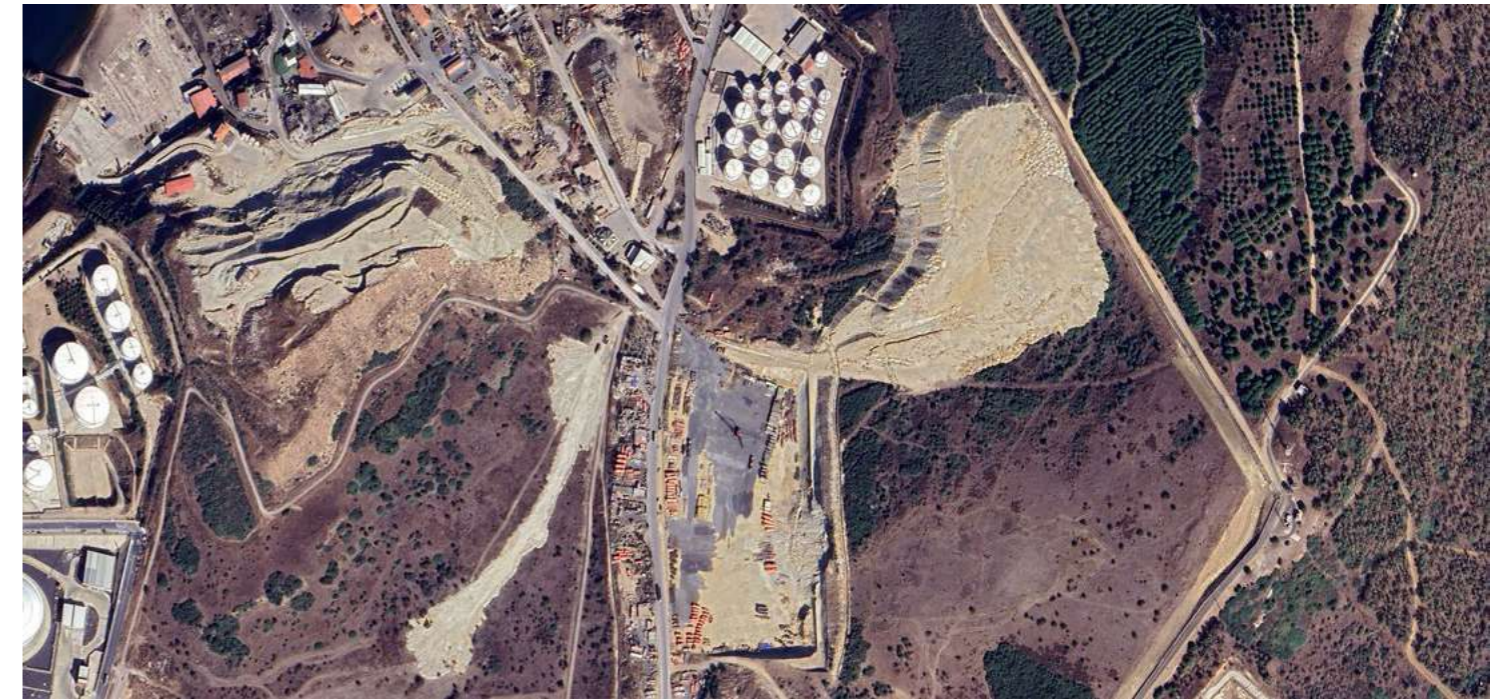
Dumping sites, May 2022

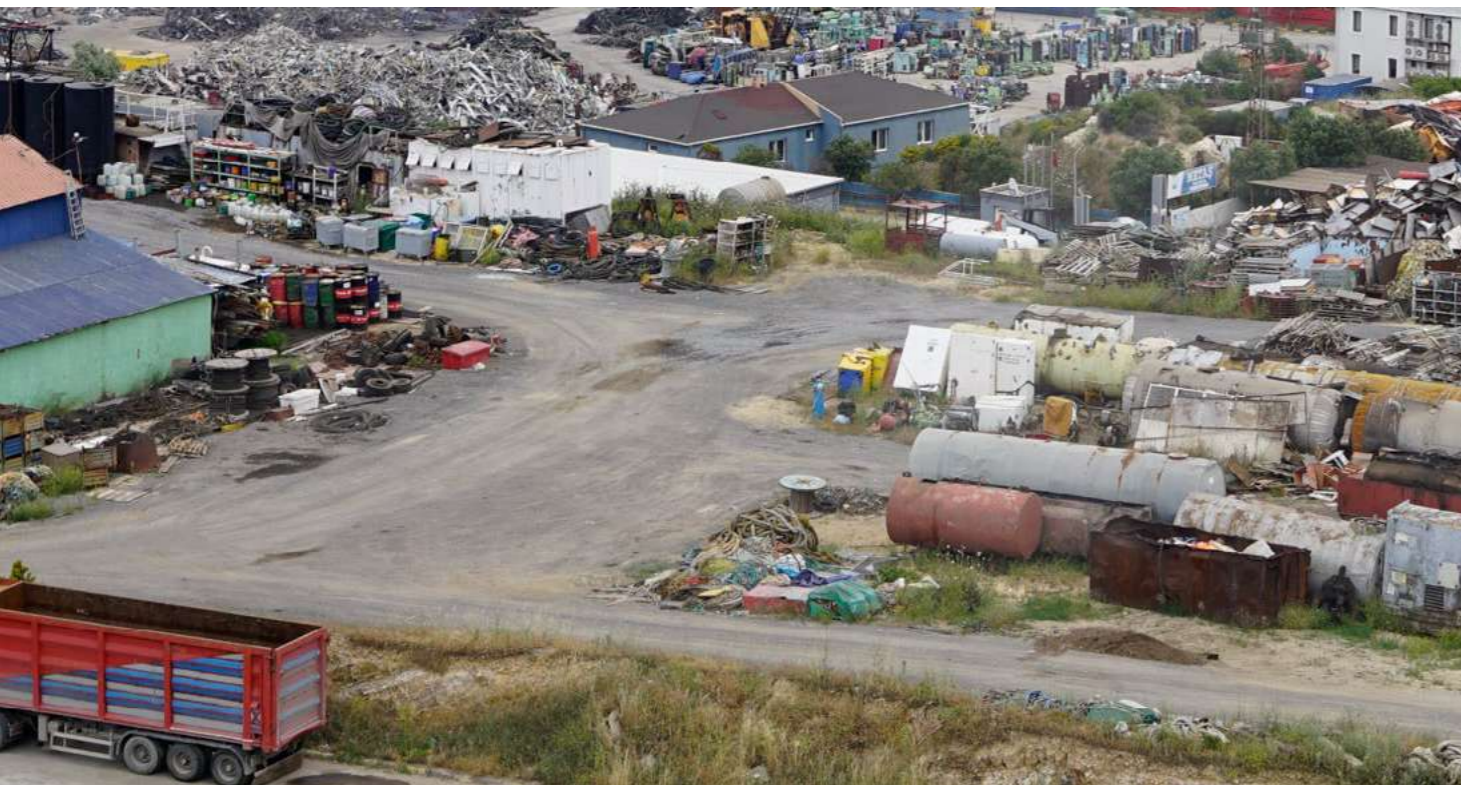
not questioned. For example, not all tanks comply with ISO standards. There must be a fire suppression system. Most of the walls are brick or aerated concrete. For real durability, the wall must be a concrete shear wall.”

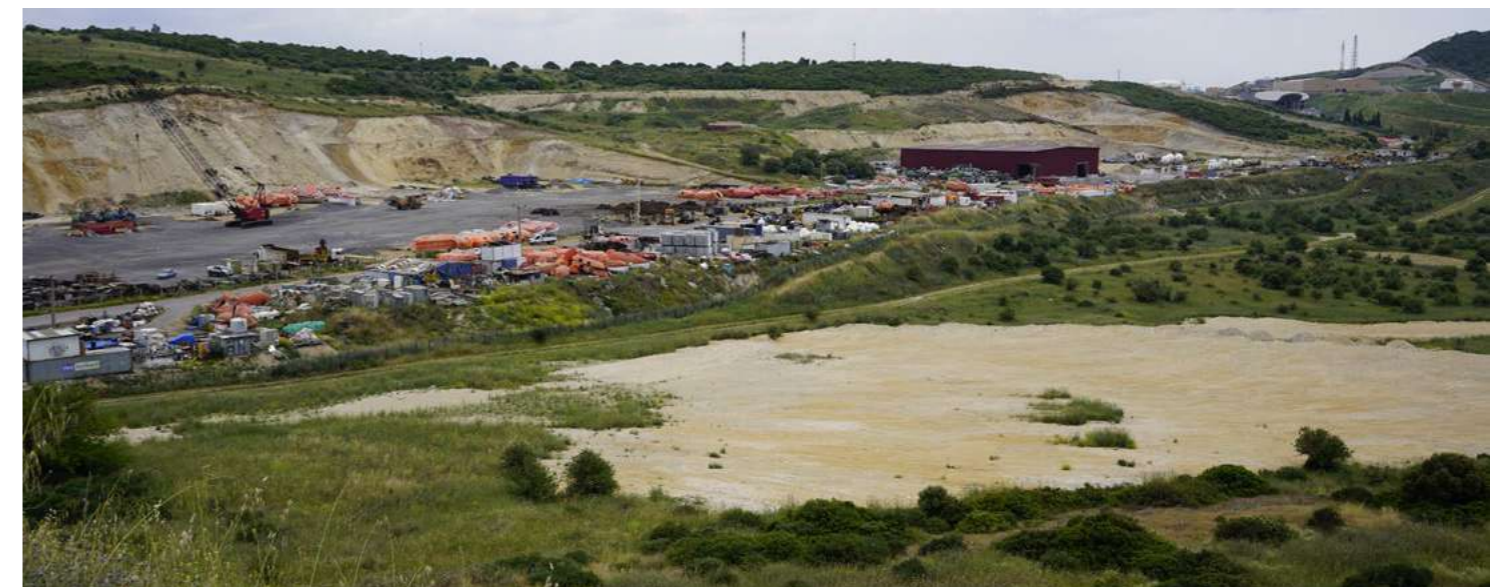
Storage Area Outside the Facilities
